# Geotechnical Assessment of Diversion Tunnels, Lower Subansiri Hydro- Electric Project Assam & Arunachal Pradesh

A.K.Choudhury\* and Biswajit Das\*\*

Five tunnels each of 9.5m diameter and 600m average length have been constructed through the left abutment of proposed 132m high concrete dam across Subansiri river for the purpose of diverting water during construction.

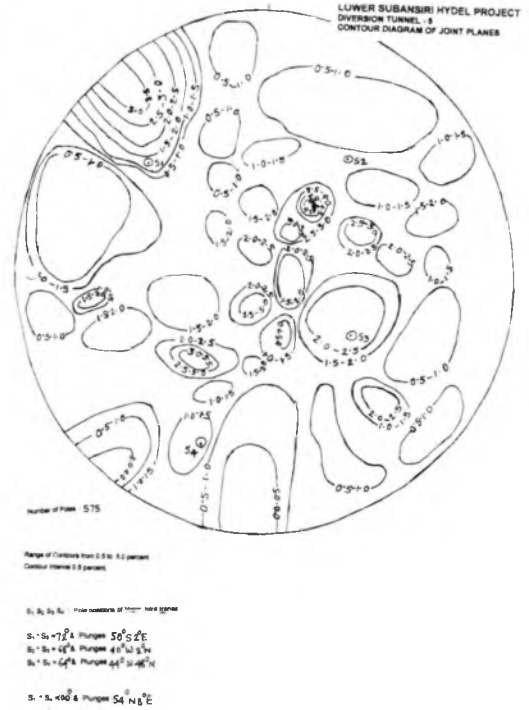
Fig. 5

The various joint patterns observed in tunnel 1 to 5 have been plotted stereographically. It can be broadly concluded through the projections that the tunnel alignment from inlet to kink point is mostly influenced by S 2, S 3, and S 4 joint sets (Fig. 4 & 5).

Wedges are formed in the kink area of the tunnels due to intersection of four joint sets. This kink area is the most critical portion of the tunnel in respect of joint orientation. The portion of tunnel between kink point and outlet

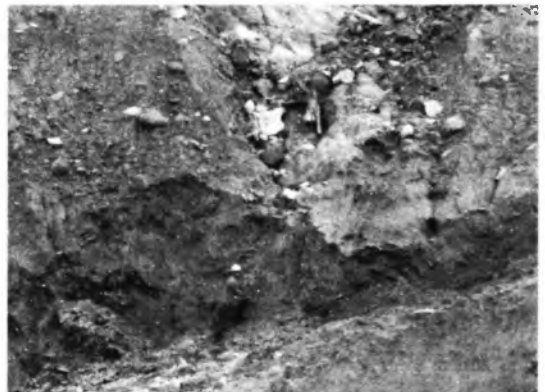
Fig. 7

Photograph showing Shear Zone on left bank of Deonala

A major shear zone traversed the entire area along the nala course. Highly sheared and crushed rock mass with black gougy material was exposed in a 10 m wide zone on the left bank of Deonala, 20-30m up stream of girder bridge. The trend of this shear zone was parallel to nala course having  $50^\circ$  dip component towards left bank, i.e south-easterly.
