Execution of a Long Tunnel Without any Mishap - Case of Bansagar Tunnel, Madhya Pradesh

Abstract

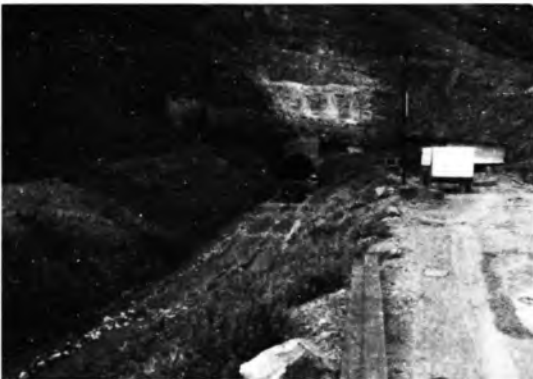
Photo 2: Inlet Portal of the Bansagar Feeder Tunnel.

rest 12% through fair to very poor (Paikray and Srivastava 2005 and Srivastava 2005). The sandstone falls in good to very good rockmass class whereas shale and shear/fault zones in poor to very poor category. Thinly interbedded sandstone and shale are of fair rockmass quality. A major shale band of about 28m thickness is exposed at inlet portal itself. Besides this, other geological problems encountered during tunnel excavation included presence of very poor quality of rockmass at the inlet portal site and flooding of tunnel because of free flow of water from the shear zone at Ch.m 1043.

The very poor quality of rockmass at inlet portal was mitigated by way for providing steel ribs as per the portal design.

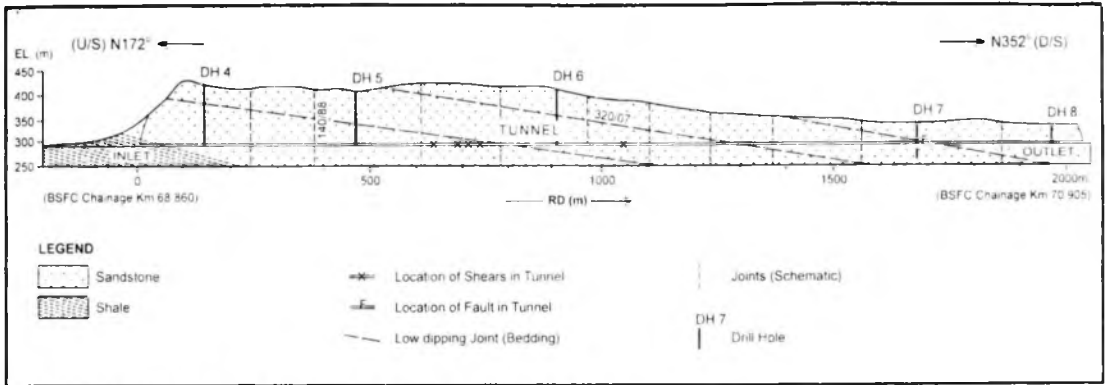
Fig. 3: Geological section along Bansagar Feeder Tunnel.

Thin shear zones of 10-50cm thickness have been encountered in the tunnel at Ch.m 25.8, 629, 690, 711, 743 and 1043 from inlet portal (Fig. 3). A gougy, steeply dipping fault with a throw of about 1m was intersected at Ch. m 1690 (Deva, 2005). The rock on either side of the fault also appeared fractured in about 15m zone along the tunnel alignment.

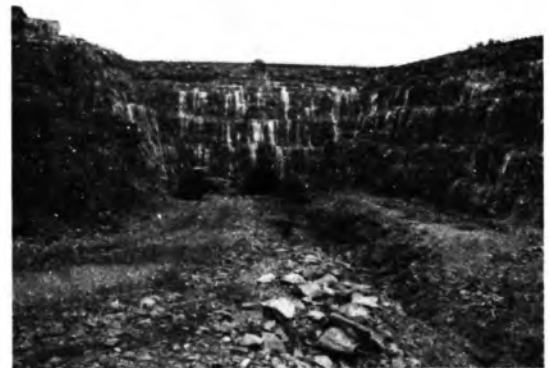
Photo 3: Outlet Portal of the Bansagar Feeder Tunnel.

A uniform stabilisation approach had been designed for the entire 115m long stretch of the open box-cut at the Outlet (Photo 3). The treatment comprised 5m long, 25mm dia torque steel rock bolts @ 1.5m C/C

staggered, inclined 10° - 20° in to the slope face, followed by wire mesh reinforced shotcrete of 50mm thickness. 75mm dia weep holes of perforated pipes, filled with pea-gravel, were being provided @ 5m C/C staggered. Seepage through these holes was proposed to be drained through contour drains on respective berms. It was, however, found that there was no provision for channelising seepage through individual weep holes that may lead to deterioration of the slope face – both technically as well as aesthetically. It was, therefore, advised to provide appropriate guided drainage from the weep holes to the contour drains (Deva, 2006).
