# Geotechnical Evaluation of Subsidence Cracks at Priyanagar Under Chakdah Block, Nadia District, West Bengal – a Case Study

Kalyan Surya Gupta\* and Debasish Bhattacharya\*

*A 60m long and 2-4m wide ground crack developed on 26<sup>th</sup> September 2007 at Priyanagar under Chakdah Block near Kalyani town of Nadia District. Besides badly damaging an old pucca house, this subsidence crack endangered the adjacent house and other structures. A detailed study of the ground crack was carried out to evaluate the causes and to assess the gravity of the incidence.*

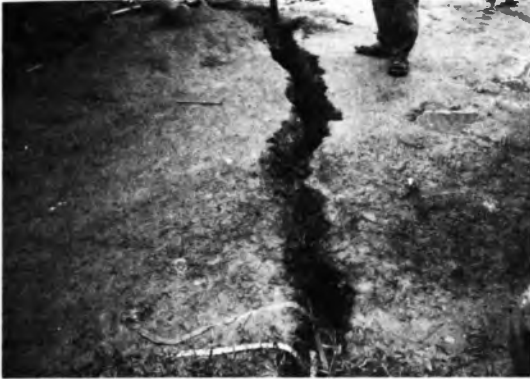
Photo 1

- i. **Ground cracks to the NE of the damaged house:** A visible and prominent crack starts from the western flank of the small pond and extends continuously for a length of 17m up to

the base of the damaged house. The crack in this stretch is 10cm wide and 30-40cm deep (Photo-1). The ground slope is towards the damaged house. The subsurface soil revealed by the crack is loose silty clay while on the surface it is clayey in nature and partly consolidated.

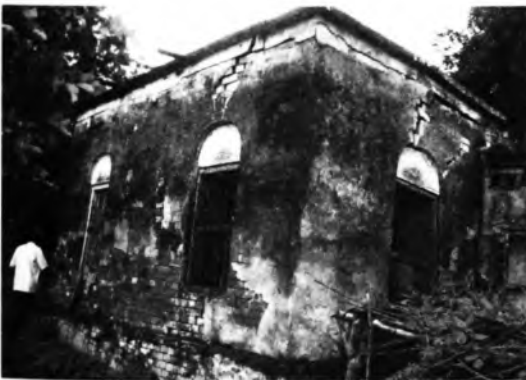
Photo 2

ii. **Cracks in the damaged house:** The 100years old house has been badly damaged with cracks all over the house, both inside as well as outside. The distress observed on the cemented floor, wall and ceiling reflects the gravity of subsidence. The tilting of the window and the base of the house is very prominent

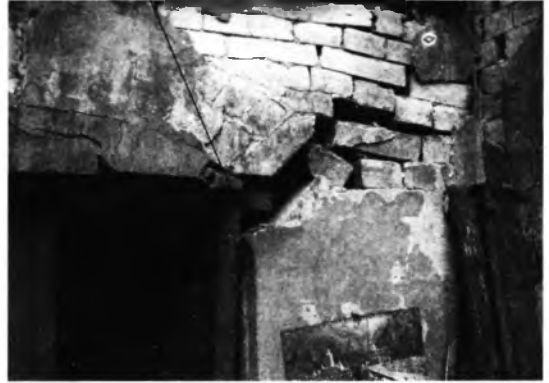
Photo 3

(Photo-2). The bricks on the wall and over the window arch are dislodged and some of the bricks have fallen down (Photo-3). The ground crack passes below the house and the trend is  $N70^{\circ}E-S70^{\circ}W$ . Both the rooms of the damaged house are badly affected. The cracks are

irregular but continuous in nature. Another house, relatively new, to the northwest of the damaged one but away from the crack alignment has not been affected at all. It is reported that the hand pump in the north of this house has intercepted ground water at a shallow depth of 3.0 m with sand layers occurring at 3 to 4m below ground level.

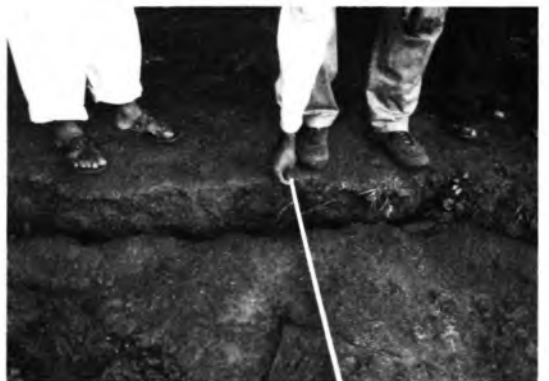
Photo 4

iii. **Subsidence zone:** The ground crack extends further west beyond the damaged house up to the bigger pond. The ground in between the house and the pond has subsided up to a depth ranging from 35 to 75cm. The width of the affected area is 4.6m(max.). The tilting of a mango tree falling within this zone is very prominent. The cracks bounding the subsidence zone trend  $N80^{\circ}E-S80^{\circ}W$  and the approximate extent of this crack is 45m (Photo-4) . The width and depth of the crack

decreases towards the bigger pond. It gradually dies out and reappears at the eastern boundary of pond-II. The seepage of water, along the crack, from the smaller pond to the bigger one is not evident on surface but a discernible flow of water with carriage of finer sand particles is observed at the terminal point of the crack near the big pond (Photo-5). It was informed by the locals that the level of water in the smaller pond, which is at a higher elevation, was decreasing gradually, though the same could not be confirmed due to monsoon. The ground

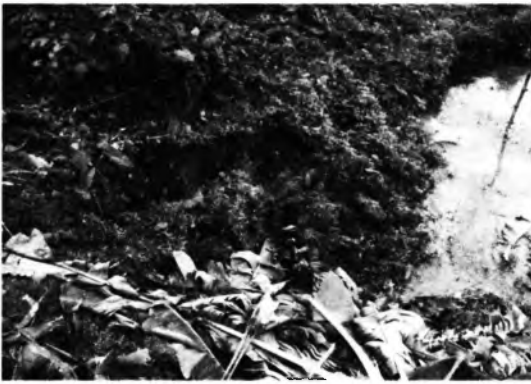
Photo 5.

cracks in the subsidence zone are up to 75 cm deep and generally linear in nature though circular cracks are also noticed. The soil collected from the fissures indicates a silty-sandy-clay composition.
