Recent Landslides In Goa - An Overview

Uttam Kumar Pradhan* and Akshaya Kumar Mishra*

Abstract

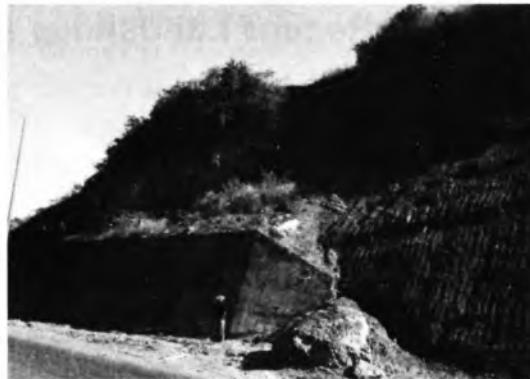
Twenty two numbers of medium and small slides were recorded in this section. The area comprises of weathered granite gneiss, granite and basic dykes. Thickness of overburden consisting of soil and weathered rock varies from 1 to 5 m. Majority of the slides were found to be shallow debris slides caused mainly by toe cutting of the slope for making roads (photo 1 & 2). The vertical cuts have failed due to heavy rainfall during monsoon.

The debris consist of boulders, rock fragments and colluvial deposits. Length of the slides varies from 10 to 25 m and breadth from 5 to 32 m. During the rainy season, heavy infiltration caused over-saturation of slope material which resulted in increase in

Photo 1. The debris slide on NH-4A Panjim-Ponda road. Retaining wall has to be extended.

pore pressure and decrease in shear strength.

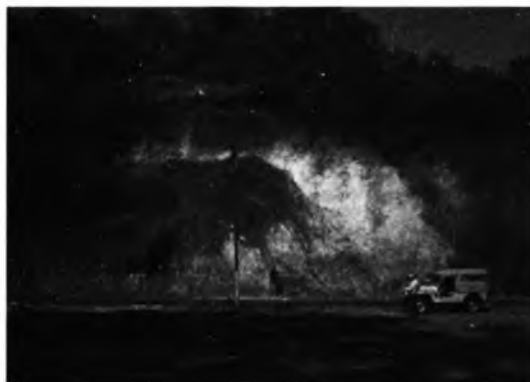
Photo 2: The debris slide at km 129 on NH-4A (Panjim- Ponda road).

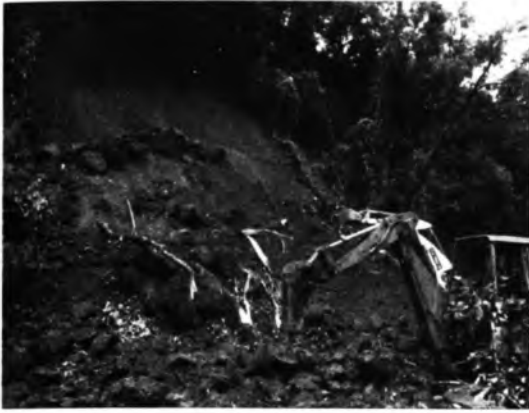
A slide occurred on the NH 17 in the hillock just opposite to the Goa Assembly Complex at Porvorim near the Mandovi Bridge circle (photo-3). The debris slide at Betin, Porvorim is due to toe cutting for road widening. The steep hill slope failed during heavy rainfall in monsoon of 2007. The slope has been graded to improve its stability.

Photo 3: The debris slide at Porvorim on NH-17.

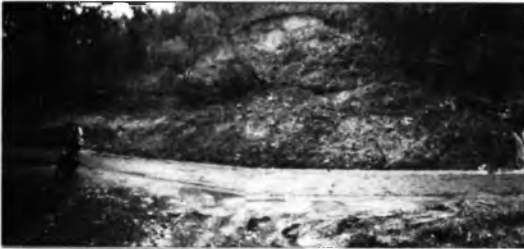
Photo 4: Landslide that occurred near Dicarpole Village, South Goa on 14-07-05.

This one occurred near Dicarpole Village, South Goa on 14-07-2005 (photo-4). Studies carried out revealed that the country rock is highly weathered quartzo-feldspathic gneiss intruded by pegmatite, quartz vein and numerous dolerite dykes. Foliation in gneiss trends N35°-40°W and dips at 35° towards NE. Factors found responsible for occurrence of the slide were weathering of the rock, increase in unit weight of the slide material due to over-saturation, cutting of the slope for road formation and increase in pore pressure (Dharuman, 2005).

Preventive measures suggested are the stoppage of indiscriminate cutting of hill slopes and stabilizing the existing cuts, provision of contour drains and restoration of vegetal cover etc.

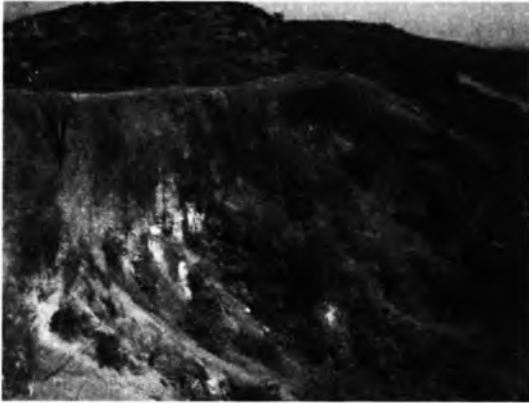
The slide at Wydongar hillock is a reactivated retrograde debris slide (photo-5). Length of this slide is 83 m, breadth 75 m and scarp depth is 9 m. The locality is covered by laterite and clay and they failed due to undermining of toe by Chopra River. Besides, cutting at the toe for accommodating the

Photo 5: Debris slide at Wydongar, North Goa.

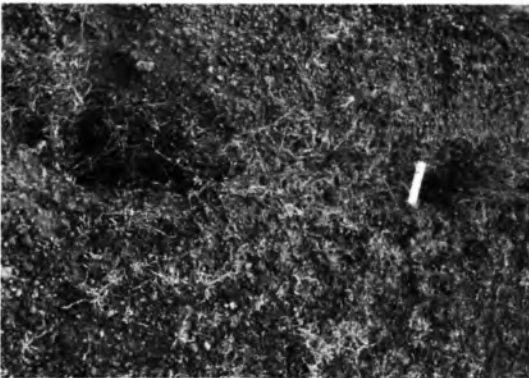
village at foot hills and modification of the slope for cashew plantation added to the problem. Concentric crown cracks of length 50 m and width 0-15 cm are noticed in the Wydongar hillock (photo-6).

Photo 6: Concentric crown cracks in the Wydongar hillock.
