Geotechnical Appraisal of Dam Foundation of Adavinainarkoil Reservoir Project, Tirunelveli District, Tamil Nadu

E. Ramalingam, S. Chandrasekharam, E. Bahasubramaniam and G. Rajgopalan

Abstract

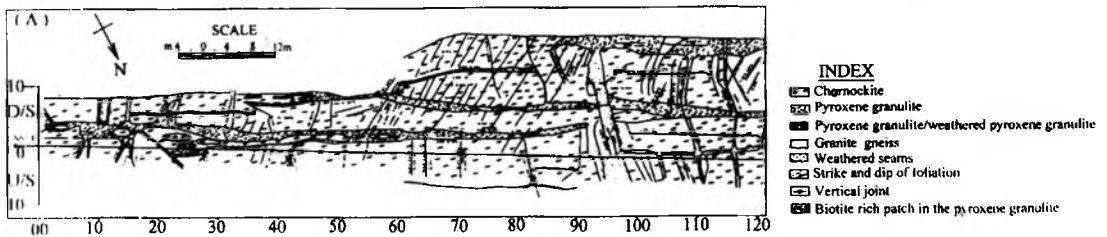
Fig.2. Foundation geological map of adavinainarkoil reservoir project (A) Part of Left Abutment

In the left abutment (Fig.-2 & 3) deep weathering is persistent along the shear zone which is parallel to foliation/ foliation joints. The shears cut-across other sets of prominent joints in the foundation area. In total, seven such shears have been observed in the foundation media, with their width varying from 0.20 m to 2 m and the length from 25 m to 175 m. These shear zones run parallel or sub-parallel to the dam axis with moderate to steep dip towards downstream.

In addition, a number of minor weathered seams disposed perpendicular to the dam axis merge with main shear zones. There are seventeen such zones observed in the foundation media with width varying from 0.50 m to 2 m and length from 2.00 m to 19.00 m. Besides these shear zones, minor seams were also observed and recorded.

- i. In general, along these shear zones, excavation has been done up to fresh rock level to the maximum possible extent or else up to double the width of the weak zone and back filled with concrete.
- ii. A number of weathered seams and joints run normal to the dam axis from Ch. 0 m to 60 m. They are likely to transmit the reservoir water from upstream to downstream. Hence, the curtain grout holes were recommended to be extended up to Ch. 30 m and also the drainage gallery/drainage duct extended up to Ch. 30 m with the provision of drainage holes. Consolidation grouting of the foundation was suggested from Ch. 60 m to 224 m with the holes inclined at 60° and directed towards right abutment.
- ii. In other reaches, consolidation and curtain grout holes of the foundation were

- iii. In some reaches, weathering was found extending to a depth of 3 m and beyond. At such locations, in addition to dental treatment, mat concreting has been suggested to transmit the load uniformly.
- iv. Wherever the dam block terminates at or close to the prominent weathered seams (trending parallel to the axis) the block width has to be extended beyond the weathered seams into the fresh rock.

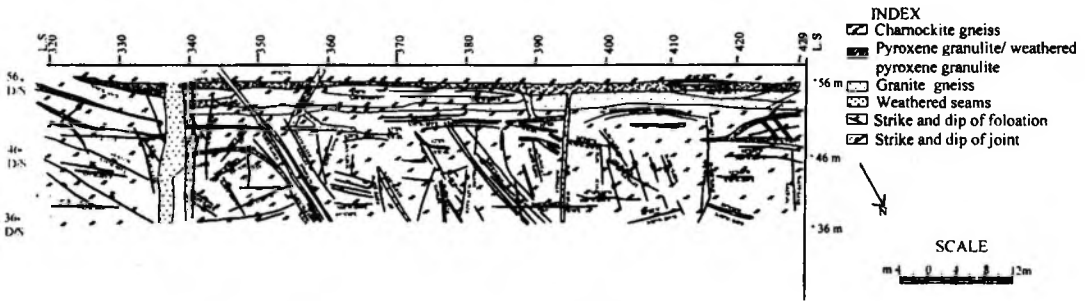
Fig. 4. Foundation geological map of Adavinainarkoil Reservoir Project (C) Stilling Basin Area

It is occupied by massive, hard and compact charnockite and granite gneiss. The granite gneiss occurs as a linear band with a width of about 1 to 3 m. The pyroxene granulite found in the foundation is deeply weathered due to foliation shear. Such type of bands with width varying from 0.5 to 2 m and length from 0.8 m to 103 m are found at eleven locations. Prominent open joints were observed at fifteen locations, with width varying from 0.4 to 4 m, length from 1 m to 15 m and depth up to 3 m. In addition, some incipient tight joints were also mapped in the foundation. For these deeply weathered zones and open joints (Fig -4), dental treatment was suggested.

The stilling basin baffle wall was proposed to be terminated at Ch. 56 m d/s from the dam axis. A prominent weathered zone was intercepted from Ch.55 m to Ch. 57 m d/s. It is disposed vertically to an indefinite depth, the removal of which down to fresh rock level was not possible. Termination of the baffle wall in the middle of prominent weathered seam might result in retrogression / scouring

of the weathered and sheared pyroxene granulite towards u/s leading to destabilization of the baffle wall. Hence, the foundation concrete was suggested to be extended up to Ch. 57 m d/s. Wherever fresh rock was available beyond the weathered zone, excavation down to fresh rock level or a shear key and anchoring the wall to fresh bed rock by pile, if the excavation is too deep were recommended. This was to be evaluated keeping in view of the techno-economic considerations. Further, additional grout holes in areas of weathered/ shear zones and joints and seams were recommended in addition to foundation grouting of the entire area.

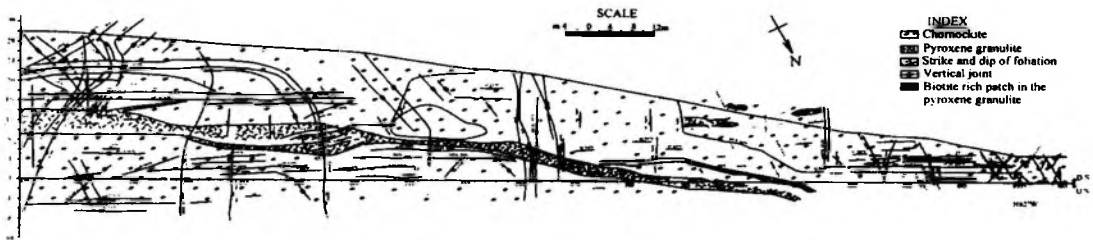
Fig. 5. Foundation geological map of Adavinainarkoil Reservoir Project (B) Part of Right Abutment

The non-overflow right abutment dam blocks fall between L.S. 475 m and 663 m. It covers an area of 5,368 sq m and is occupied by charnockite gneiss and pyroxene granulite. At places, biotite rich patches occur in the pyroxene granulite bands. Occasionally coarse grained pegmatoidal charnockite was found running parallel to gneissosity. The general foliation direction is $N60^{\circ}W - S60^{\circ}E$ with a dip of 70° to vertical towards $S30^{\circ}W$. Five prominent sets of joints have been recorded. They are curvilinear, smooth and some of them are almost parallel to dam axis. (Fig. 5). Generally the rocks covering this abutment are massive because they are in rain shadow region of Western Ghats. The weathering effect is very less when compared to left abutment. The charnockite gneiss exposed in the foundation is generally hard,

fresh and compact and the discontinuities / joints present in the foundation are slightly open to tight in nature.

- i. Wherever weathered and stained surfaces were found in the foundation they were recommended to be removed by chipping before concreting.
- ii. Between Ch. 542 m and Ch. 559 m, 9 m and 14 m d/s, a huge charnockite block rested on weathered pyroxene granulite. This was to be anchored to the fresh rock available below the weathered rock.
- ii. Additional consolidation and curtain grout holes were suggested from Ch. 535 m to 565 m; 8 m to 26 m d/s at a spacing in the order of 3 m x 3 m square pattern. It was recommended to consolidate the rock with foliation and N – S trending joints, which are open and highly weathered.
