Leakage in Head Race Tunnel and Surge Shaft and its Remedial Measures - Case Study From Ranganadi Hydroelectric Project, Lower Subansiri District, Arunachal Pradesh

Ranendra Sarma and Anjani Bora

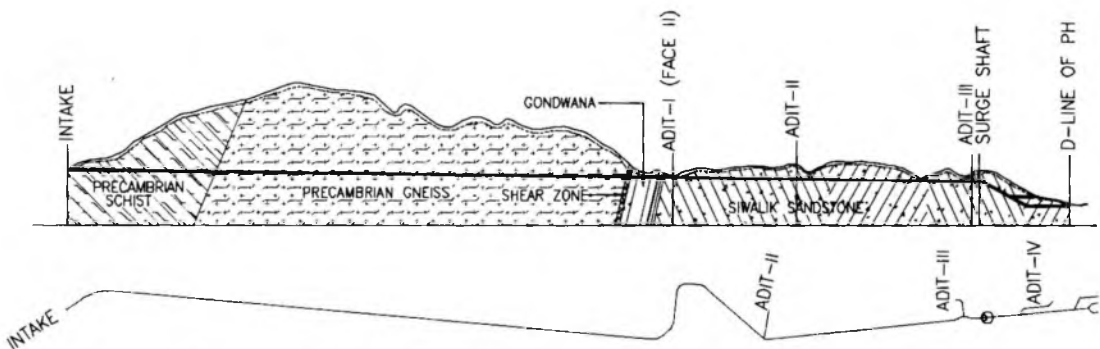
Fig. 2. Geological section along head race tunnel

Surge shaft and HRT were excavated through fresh, grey, medium grained soft and friable sandstone. The rock is mostly under the cover of 1 to 2 m thick overburden. Due to the Himalayan building activity, the Siwalik sediments are overridden by the Gondwana rocks along the Main Boundary Fault and got intensely folded and faulted. Series of plunging anticlines and synclines are, therefore, commonly seen in the area.

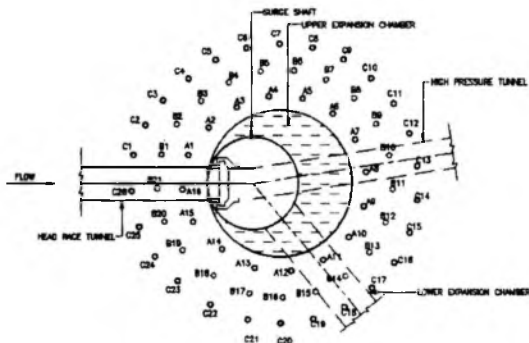
Fig. 3. Grout hole pattern for surge shaft

Water leakage around Adit-II and Adit-III of Water Conductor System (Fig.3) of the Project had been a constant source of problem for the project since its commissioning in 2001. Earlier, the leakage was observed in Adit-II with maximum quantity of 800 lps. Treatment was carried out twice; once in the year 2001-02 and again in 2003-04. It was successfully tackled with cement/epoxy grouting of the contact between steel liner and concrete lining, cracks in rock and around the plug.

Three rings grout curtains with depths varying from 60 m to 105 m were placed around periphery of surge shaft at a pressure of 2 kg/cm² (Fig.3). The spacing of holes was 4.5 m to 6.0 m and grouting was done in 5 m

stages by ascending order. There was a wide range of grout intake as shown in Table 1. Total number of holes drilled for grouting purpose was 63 and the cumulative depth drilled was 6,045 m and the total quantity of cement injected was 19,250 bags. The inner ring was initially placed followed by the outer ring. The middle ring was placed at the end and average grout intake per running meter was comparatively less in this ring.
