Slope Stability Measures Adopted In Kimi Powerhouse - Case Study of Kameng Hydroelectric Project

Dipankar Baruah and Rajanish Ranjan

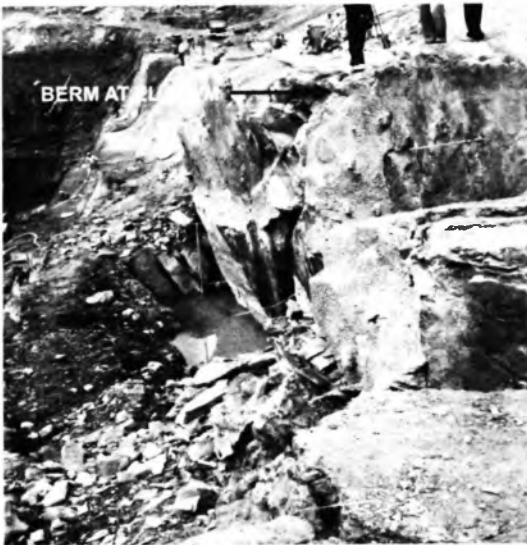
As observed in August'2006, joints started to open up day by day and as a result the berm width (~10m) reduced to 5 – 7 m at some locations. Cracks of width up to 30 cm were observed to be forming in thickly bedded sandstone at EL 263.00 m berm for a stretch between RD (-)32 and (-)50m. This was localized toppling of the rock mass due to unfavorable attitude of the smooth bedding plane and heavy seepage from the upslope. The southern side of the berm at the place of slope failure comprised Carbonaceous Shale with coal partings. The berm width reduced due to collapse of the weak zone formed by Carbonaceous Shale. At EL 257.00 m cracks were formed between Carbonaceous Shale and Sandstone transition and filled with water (**Fig.3**). Immediate protection of the berm was felt necessary to stop further deterioration of the rock mass. As a temporary protection measure, the cracks were filled with sand/

Fig. 3: Effect of toppling in Sandstone at EL 263 m (view to west)

cement grout and then with PCC in proper grading as per the dimension of the cracks. This was followed by placing grouted rock bolts of 7m length, $\text{Ø}25$ mm, @ 2.0 m-2.5 m c/c in staggered pattern. Rock bolting was done from the slope face between EL 263.00 m and EL 257.00 m and from the berm at EL 263.00 m in 20° downward angles towards switchyard. After adopting the above protection measures, slopes were found to be stable even in the monsoon season.

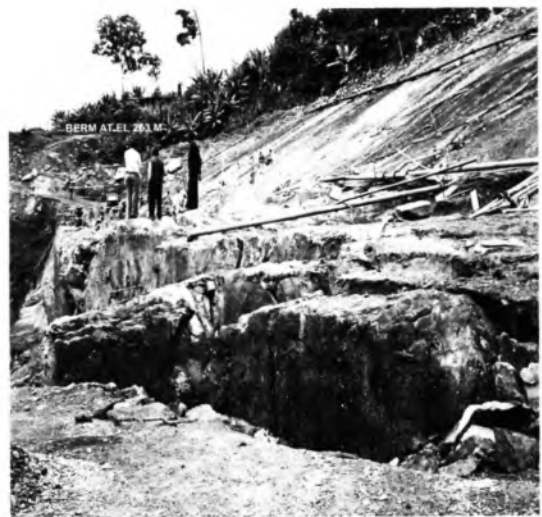
The slopes seemed to be stable after adopting temporary protection measures, but, in the month of October '06 multiple vertical cracks were observed at the berm EL 263.00 m and 258.00 m. As excavation in the power house was in progress and reached the level of about 235 m (between A & D line), some subsidence cracks were observed at EL 253.00 m and EL 275.5 m and in the slope below EL 275.5 m (beneath the shotcrete face). Multiple cracks were also observed almost along the entire berm at EL 263.00 m. A crack measuring about 77 m long, 1 mm to 10 mm wide parallel to the berm at EL 275.50 m on the northern side was also

observed. By the month of November'2006, cracks were found to be continuously widening up and propagating to the turfed slopes too. It seemed as if the whole mass was settling down differentially. The rock mass was either toppling or subsiding at different stretches. New monitoring pegs were placed on the cut slope below EL 243.00 m between D-line and E-line. The cracks in Sandstone beds were opening up along joint planes and the Carbonaceous Shale/Siltstone beds were settling differentially between RD (-)21.50 m to (+) 19.00 m (Fig.4). Due to fast deterioration of the slopes, further excavation of power house was kept on hold from 25/11/06. To know the exact nature of failure, four nos. of drill holes (EBH 1, EBH 2, EBH 3 and EBH 4) were drilled on the berms at EL 275.50 m and 263.00 m. After drilling of the holes to a depth of 40 m, 25 - 30 mm PVC pipe were inserted in the hole to the base. These pipes were slotted in the lower 3 m to allow water flow and not the sand that was backfilled in the hole between pipe and the hole. A steel rod of one metre length connected to a string was lowered in all the holes. The rods were lowered to observe:-

Fig 4: Subsidence at EL 263 m as on Nov'2006 (view to west)

Based on the observations of boreholes, crack and the geological formation, northern slopes were redesigned. The proposed remedial measures (**Fig. 5**) are as follows:-

- i) Re-gradation of the entire northern side slope right from the level EL 288.00 m down to bottom most level EL 214.80 m along with all slope stability measures like turving, shotcreting with wire mesh, rock anchoring, drainage etc.
- ii) Re-gradation of the western side slope from EL 268.00 m down to EL 243.00 m including lowering/lining of natural nallah and construction of masonry wall at the bottom of the slope.
- iii) Providing 30 cm diameter cast in-situ RCC bore piles in two benches namely at EL 248.00 m and EL 237.00 m in three rows in both the benches. The bore piles are having maximum length of 25.0 m and will be provided with all instrumentations required for monitoring.
