Distressed Railway Bridge No. 144 near Lailak-Mamalkha Railway Station, on Sahebganj Loop of Eastern Railway Bhaigaipur District, Bihar

Chinmoy Paul*, S. Basu Roy** and Prasanta Mishra***

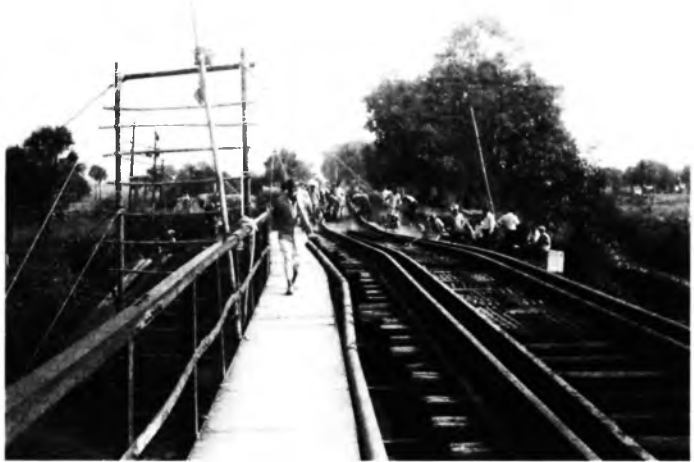
Photo-1 A view of the distressed bridge

The right abutment and P-4 pier which is close to the left abutment have been affected by settlement and subsidence cracks. Due to this effect the rails got twisted and shifted towards downstream (Photo-1). The P-4 pier developed tensional cracks in the top part. However, no sign of subsidence or shifting of alignment was observed in P-4 pier. The cracks and fissures of the P-4 were repaired through grouting and after that no further deterioration has been noticed in P-4 pier. Gaping ground cracks and fissures were also noticed around the right abutment.
