Geological Investigation of the Landslide Hazard Prone Hill Slope in Mizoram

D.Mukherjee* and Jai Bhagwan*

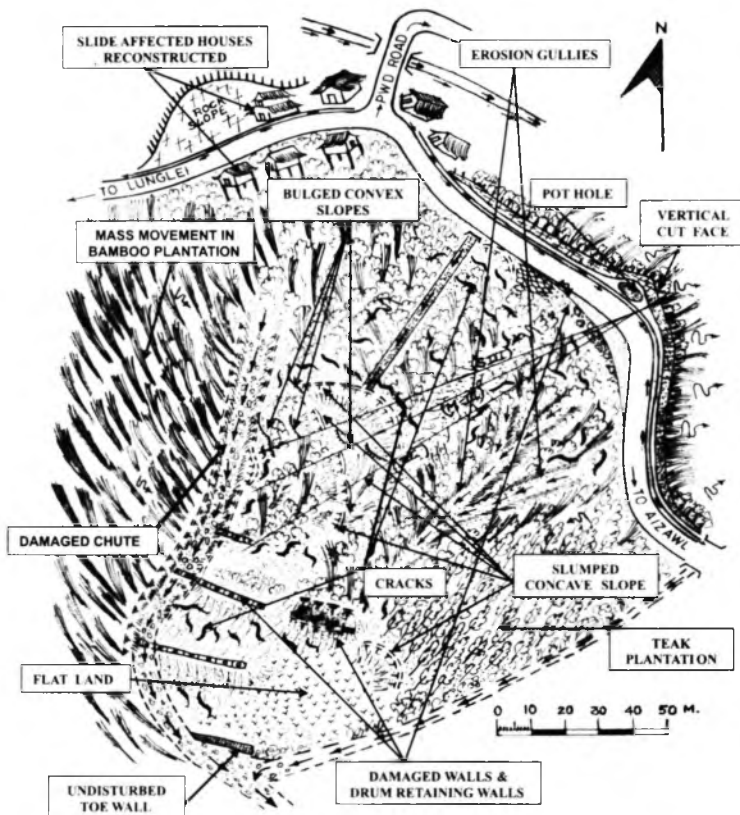
Fig. 1

Starting from km. 209.00 on the National Highway NH-54 near Lunglei in Mizoram, about 350m long stretch of highway and the adjoining downhill slope area were severely affected either by creep, sinking, debris slide or rockslide etc. The hill slope here comprises of reddish to buff, pale yellowish and greyish thinly bedded soft slate and shale which are steeply dipping inside the slope. The rocks are closely spaced jointed, folded and highly shattered in nature. The uphill slope area is comparatively harder and competent from stability point of view than the downhill slope region which was evidenced by the cut slope face vertically standing to a height of about 10 to 15m adjacent to the National Highway without any support of retaining wall as seen in Fig1. Slightly above this vertical cut face the ridge

of the slope is visible without any sign of damage. Beyond this ridge the entire uphill slope dips downwards and away from the highway towards the uphill direction to meet a nalla flowing from the higher reaches of Lunglei side. This flowing nalla passes underneath a bridge which connects the PWD road with the National Highway before reaching this portion of the uphill slope as seen in the plan. At the junction point of the PWD road and the National Highway, this uphill slope surface becomes almost flat and merged with the road level; thereafter it becomes steeper and rocky in nature once again towards the other extreme end of the highway ie; the Lunglei side at chainage km209.350. Just before this rocky portion many houses on the downhill slope got completely destroyed by this landslide but they were reconstructed. Similarly rockslide also damaged two houses on the uphill slope area at the extreme right end of this stretch of the highway. Major portion of the downhill slope region is mostly composed of dominating soft red thick soil present in a loose state and intermingled with some highly shattered rock blocks. The slope is covered with dense vegetation. Besides soil erosion, creeping of the entire debris materials are evidenced by the tilting of trees at different locations on the downhill slope area. In future saturation and erosion may definitely cause a gigantic landslide in this area if proper remedial measures are not implemented immediately. During the heavy monsoon in the year 2003 the entire stretch of the highway from km209 at Aizawl side to km209.350 towards the Lunglei side was severely damaged by landslide activity. About 150 m. stretch of the highway was affected by sinking as well as sliding. The boundary of this sinking cum sliding zone starts at a distance of about 29m. from the extreme one end ie; starting from the Aizawl side of the National Highway. At chainage km 209.100, a big pothole marked as 'A' was developed at the shoulder portion of the highway adjoining the vertical cut slope face as seen

in Fig.1. A large extent of this shoulder portion surrounding the pothole has already sunk. Enormous amount of rainwater from the uphill region flows along this sunken shoulder portion of the road and passes very rapidly deeper into the downhill slope area through the pothole due to the lack of road side drain. Especially during the monsoon continuous entrance of voluminous amount of rain water through this pothole created excess pore water pressure within the downhill slope materials and consequently hill slope failures occurred in this area. In the peak monsoon period during emergency about twenty five truck loads of boulders were laid down as a temporary remedial measure in this sunken zone and the pothole area to maintain a steady traffic movement on this highway. Permanent remedial measures are still now needed here to completely remove the problem of sinking and sliding. After thorough investigation it was observed that most of the slope failures occurred at the downhill region and consequently sinking with minor sliding occurred towards the higher reaches at three different locations at distances 14m 37m and 46m respectively from one end of the stretch of the highway ie; towards the Aizawl side at km209.00. It is observed that besides erosion and creep the downhill slope area is also vulnerable to slide but it is not actually visible from the road level due to the good growth of vegetation in this area. Sometimes the scattered tension cracks are also present in a semicircular pattern. Due to the untreated condition of the tension cracks multiple small scale failure of slope materials accumulated in a curvilinear fashion nearby the focal point of these tension cracks. Similarly step like features were also developed due to small scale failure of the slope materials along series of tension cracks at different levels. Long time impact of erosion and slope failure along the untreated tension cracks have created number of small gullies and a few major erosion channels also on the downhill slope region. The influence of creep or mass movement activity is clearly visible by the tilted nature of trees in this area. At the

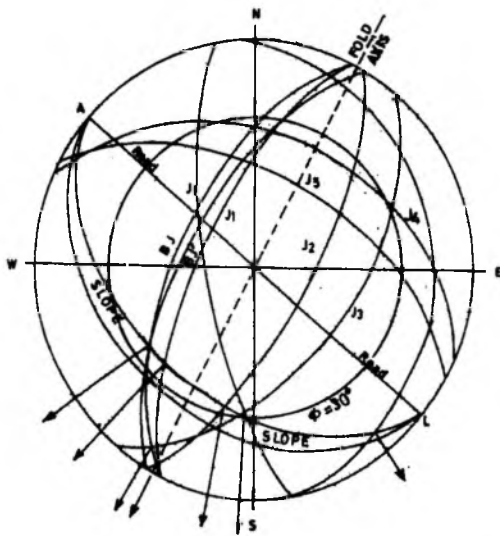
Fig.2. Stereodiagram of Different Planes of Discontinuities

and trend of different joint planes, shear planes, slope angles and their directions etc. were all collected for the purpose of detailed geological studies. In the field both chevron and recumbent types of folds were observed. Probably influence of two generations of folding actually has made the rock highly shattered and fragile in nature. Intersection of various planes of discontinuities has caused highly shattered nature of the rock formation. Different structural geological data were plotted along with the (f) value of the finer matrix of the debris materials on the stereonet diagram as seen in Fig.2 with a view to study the formation of different type of rock blocks by the intersection of different planes of discontinuities and their nature of behavior on the hill slope in worst environmental condition. From the stereonet diagram it is observed that a number of thinly bedded and closely spaced jointed rock blocks are formed due to the intersection of

various planes of discontinuities and they are prone to slide or creep in wedge fashion. The direction and type of movement of these rock blocks are actually controlled by the existing geological properties of the rock formation and are also marked in the stereonet diagram. In this area small scale wedge type of failures are occurring in a scattered manner towards the south west direction. Due to the influence of past tectonic activities the rock blocks have become highly shattered and fragile in nature. Rapid fragmentation of these rock blocks are therefore taking place when they start sliding along with the overlying surficial slope materials. These brittle rock blocks generally slide like fan shaped spread up debris. Very clear picture of rock block sliding in a wedge fashion is not visible in this area. The slide debris therefore more or less looks like planner type of debris failure. Generally shallow types of failures are occurring in this area. For carrying out detailed geotechnical investigations of the landslide affected area, both disturbed and
