## **Geotechnical Evaluation of the Unstable Slopes of Cabohill, near Rajbhavan, Panaji, Goa**

R. Panduranga, R. Dharuman and M.M.Swamy

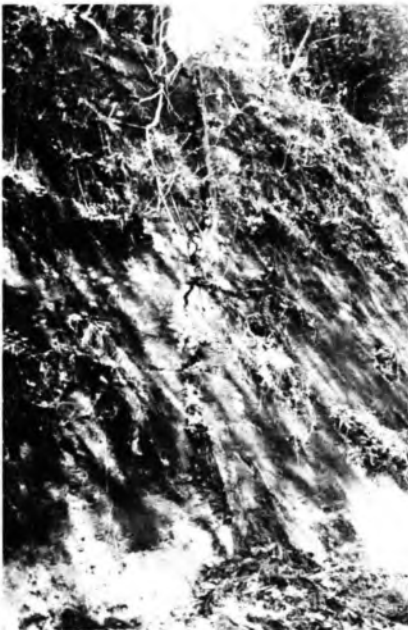
Photo : Cracks developed on the cladding wall with lateral shifting.

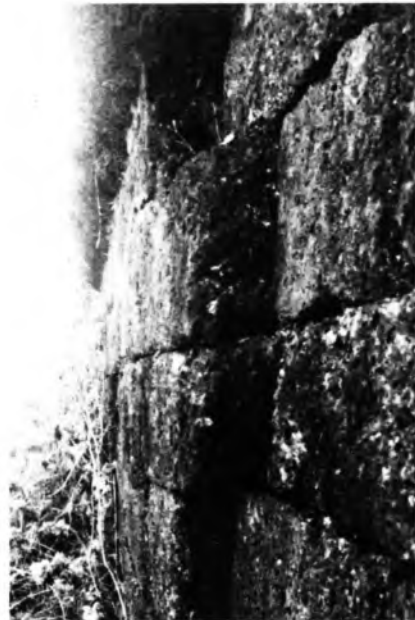
Photo : Old sea wall showing lateral shifting along the vertical cracks

- c) **Toe portion of the slope:** The toe portion of the slope in this study area has been under continuous threat by the onslaught of the sea waves leading to scouring and erosion of the shore line. In this area the curvature of critical slip circle passes through toe of the slope adjoining the sea. A continuous destabilization of the bottom support/ toe support of this unstable slope and a progressive creeping of the thick media lying above the critical slip circle has resulted in bottom upheaval, toe bulging etc. Due to this lateral thrust of the moving material, the sea wall constructed earlier is found cracked at many places with significant displacement of the laterite blocks of the sea wall. (Photo)

The shore protection works already carried out by providing a layer of Armour blocks all along the shore line of the unstable slope to protect the toe portion of the distressed slope are found insufficient as the level of the sea tides are extending beyond the outer limit of these armor blocks and the onslaught by the sea tides have caused continuous scouring of the bottom line of these protective measures. In light of the above situation, it is recommended to extend the armor blocks cladding along the effected shore line for at least another 2m height with the required standards. (Photo)

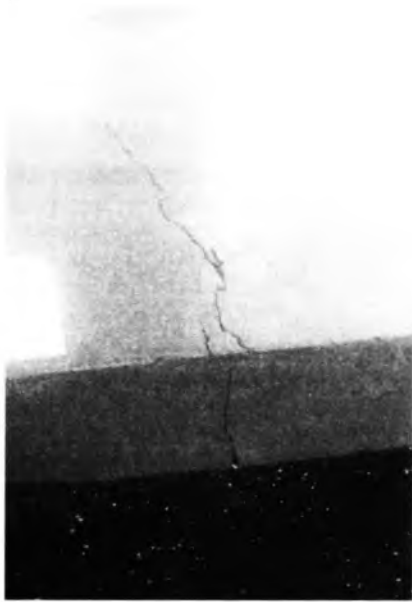
Photo : Development of cracks on the Verandah of Rajbhavan

The western and the north western slopes of Cabo hill adjacent to Raj Bhavan, facing the Arabian Sea have been experiencing continued distress since a few decades. Cracks have been developed on the pavements, floor of the verandah and also extending head ward retrogressively intercepting the corners of the back portion of the building, Cracks on Parapet wall, Cracks on the western slope, Cracks on the slope protection structures, Cracks on the Sea wall. The available record indicates a section of northwestern slope of Cabo hill was subjected to severe sea erosion. This erosional phenomenon which has existed on the coast line adjacent to Raj Bhavan for the last 40 years has slightly increased since a decade. (Photograph).

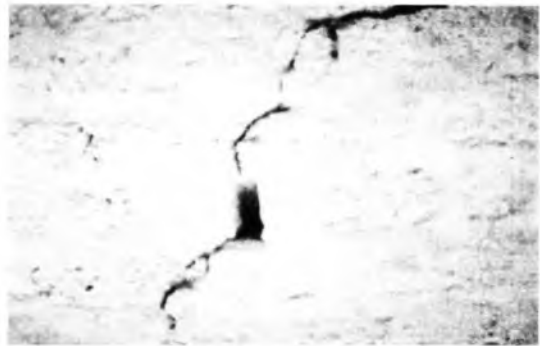
Photo : Cracks on the slope protection structures include topographic mapping on 1:200
