Geotechnical Assessment of Kallar and other Landslides along NH-67 and Mountain Railway Track in the Nilgiri Hills, Tamil Nadu

C.Thanavelu and S.Chandrasekarán

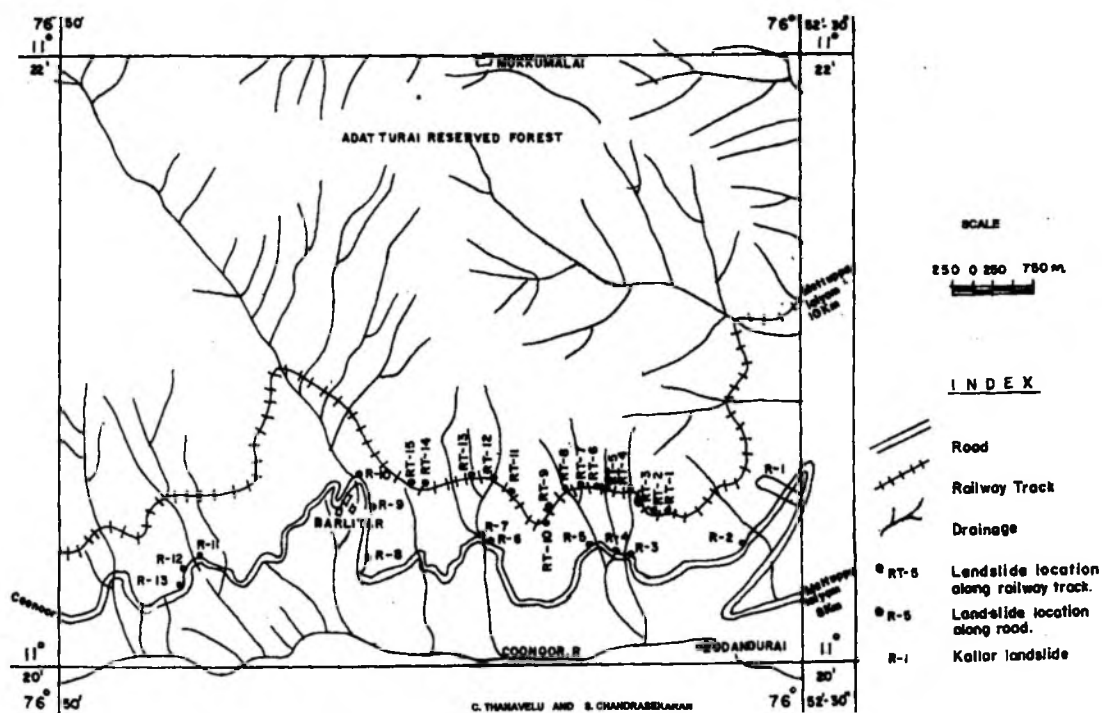
Among the twenty eight slides studied thirteen slides are located along NH-67 road between Kallar and Pudukkadu villages and fifteen are along Mountain Railway track between Adderley and Barliyar stations (Figure -1).

Kallar slide is the largest slide that has taken place between hairpin bends 1 and 2 of Mettupalayam – Coonoor stretch of NH-67 at Latitude: 11° 20' 21"N, Longitude: 70°51'52"E (figure -1) near Kallar village on the foot hill slope covered with dense forest. The slide has caused partial damage and blocked two arms of the road, uprooted trees and plants and deposited silt and debris over the plantation areas. The Mountain Railway track passes through the slope above the crown. The slope angle prior to failure was 35°, and was covered by the lateritie, lithomarge, saprolite (completely weathered -W6), weathered rock and perched boulders with thin loamy humus soil. The bedrock part

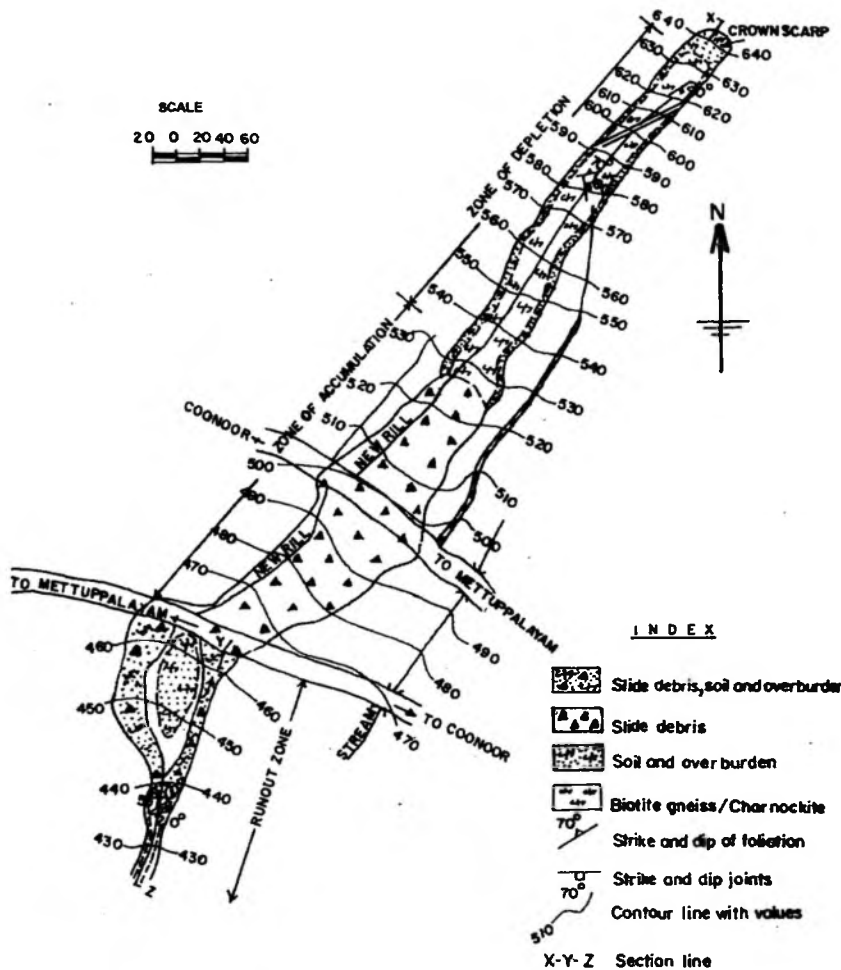
Fig. 2 : Geological Map of Kallar Landslide

of the slope forming material consists of garnetiferous gneiss and charnockite. The depletion part of the slide lies above the upper arm and the accumulation part extends just downside of the lower arm of the road (figure 2). The run out zone was observed to cross the lower arm of hairpin bend -1, west of Kallar village.

The slide flow was towards S 50° E, between elevations +408 m and +637 m. The length and width of the slide are 430 m and 30 m respectively. The height of the crown scarp is 5m. The depth of the slide at the down side end of the zone of depletion is 2.5 m

and the average depth worked out to be 3.5 m. It is estimated that 11550 cu.m debris materials has moved out exposing fresh bedrock. Fresh bedrock is also exposed in the run out areas due to erosion and removal of capping/surface material by the rapid movement of fluid debris. The run out fluid debris has also choked and damaged the culverts on either side of the side. Foliation, four sets of joints and one set of shear zone are the discontinuities present in the bed rock. Weathering is controlled by joint set with strike N 50° E – S 50° W, dips S 40° E. The bedrock profile is mildly cascading with

minor fall across some of the joints and shear zone. Temporary springs/seepages are noticed at the contact between bedrock and debris. A new rill has been developed due to flow of debris from the crown area to upslope edge of the lower arm of the road.

The landslide is a climatically triggered and is of ' Debris Flow ' type. The failure is rotational cum translational that started as a slip circle failure and moved along the plane of contact between bedrock and overburden. Steep slope, movement of ground water and eluviation process at the contact between the rock and overburden and increase in soil water content due to antecedent rain fall are considered to be the preparatory causative factors. Sudden increment of pore/cleft water pressure due to heavy rain in a short duration is inferred to be the triggering factor. Heavy flow of water reported to have been observed immediately through springs at the contact of overburden with rock support the above inference. The flow has been reduced considerably after ten days and completely dried out subsequently. Similar phenomena was also observed in the neighbouring slide, where 12 lpm of water flow was recorded on 25th November which has been reduced to 1.5 lpm on 29th of the same month. In addition, nineteen new springs have emerged in the area and disappeared after a fortnight.

In order to clear the road for light vehicles as early as possible, National Highway Authority of India has taken up removal of slide debris accumulated over the road arms and temporary restoration work. The following stabilization and long term control and corrective measures are recommended for the Kallar slide area.

1. Loose, large sized boulders with weight ranging from 1 to 20 tonnes are lying in the crown scarp and in the slide debris in the accumulation zone. These boulders are to be broken in situ by manual methods or mild blasting and be removed.

2. Construction of gabion across the slide at the end of depletion zone i.e. at about R.L.535m with a cement pipe of suitable size at the newly formed gully location for channelising the surface water.

3. Construction of retaining wall founded from rock on either side of both the arms of the road connecting the parapet of the culverts present near to both the edges of the slide.

4. Training and partial paving of the newly formed rills/gullies so as to lead the surface water to the adjacent culverts at the respective arms and sides.

5. Dressing and leveling of slopes between the proposed gabbion and retaining wall at the upslope side of upper arm and in between retaining walls at down slope side and upslope side of upper and lower arm of the road respectively and turfing/partial pitching.

6. Cleaning and rectification of culverts present adjacent to the slide which are choked and partially damaged.
