Occurrence of Landslides in Araku Valley and its Environs, Vishakapatnam District, Andhra Pradesh

P.Balaji** and R. Pavanaguru**

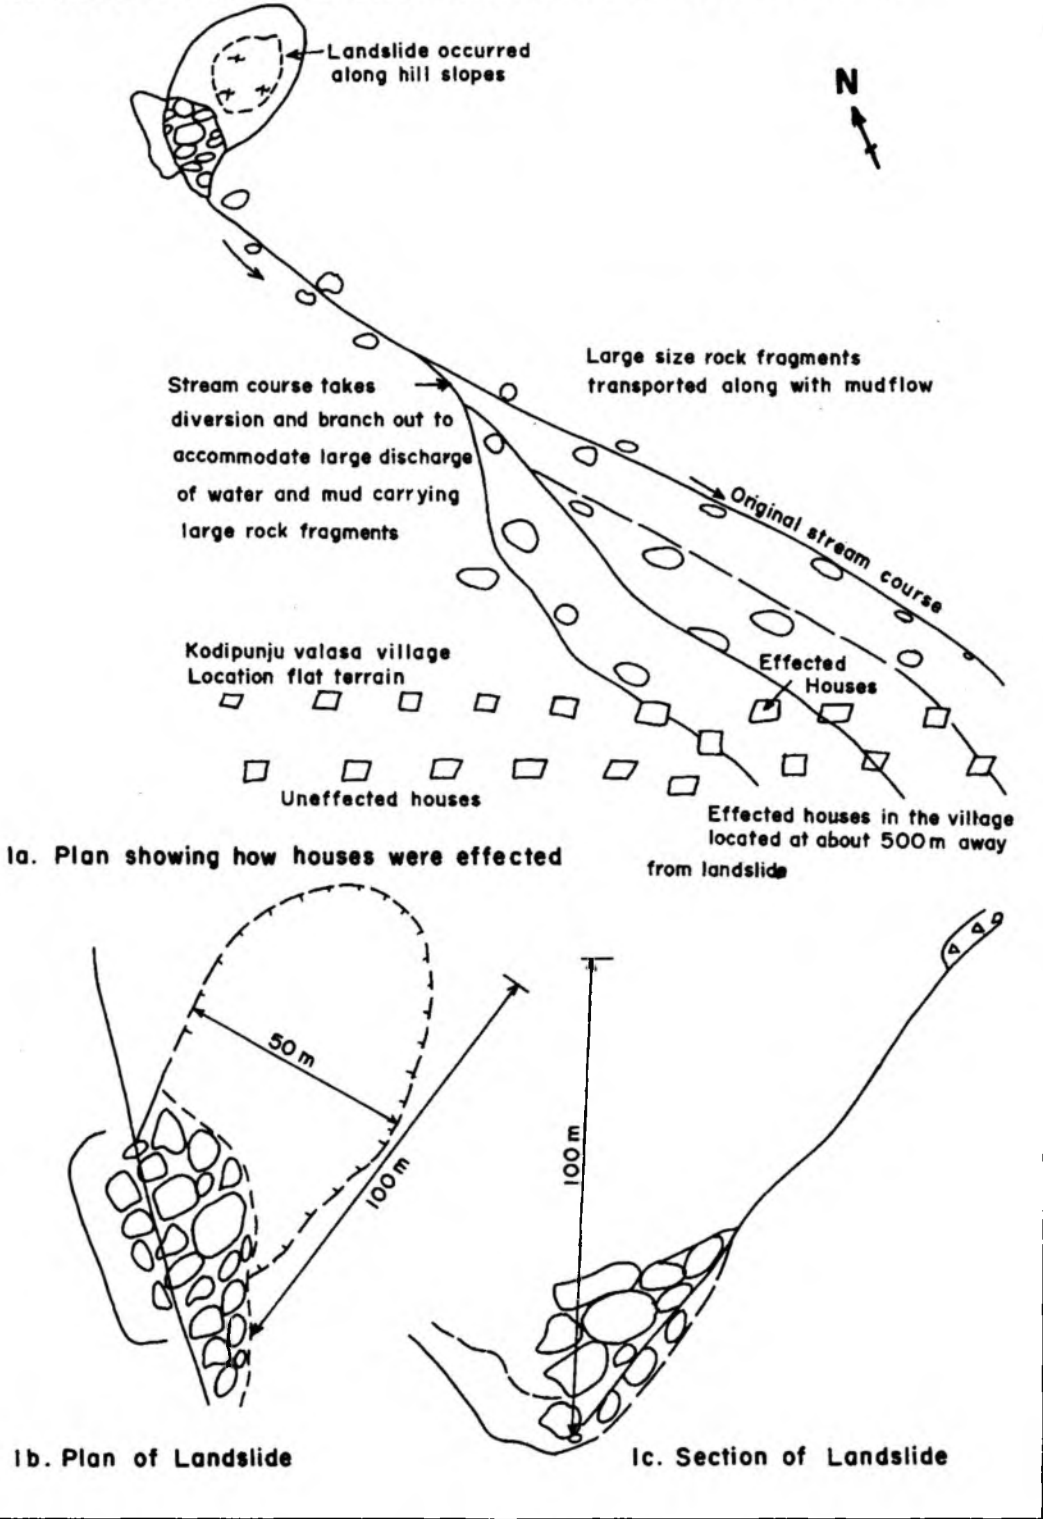
Fig. 1

I. LANDSLIDE AT KODIPUNJU VALASA: SCHEMATIC DIAGRAM

The slide occurred on the night of 3rd/4th August 2006 killing 18 people and destroying 10-15 houses. The settlement is located nearly half a kilometer away from the slide and located in a relatively stable, flat area. The slide occurred in the uphill direction of the village where the confluence of two 1st order streams join with a second order ephemeral stream. A discharge of 10-15 litres of water flowing along the stream was observed issuing from where the stream emerges into the plains from the hills indicating development of pore water pressure even after a lapse of 2 months period after the occurrence of the event. The slide had occurred on the left flank of the second order stream measuring 100m long, 50m wide and the zone of accumulation happened to be the riverbed (Fig. 1). The failed area was grass covered with wild shrubs and with occasional isolated trees. The pre failure slope of the failed area was of the order of 30° and the slope forming material made up of scree, soil including high to moderately weathered rock. The country rock as exposed in the riverbed is garnetiferous biotite gneiss. The slide is essentially identified to be a translational slide failing along the interface of soil and weathered rock and classified as debris avalanche due to rapidity of its movement. The crown scar is of the height of 1.5 m to 2 m while the side scars are about 1.5 m to 2 m. The failure is triggered by toe erosion as the stream could have been in spate and occurred in the convex bend of the stream or the cross over. The failure extends upto the mid slope and shallow in nature.

It is estimated that about 15,000 cu.m of material got slid and blocked the stream course leading to natural damming during

continuous and incessant rain in the area received owing to cyclonic weather. It is inferred that the dam burst occurred within a short time and the flood discharge containing suspended load and huge rock boulders impinged on the village on account of the change in course of the stream and increase in velocity and also possibly due to lack of accommodation of such a discharge by the original 2nd order stream. The hydraulic head difference between the slide area in the valley and the affected portion of the village is estimated to be of the order 60 m. The impact has resulted in complete devastation of the mud walled houses burying people alive in its wake. The run up of flood waters is estimated to be of the order of 2 m as witnessed by slush marks in a tree trunk and perched boulders on roof top of house. In the case of two cement concrete houses only the window grills were bent and the boulders strewn over the rooftop of these two houses ((Plate-III) Photos 1-8). No damage due to settlement or damage due to erosion and scouring was observed. A well, located further towards the valley, which remained disused, has not provided any information on the increase in water level.

The damages to elements are not directly related to the slide but a freak occurrence and providential happening where sliding and natural dam burst in a far away area on the uphill appears to have resulted the catastrophe.

It is recommended that the failed area i.e., the zone of depletion, be covered by turfing and also by growing vegetation that can help in run off than infiltration. It should be done after easing the side and crown scars to the pre existing levels. Provision of a berm at mid level can be contemplated to prevent retrogressive failure. Any open crack observed may filled with impervious material locally available.

It is also suggested that huge boulders resting at the toe of the slide blocking the

waterway be cleared by breaking them in place by labour intensive methods and the material thus harvested be utilized for river training to prevent bank erosion, and overtopping leading to flooding.

River training works in the form of guide wall gabions can be provided in places particularly at the convex bend of the stream to prevent erosion and scouring as well as in the other bank. The bank cuts wherever it is considerably protected by boulder pitching or by masonry pitching. In all the endeavors the local people can be gainfully employed and the administration can render requisite support.
