The Collapse of Staircase at Gapernath Temple Site, Kota, Rajasthan: A geotechnical assessment

Rajendra Sanwal* and P.K. Sharma**

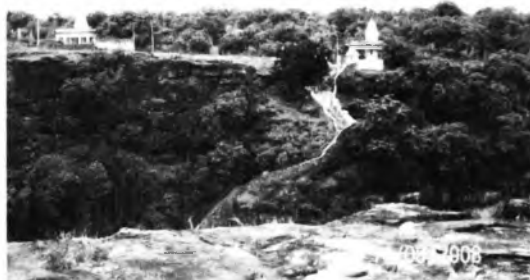
Photo 1. Staircase leading to Lord Shiva temple.

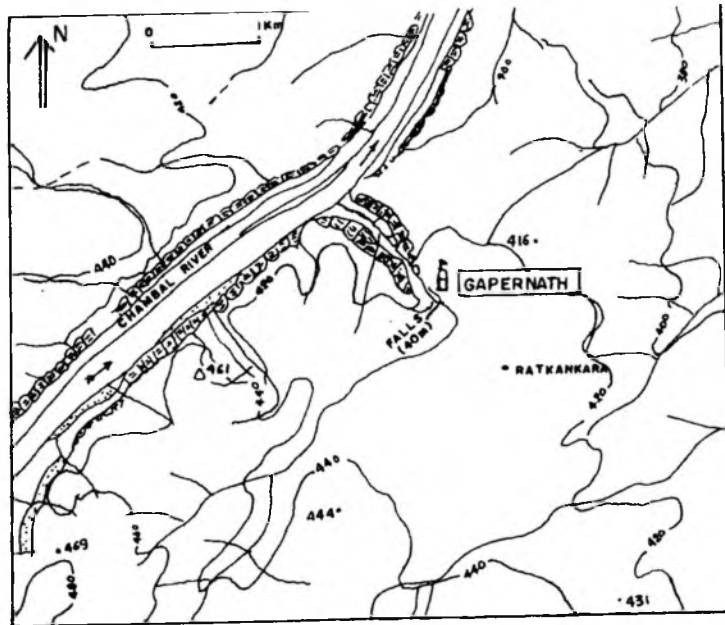
Fig. 2. Geomorphological Map of Gaper Nath Area

The area features a vast rocky flatland deeply incised by a NW flowing tributary of river Chambal. The temple site is located on the mouth of the deeply entrenched valley, flanked by steep rocky cliffs (Fig. 2 and photo 2). An abrupt and deep rock cut at the temple site has given rise to a 40 m high water fall. The drainage pattern, in and around the area is more or less rectangular, vividly controlled by NE-SW and NW-SE trending joints.

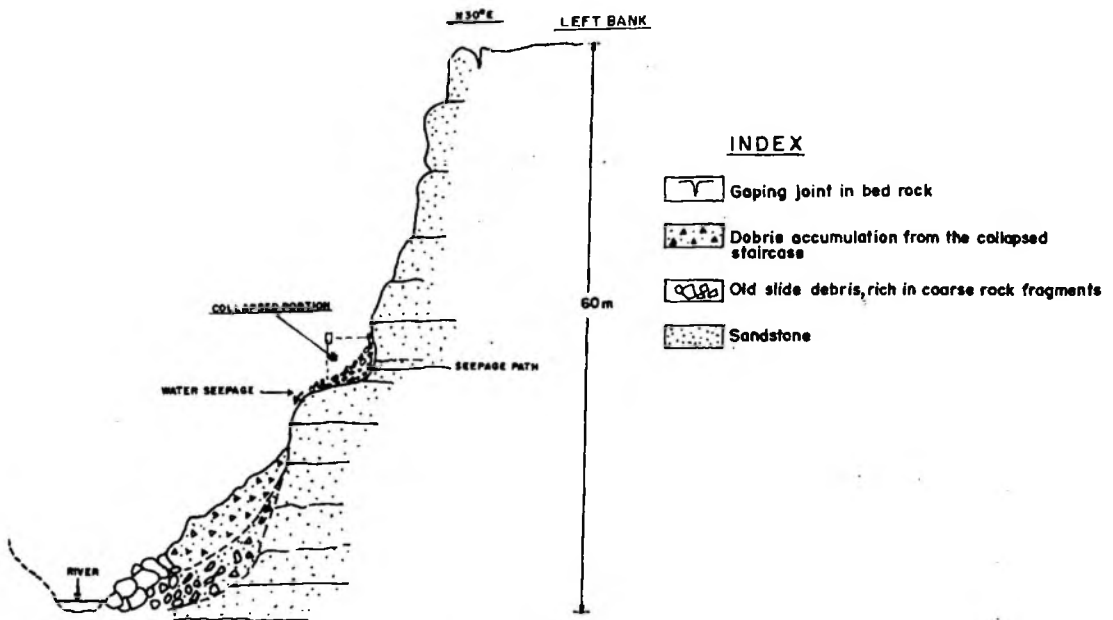
Fig. 3. Schematic section showing staircase collapse of Gopernath temple site

The approach to Gopernath Shiva temple and the picnic spot located on the left bank, through narrow (2-2.5 m) steep staircase, is founded on firm bedrock (sandstone). The steep rock face, along the approach, represents sub vertical valley wall sloping in N30°E direction (Fig. 3). The top of the rocky cliff at elevation 415 m, abruptly grades into an extensive, sub-horizontal flat rocky surface. The bottom portion of the valley marks a constricted section with river bed level at about elevation 345 m.

The rock mass structure is beset with 3 sets of open joints. The vertical open joints, parallel and perpendicular to the valley course, are spaced 1 to 3 m and provide passage for water infiltration. Sub-horizontally disposed bedding joints are undulating. The valley parallel, vertical joints (N70°W-S70°E) represent relief structure and show dislodgement at few places. Barring this, no potential slope failure mode is evident at the site resulting from an interplay of joints sets or their daylightment.

sandstone at the site. Easy percolation of water through joints especially the relief joints is an influential phenomenon in destabilizing the staircase through sub surface erosion after a heavy rainfall.

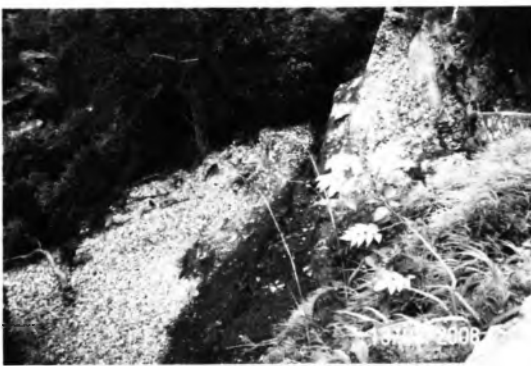
The partial collapse of staircase structure (Photo 3), along a length of about 20 m, is restricted only where water seepage and saturation on the valley walls is most pronounced. The staircase, here, rests on a 3.5 m high wall, having a width of only 2.1 m. The structure has construction in dry stone masonry with lime cement mortar at few locales. In the upslope end of the collapsed structure, as seen in the overhang, the construction has been in stone masonry in clay mortar. Apparently, the structure lacked weep holes and effective drainage arrangement, to release the pore water pressure. Prima facie, the structure is poorly designed to withstand the load (including live load) and loss of shear resistance disregarding the ground conditions.

Photo 3. The collapsed staircase structure and its debris.

- Construct a concrete gravity wall with adequate reinforcement.
- Alternatively, the retaining piles may be installed in the bed rock through the boreholes.
- Tie up the structure to bedrock, on the steep wall section.
- Provide appropriate drainage arrangements so as to prevent water accumulation behind the wall at the interface and within the structure.

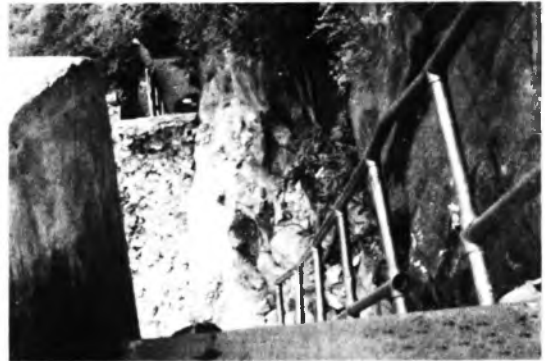
The process, which promoted the collapse and subsequent down slope movement, was primarily continuous water seepage along the open joints, causing progressive erosion along the interface between the bedrock and the staircase structure (Photo 4). The process of erosion resulted in formation of gap/cavity and overhangs which subsequently enlarged in due course of time.

Photo 4. A portion of the collapsed staircase with prominent gap along the interface.

The increased pore water pressure and the loss of contact of the structure with the bed rock resulted in decrease of the shearing resistance.
