Failure of Pressure Tunnel Constructed in Soft Media - A Case Study Focused on Possible Cause

A.K. Jain

The Umiam-Umtru stage-IV Hydro Electric Project, located in the East Khasi Hills district of Meghalaya state and commissioned in the year 1992 consists of 43 m high concrete gravity dam, 6.13 km long Head Race Tunnel (HRT), a surge shaft, penstock and a surface powerhouse with an installed capacity of 60 MW.

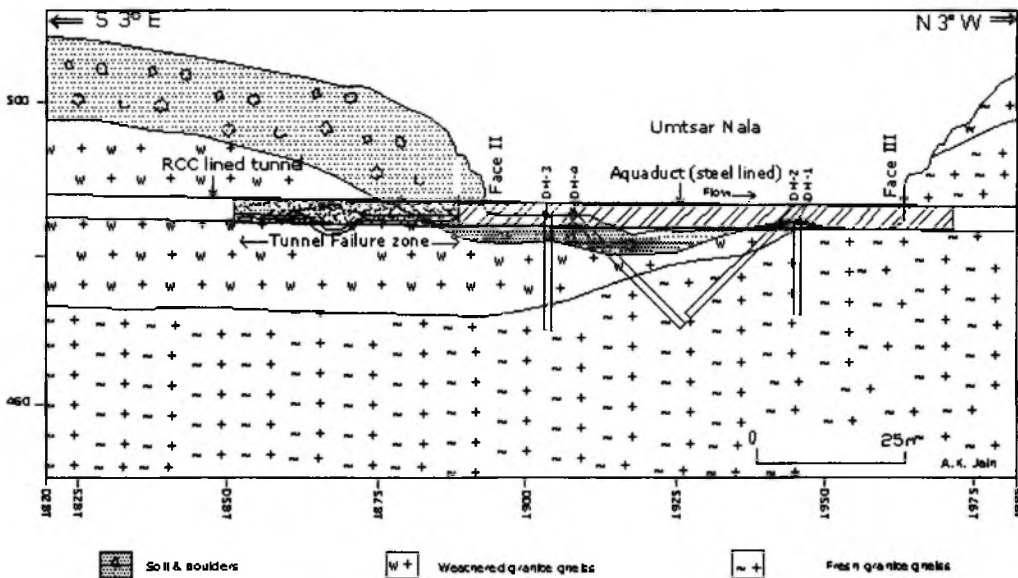
Fig. 1. Geological section along HRT alignment between RD 1820 and 1985 of stage 10 H.E. Project at investigation scene

At Umtsar nala the tunnel surfaces and crosses the nala through an aqueduct. The 80 m long aqueduct is supported by a steel liner which ends in fresh gneiss in right bank and in highly weathered rock in left (Fig. 1).

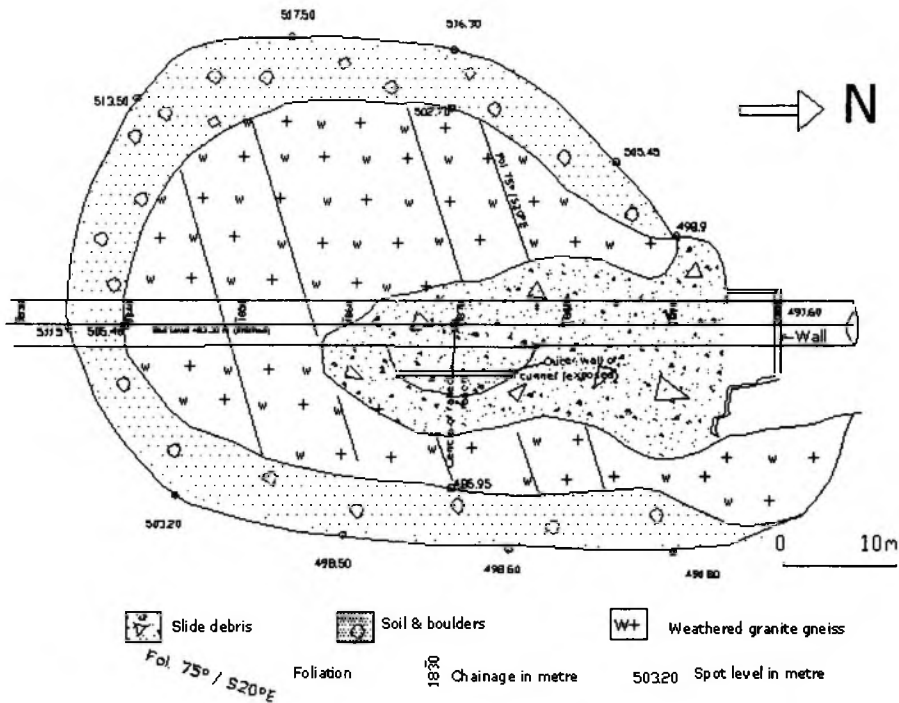
Fig. 2. Surface Geological Map of the HRT area of Umium Umtru Stage IV H.E., Project after tunnel failure

The rate of leakage from the tunnel suddenly increased abnormally to 1.0 cumec in November, 2002 following occurrence of a landslide in overburden that covered the tunnel in the critical reach after a heavy precipitation (Fig. 2 & 3). The slide was apparently caused due to weakening of toe by leakage water from the tunnel and was triggered by the rains. Before any remedial measures could be taken, the tunnel developed major leak on 1st December 2002 leading to draining of the tunnel. Consequently the intake gate of the tunnel was closed and the reservoir was emptied.

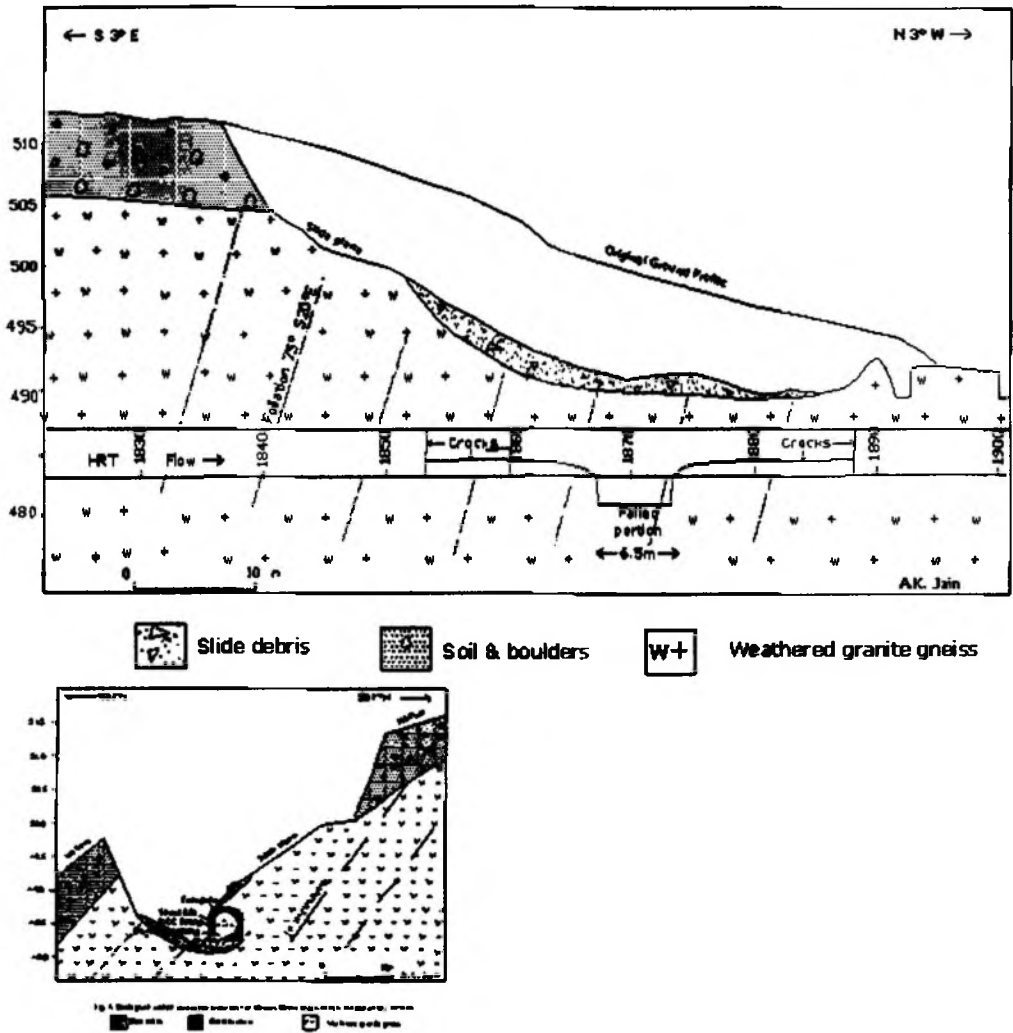
Fig. 3. Geological section along HRT of Umium Umtru Stage IV H.E. Project after tunnel failure

In addition to the above, longitudinal cracks have developed along the cold joint between the overt and invert lining from RD 1852 m to RD 1888 m on the right wall of the tunnel (Fig. 3). Between RD 1860 m and RD 1866.5 m the cracks were found pronounced with about 10 cm wide opening. There were several oblique cracks of smaller dimension. The damage was found to be confined to the invert section of the tunnel and the overt was intact.

After careful examination of the problem, the tunnel was repaired by providing reinforced concrete below the tunnel invert level and 2 m long 25 mm dia anchor bars at 1 m spacing

near the invert portion. The steel liner of 16 mm thickness and 3.5 m dia was extended from the aqueduct end for a distance of 115.5 m including 2.5 m of transition zone at both sides. Repairing of eroded lining zones and filling up of voids created behind the concrete lining was also carried out followed by consolidation and contact grouting.
