# Geological and Geotechnical Evaluation of Cut Slope of Diversion Channel of Nimoo Bazgo Hydroelectric Project, Leh, J&K

*The present paper deals with the geological and geotechnical evaluation of rock mass of the cut slope of the diversion channel.*

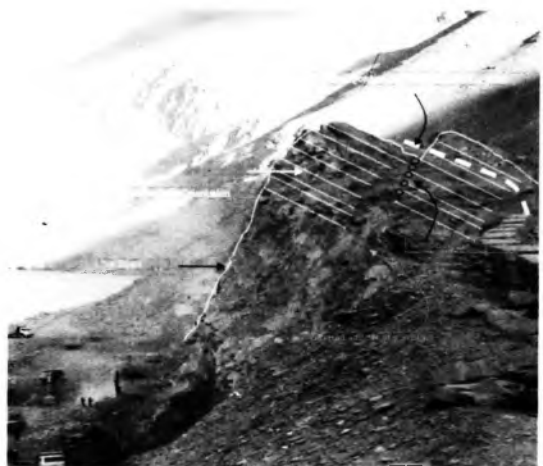
Fig. 8: Photograph showing the disposition of slip plane along the cut slope.

During the progressive excavation of diversion channel, when the cut slope has reached to an El: 3064m (an average), distressed zone in form of tension cracks along the strike of slope was observed between section D to F at the El: 3104m, no manifestation of this discontinuity/distress on the excavated surface of the cut slope was observed. The development of crack has forced the project to evaluate the slope stability, based on the strength and the deformability of rock mass.

After the removal of the overburden it was seen that the RBM and fluvial glacial material was filled along the tension crack zone, dipping towards the valley i.e. towards the cut slope and formed a huge wedge. The entire area around the crack zone was examined, and found that 4-6 inches aperture of crack has been developed almost along the strike of slope. Movement across the crack plane was also noticed in the initial phase, (refer photograph showing disposition of slip plane along the cut slope fig: 8).

As the toe of the hidden slip plane got daylighted during the excavation, causing slide/collapse along the potential slip plane filling the diversion channel area with its debris.

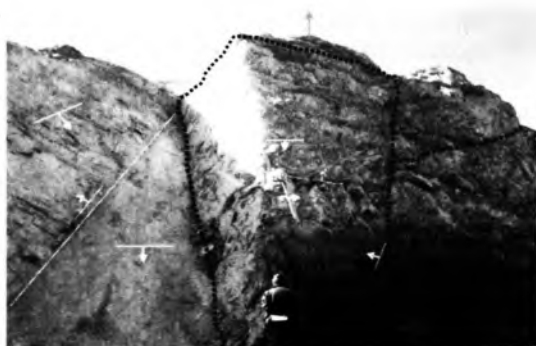
Fig. 9: Photograph showing slip plane after failure

1. **Discontinuity related failure, related to the orientation of slope and discontinuity:** - Stability of slope related to discontinuity in the rock mass and slope, i.e. related to the orientation of the discontinuity and the slope orientation (orientation dependent stability). The rock mass in the influence area dissected by four sets of discontinuity viz. 230/52-62; 040/68-70; 315-340/54-62; 150/55, out of these four sets, two sets plays a major role for the stability of cut slope namely 040/68-70; 315-340/54-62, these two joins are valley dipping and clay filled at some places,

(refer photograph showing slip plane after failure fig: 9).

- (i) In present case, as per the slope mass rating, difference of joint dip direction of valley dipping joint ( $\hat{\alpha}_1$ ) and slope dip direction ( $\hat{\alpha}_s$ ) was less than  $5^\circ$ , and consequently planar failure occurred.
- (ii) Dip amount of slip plane varies from top to bottom, when dip amount of the slip plane was plotted for examination of slope stability, the slip plane extended upto the bottom of cut slope, but during the progressive excavation slip plane got daylighted and planar failure occurred along the identified slip plane.

Slope failure involves the sliding of rock mass along two or more surfaces, by virtue of different forces acting on them. The 'V' shaped wedge slid along the weathered slip plain, along which no cohesion between the adjacent rocks mass was observed. The rock mass in influence area comprises of sandstone with intermittent bands of shale. The area also dissected by frequent shear seams.

After the occurrence of wedge failure along the clearly identified slip plane, adjacent block started moving, which was not only critical from slope stability point of view, but also for the diversion of river. To understand further failure, and stabilized the block, geological cross sections were examined, and conclusion was drawn that toe support in form of reinforced concrete should be provided at the earliest to stop/minimize the movement of adjacent block.

After providing the toe support and cement

grouting, from the top of the cut slope along the slip plane, the movement of block got stabilized.

1. Cement grouting from top of cut slope at regular intervals, through 6m to 10m holes of 45mm diameter.
2. Additional rock bolting from the concrete surface into rock, at 3m to 7m above the bottom of cut slope.
3. Slush grouting along the cut slope, mainly along the identified weak planes, to provide cohesion between adjacent rock mass.

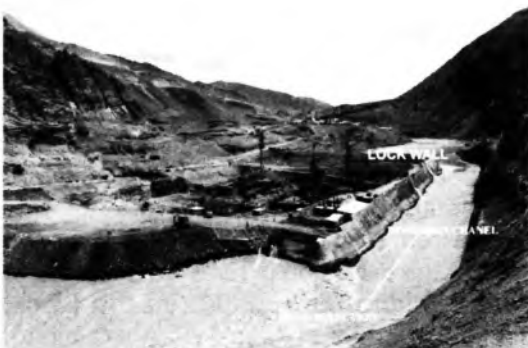
Fig. 10: Photograph showing full phase diversion

Meanwhile, monitoring of cut slope was made through topographical markers, established at top along the cut slope. After ensuring the stability of the cut slope, diversion was successfully achieved on due date, (refer photograph showing the full phase diversion Fig. 10).
