# Effect of Joint Orientations on Blast Induced Damage in Gneiss Rock Mass Subjected to Repeated Blast Vibrations

M. Ramulu<sup>1</sup> and T.G. Sitharam<sup>2</sup>

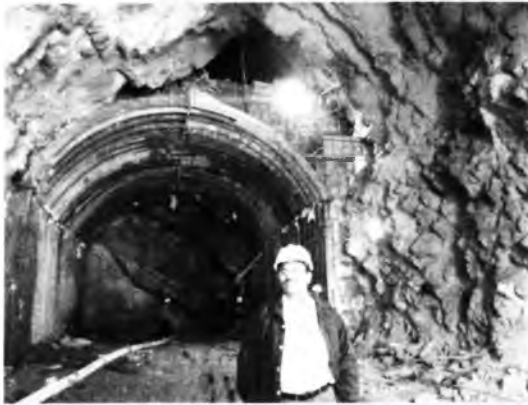
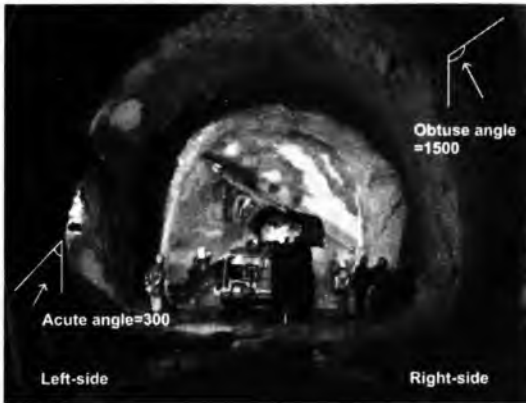
walls of the tunnel as the joint orientation with respect to tunnel perimeter line was making acute angle at the left side and obtuse angle at the right side of the tunnel. The damage assessment was also carried out at crown rock mass of the tunnel where the joint orientation was making nearly 180° angle with respect to tunnel perimeter line. The objective of damage assessment at three different locations is to know the effect of joint orientation with respect to the perimeter line of the tunnel. The tunnel profile where the experimentation was carried out is shown in Fig. 3.

Fig. 3: Experimentation tunnel with varying joint orientations at both left and right-sides

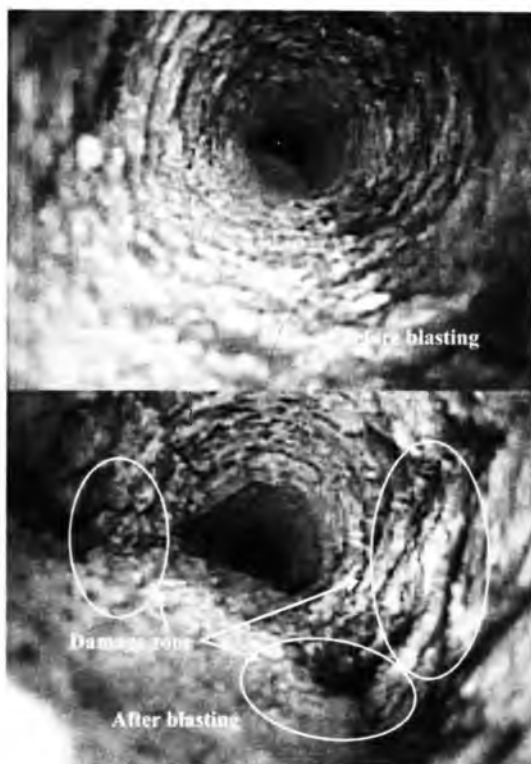
determination of exact depth of damage as well as extent of crack network and fracture frequency. As the range of damage extension was already assessed by means of extensometer, the inspection of exact extension of damage by borehole camera had become much easier. Images were captured by an interval of 5cm, within the range of probable damage extension for precise inspection of rock mass damage. The images of borehole sections which contain the interface of intact and disturbed rock mass of tunnel wall are shown in Fig. 10. The damage depth measured by the borehole camera inspection survey at the left-side wall with acute joint orientation was 2.70m.

Figure 10. Images of pre-blast and post-blast inspection surveys of rock mass with acute joint orientations captured by borehole camera

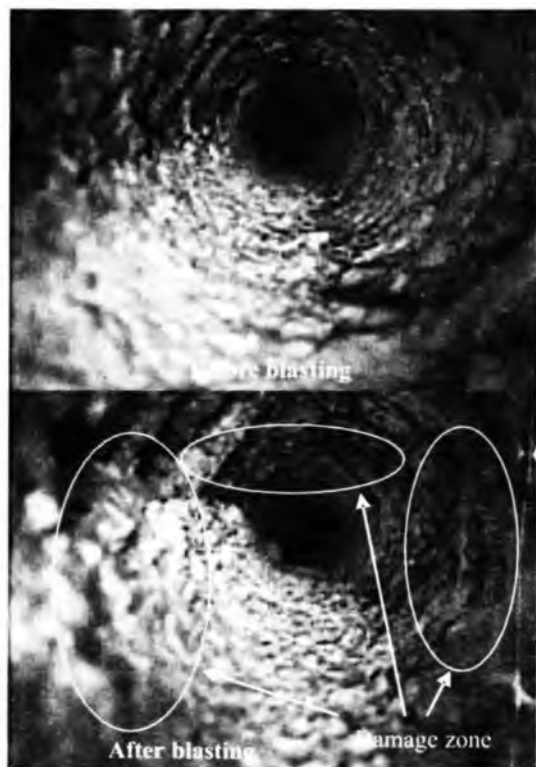
Fig. 13: Images of intact and disturbed rock mass with obtuse joint orientation, captured by borehole camera

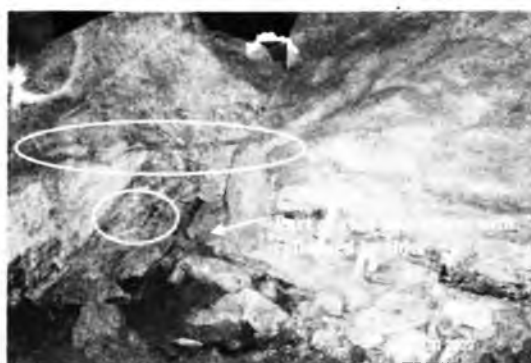
Fig. 14: Roof failure due to extension of fractures on account of repeated blast induced damage

below  $V_{cr}$  for the blast rounds of same locations. After 40 rounds of blast occurrences, the displacements were again observed at the vibration level, 254 mm/s, which is much below the  $V_{cr}$ . There were no displacements observed below the  $V_{max}$  level (98 mm/s). This result gives an inference that the anchor point of 4.0m rod was in elastic zone and the damage zone was within 4m from the tunnel perimeter. The borehole inspection survey was conducted to cross check the damage assessment by extensometers and for exact damage measurement. The images of borehole sections which contain the interface of intact and disturbed rock mass are shown in Fig. 13. The maximum damage depth measured by the borehole camera survey with obtuse joint angle orientation was 3.6m. This was the reason for the roof failure that occurred near the test site. The roof failure due to extension of fractures beyond 3m due to repeated blast induced damage is shown in Fig. 14. The maximum length of roof bolts designed for that rock mass was also 3m.
