# Rare Foundation Media for Masonry Spillway at Lhasi dam, Baran District, Rajasthan - A Case Study

Sharma, V.P. \*

Engineering Geology Division, Geological Survey of India, WR,

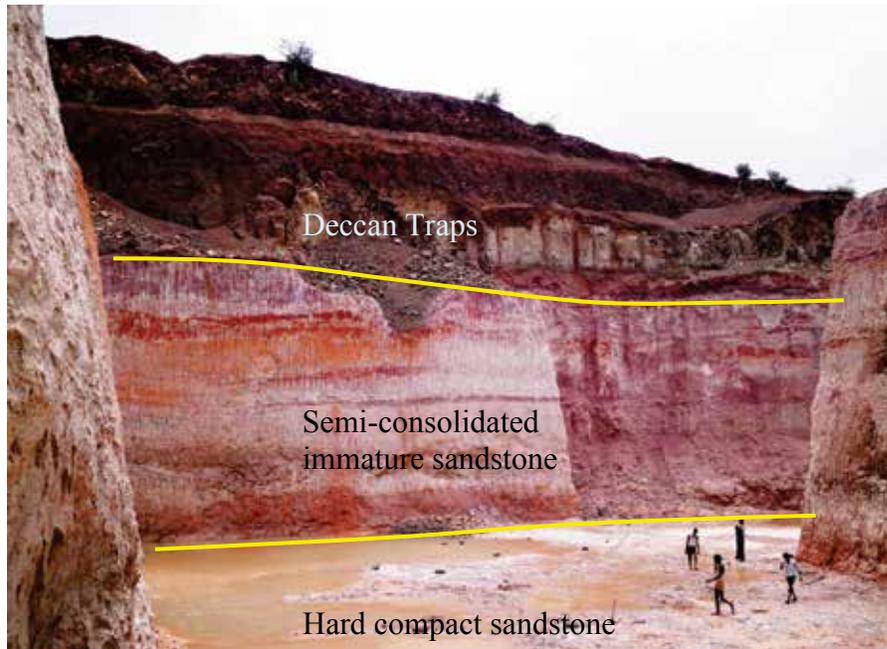
The cut sections of the hill slope as well as the strata exposed at the designed foundation level of the spillway was examined. The rocks exposed in this section are highly weathered basalt underlain by semi-consolidated mildly calcareous immature sandstone (figure 1). The whole unit has certain variations in the upper part with two main varieties; the purplish pink and grayish white. The later variety continues further down up to considerable depth. The contact of the basalt with this argillaceous unit is marked by about one m thick indurated cherty clay. The peculiar characteristic of this unit is its two components with altogether different geotechnical properties. The upper 15 m thick portion of the unit is soft and semi-consolidated followed by a well compacted and silicified, quite hard and massive lower portion with sub-angular clasts of quartz, chert and other rock fragments of Vindhyan sediments, a ubiquitous feature common for whole unit., though with varying proportions from place to place. The rich concentration of these clasts gives an appearance of conglomerate in some of the horizons (figure 2) especially at the contact zone of both the portions of the unit.

Figure 1 A view of foundation excavation for right wing wall and spillway

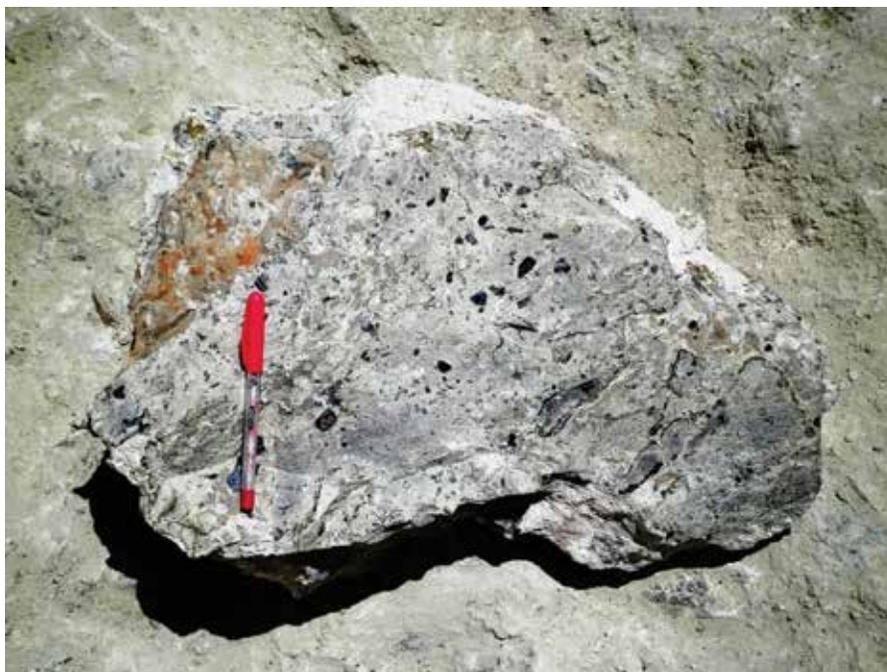
Figure 2 A piece of silicified conglomeratic sandstone excavated at Foundation level
