## **Design of Remedial Measures at Lukhbir Slide on NH – 31A**

### **Abstract**

Lukhbir slide sandwiched between two major drains located at km 26.8 on National Highway, 31-A (NH-31A) is in active stage since 1968. It extends for about 400m along the road, 50-60m above the road & about 20-25m below the road. The prevention of landslide was important for uninterrupted & risk free traffic flow as well as for prevention of unwanted siltation to the dam being constructed on the Teesta flowing at the bottom of the slide toe. The lithology of the area includes the metamorphic rock, i.e. mainly mica schist, which is very fissile and breaks easily along its plane of schistosity. The rocks are in highly weathered conditions and in some locations they are found in the form of powder due to excess overburden pressure and availability of moisture. In addition, the slope has plentifully of seepage water which makes the slope more vulnerable to fail. As per Indian classification system the soil is classified as SW. The stability analysis and design of remedial measures of the uphill slope and downhill slope has been carried out by using GEO 5 software. The paper highlights the investigation o

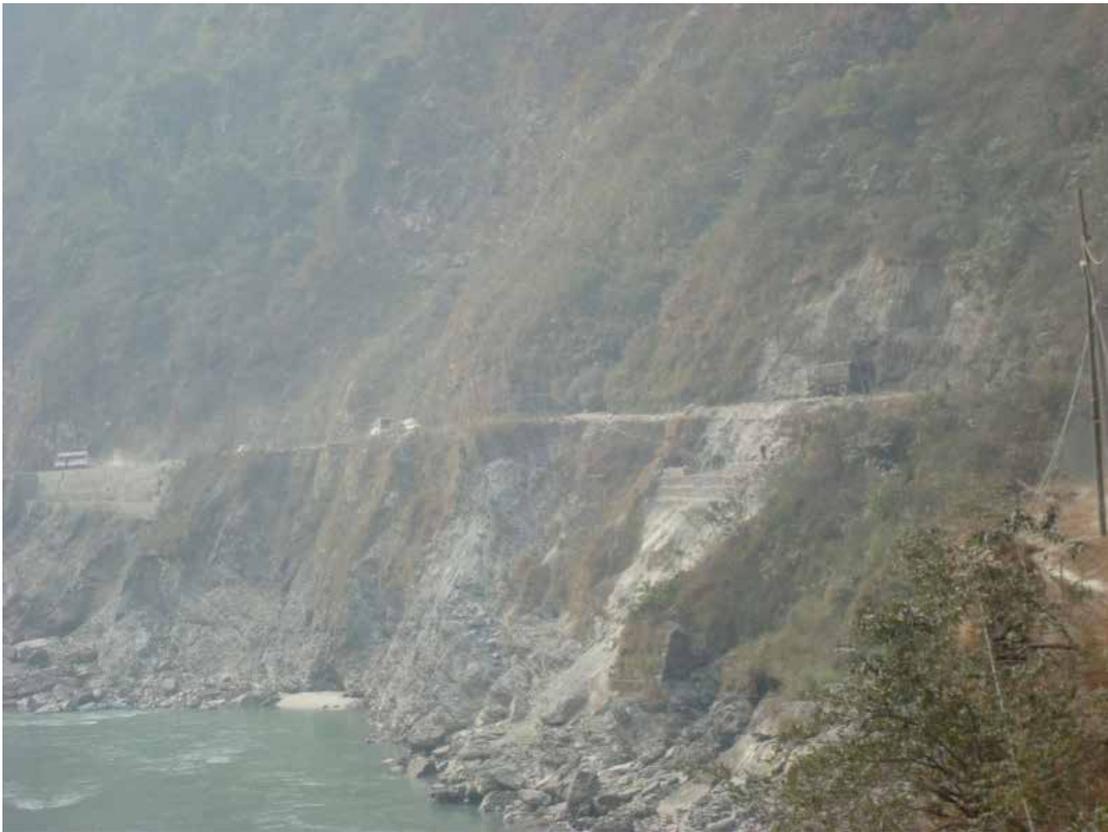
National Highway 31A links Gangtok to Sevoke on NH 31. NH 31A runs along the banks of the Teesta River and is the lifeline of Sikkim state. Lukhbir slide is located on Latitude: 27° 2'17.63"N and longitude: 88°25'35.71"E at km 26.8 on NH 31- A as shown in figure 1. This Landslide is active since 1968. Several agencies have already carried out studies on this landslide and suggested different schemes of remedial measures like benching of slopes, ceiling of cracks, retaining walls and Brest wall. The suggested measures have been implemented but none have been proved successful.

Figure 1 View of the Lukhbir Landslide

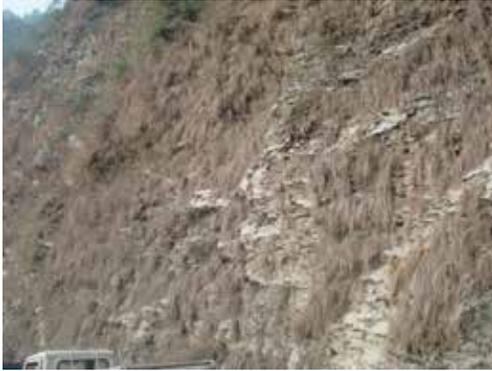
The rock type is a metamorphic rock, mica schist (figure 2 & 3). Schist is a very fissile rock and it breaks along its plane of schistosity. Flakes of mica schist break along its planes of schistosity which can be easily powdered by a bit rubbing. Though the planes are dipping away from the slope but the rock type itself is dangerous in its nature. It would not sustain any compact structure on its surface due to its fissile nature. It can be easily weathered to break along planes forming powdery soils or small blocks of rock, if weathering agents like water, wind etc., and over loading of slope is there. Since the rock is highly fragile, buildup of stress on its surface can cause the development of cracks very easily in the rock and once initiated cracks can further enlarge to cause fragmentation of the rocks into blocks along other surfaces other than the plane of schistosity also. The rock type is highly vulnerable to weathering and would easily give up at the action of weathering agents (i.e. air or water). In dry condition the rock breaks along fissile planes and in saturated condition it may be damp as muddy soil also.

Figure 2 condition of rocks on uphill slope

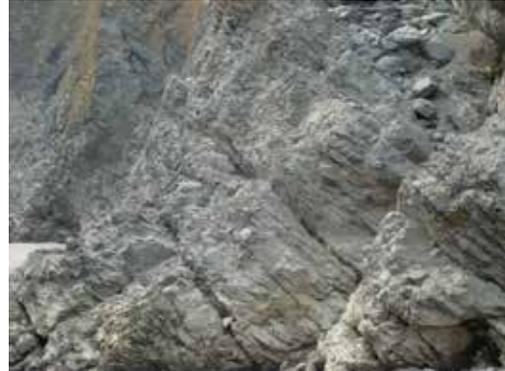
Figure 3 Condition of rocks on downhill slope

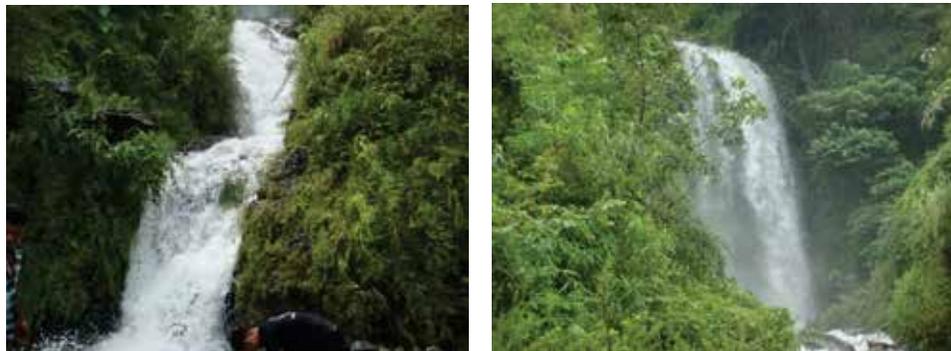
As observed in the field, the landslide area is sandwiched in between the two major drainages (figure 4). These two drainages are the main source of the water from uphill side during rainy days. The area comes under high rainfall the average annual rainfall observed approx 2000mm. The rain water flow with a very high velocity due to the high gradient and probably, due to good catchment characteristics. Almost whole slope is found damp, due to which the rocks weather continuously slide under the gravity and steepen the slope making it more vulnerable to failure.

Figure 4 Major drains on uphill slope

1. The two major visible drainages are required to be properly treated so that water drains without endangering the slope. It is proposed to construct stepped chutes all along the slope through highway & draining into the river.
2. To prevent the water coming onto the slope above the crown of the landslide, it is proposed to construct a catch water drain at an appropriate place, depending on the topography. The catch water drain should be connected with the chutes on both side of the slide with proper gradient so that water from the catch water drain flows into the chutes of both sides.

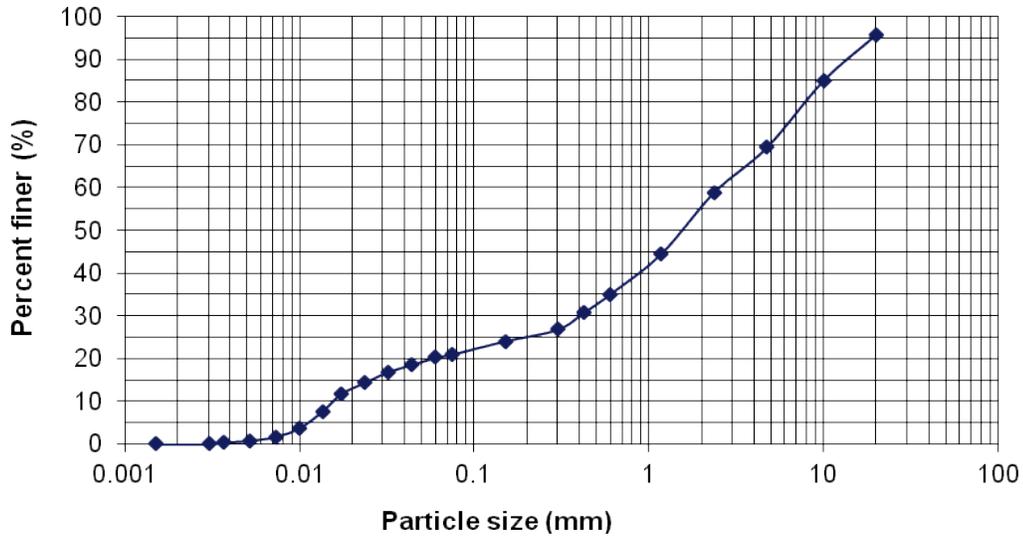
Figure 5 Grain Size Distribution Curve

The soil samples collected from the field have been tested for the index as well as the engineering properties. Figure 5 shows the typical grain size distribution curve of the soil sample. The gravel content is 31%, sand content is 48%, silt content is 21%, and clay content is 0%. As per Indian Standard Classification the soil is classified as SW. The liquid limit value of the soil sample is 24 % and PI value is zero (Non – Plastic). The direct shear test results conducted at average field dry density value (saturated, i.e., after soaking the sample for 24 hours) showed that cohesion,  $c' = 0$  and angle of internal friction ( $\phi'$ ) =  $25^{\circ}$  as indicated in figure 6.

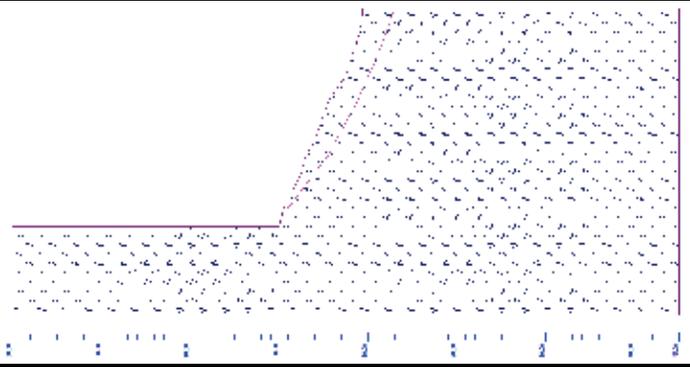
The stability analysis of the slope was carried out using GEO 5 software. Since, the area comes under Zone V (Very high seismic zone), stability analysis has been considered with and without earth quake factors. The parameters considered in the stability analysis are given in table 1. The results of the stability analysis of downhill slope were presented in table 2. The Factor of safety of the present slope is just stable without considering earth quake forces and fails under the consideration of earthquake conditions.

1.04	0.89
2

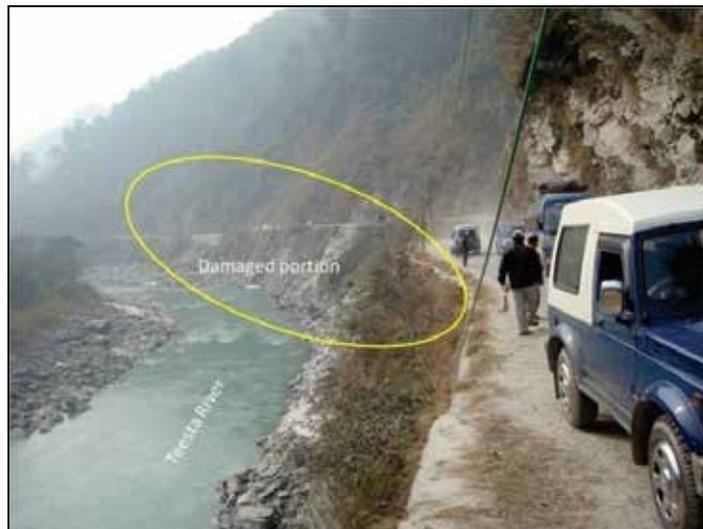
Going through the history of the landslide it is learned that the initial triggering factor was the intense toe erosion particularly during the high flood instances. Due to this reason repeated damage/subsidence of the highway had been occurring. With frequent damage of highway, to restore the same, instead of strengthening downhill side slope the uphill slope was cut. This practice was repeated almost every time the road was damaged. As a result the uphill slope had become active and continues to be same till date. The focus on preventing the slope uphill side has therefore become a priority and no attention was paid to the need of toe protection. The gradual cutting of the toe may become a cause of concern in years to come. It is therefore required to think holistically to undertake all the measures in view of the long term stability of slope instead of very short term approach.

River Teesta takes a turn (meandering) at the base of the slide resulting in direct impact of the water particularly during the monsoon season (figure 7). It is proposed to protect the toe from the onslaught of high velocity river Teesta. Some river training protection measures are required along the river like construction of spurs or placing concrete blocks in the curved portion to reduce thrust on the slope. Deflecting spurs can solve the problem of toe erosion effectively since they are designed to deflect the water coming on to the toe of the slope.

Figure 7 Downhill slope damaged due to river meandering

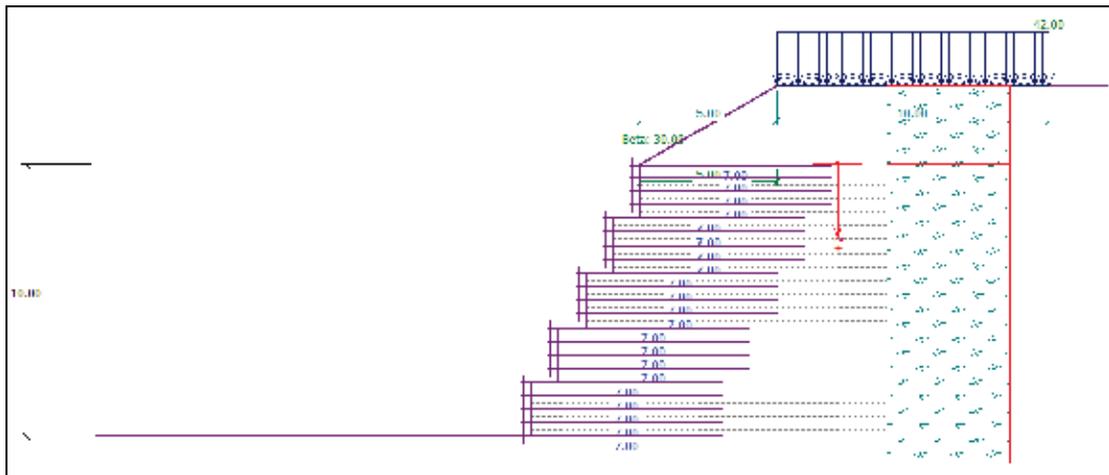
Figure 11 Soil nailing on uphill slope

Uphill slope is almost vertical up to 10m and afterwards it is sloppy having an average of  $45^{\circ}$ - $50^{\circ}$ . The rock is highly weathered and with high damping due to excessive water on the slope. It is therefore required to tackle the stability as well as the drainage issue so that effective long term stability of the slope can be sustained. The measures are designed as per figure 11 & description below.

The slope is very steep and the angle varies from  $80^{\circ}$  to  $90^{\circ}$ . Most of the steeper slopes are more prone to sliding & required treatment as suggested here. Since the working space on the slope is less, crown of the affected slope is near to existing road, it is, required to stabilize the mass in such a way that there is minimum disturbance with optimum effects. In the existing slope conditions conventional slope protection methods may either be inapplicable or may prove to be very costly mainly due to the restriction of

**Facing elements:** The purpose of facing element is to protect the soil nailed surface from damage due to direct rain falling on it and subsequent erosion due to run-off. Use of pre-cast concrete panels, wire mesh with shotcrete, fibre reinforced shotcrete are common for constructing facing element. In this project, the surface of the slope was protected by a layer of cement mortar applied on a wire mesh on to the slope. The design parameters and stability are presented in table 3.
