Perspective slope stability assessment along Aizawl – Variengte Sector of NH 54, Mizoram, India

Abstract

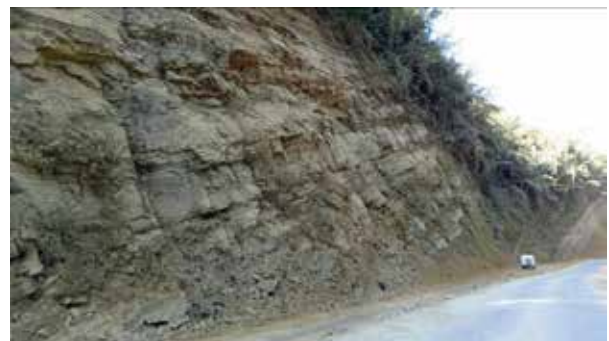
Bed rock: The bed rock encountered in the exposed part is largely argillaceous dominated sequence in which siltstone is the major component along with variably thick sandstone and shale at places. The alternate sequence of rock sometime clearly shows different competence and strength character as exhibited by presence of thin layer of crumbled shale within more competent sandstone/siltstone (figure 2 & figure 3).

Figure 3 Interbanded sequence of litho units in the area

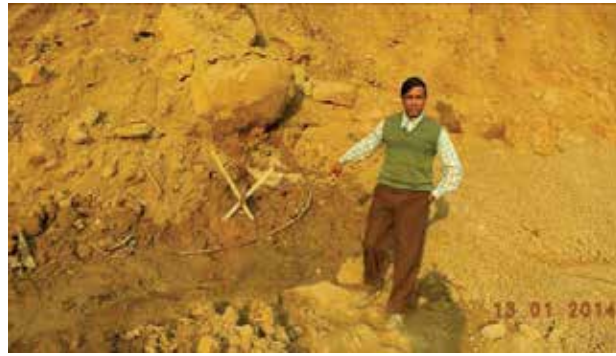
The weathering is facilitated by fractures, especially through percolation of water (figure 4) through the axial plane regions of the folds (figure 5) which shows higher density of fractures.

Figure 4 Seepage of water in the loose overburden

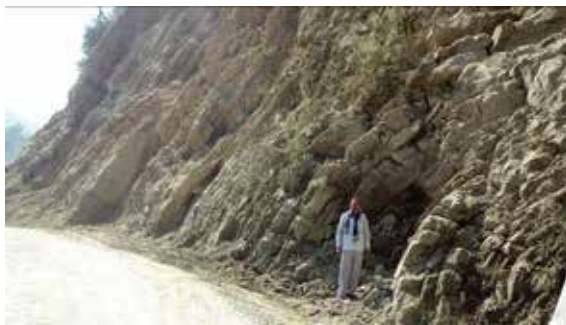
Figure 5 Steepening of the dip and seepage of water

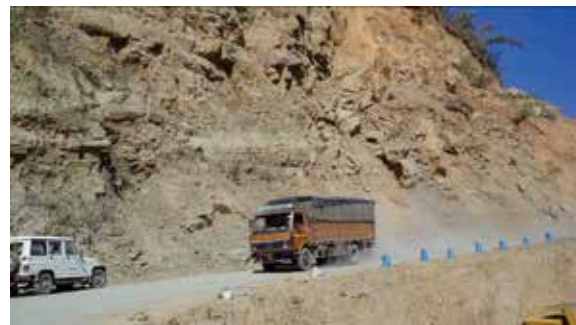
The rock mass strength is highly variable (RQD estimated to be varying from 15 to 40). The reduction of rock mass strength is evident from diffusion of the bedding and sometime discontinuity in the exposed cut face (figure 6). The rock mass at places is also found to be traversed by high angle shears which reduce the rock mass strength considerably (RQD values 10-30).

Figure 6 Diffusion of bedding in the exposed section near the axial zone of the antiforms

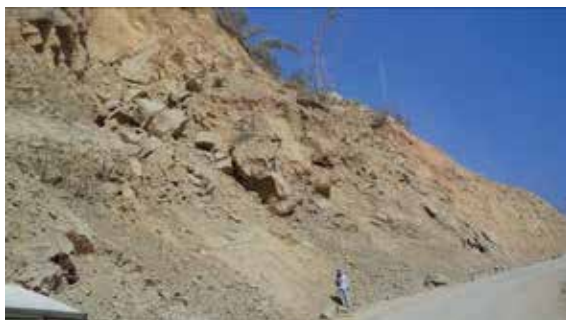
Near the shears the rock mass is fragmented and become powdery at places (figure 7). The primary bedding is the major discontinuity plane. Apart from bedding discontinuity a number of variably disposed fractures and joints were also identified in the bed rock which is resulted due to deformation. The secondary fractures and shears at places indicated local slip and further reduction of the strength character of the rock mass (figure 8).

Figure 7 Fragmented and powdery rock mass exposed

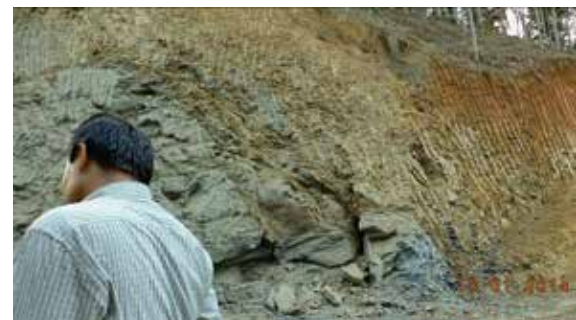
Figure 8 High angle shears traversing the rock mass in the cut slope

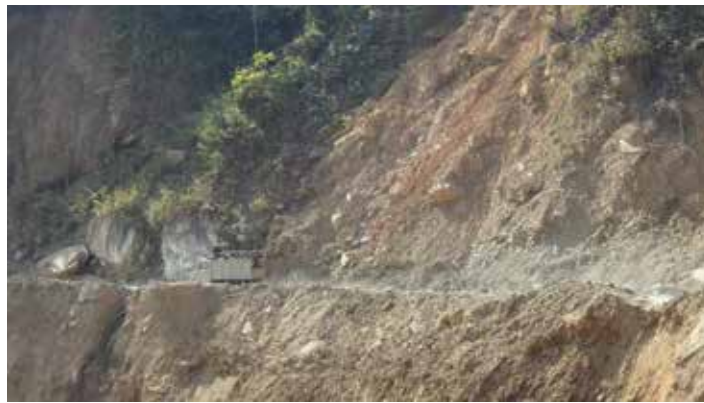
Surficial Geology: The bed rock encountered along the highway corridor and adjoining slope is largely made up of thickly bedded siltstone with subordinate shales and sandstone belonging to Tertiary Surma Group. However, since the bedrock is subjected to intense weathering, at many stretches competent bedrock is not encountered at shallower level. Due to intense weathering the bedrock is found to be overlain by thin to thick (1-5 m) overburden consist of highly weathered rock mass, insitu clay to silty soil (occasional sandy pockets at places). Because of the primary compositional differences, the weathering profile has variable nature and thickness. Further, because of the past and paleo mass wasting, surficial materials like that of older well compacted debris, younger loose debris, scree and slope wash are encountered in the slope. The surficial material, at places, especially proximal to the accumulation zones of past failures is found to be highly heterogeneous and unevenly distributed. The surficial material, therefore, shows variable volumetric proportion, size fractions and variation in permeability. Since the area experiences heavy monsoon discharge on the said variable slope forming material, therefore the response of the slope on the hydrological situation, is largely variable and complex in nature. Further due to the weathering of the siltstone, the derived soil shows higher porosity and reduced permeability (dominantly fine grained silt to clay). Along with the natural material the slope also hosts at places large volume of loose excavated unconsolidated material. Hence, the large scale excavation has not only modified the slope but the slope forming surficial material (figure 9). At many places long rectilinear to curvilinear cracks of 1 to 8 m observed in the surficial material.

Figure 9 Loose unconsolidated overburden mass in the excavated slope

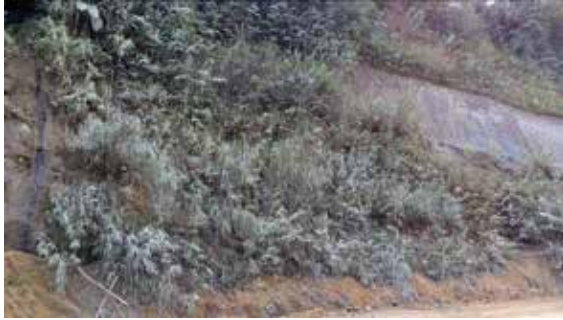
the slope and slope forming material in a complex and varied way. Further due to the higher porosity and reduced permeability of the weathered soil (dominantly fine grained silt to clay); local development of pore water pressure was observed at places. During the study in pre-monsoon dry period, a significant part of the slope proximal to the road bench exhibited flowing, wet and damp condition, especially in the overburden slope (figure 10 & figure 11).

Figure 10 Flowing condition in overburden mass during the dry period

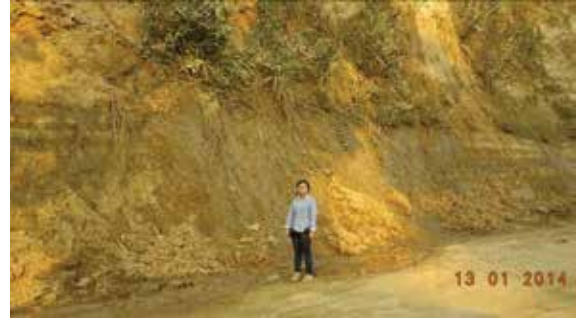
Figure 11 Extensive damp patches in the exposed rock mass as observed during dry period

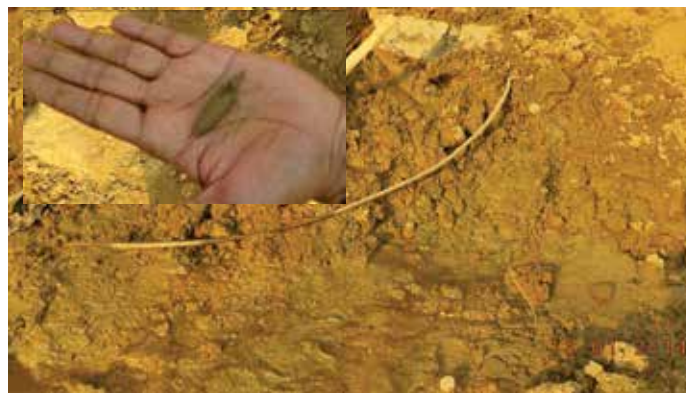
These clearly indicate that sub-surface drainage network could be active for a longer period and can act on the slope forming material. One of the significant observations made during the study is the identification of loci of hydrostatic pressure behind the cut slope even during dry season and consequent bulging and fracturing of the slope. Further active removal of clay material by the surface run-off and deposition of the same at places indicated piping condition (figure 12). These clearly reflect pre-condition of failures in the event of further anomalous rainfall and anthropogenic intervention.

Figure 12 Prominent seepage and clay deposition in the basal overburden slope
(Inset shows deposited moulded finer material)

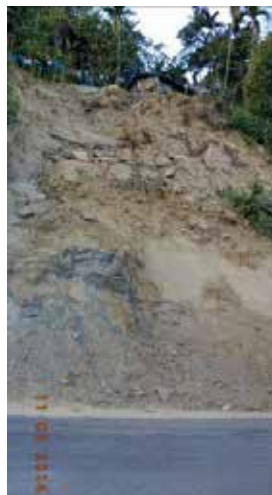
However, detailed inventory of two slope failures in rock and over burden which are recently initiated or reactivated are documented. The two most prominent among them are at Variengte ($24^{\circ} 30' 35.8''$: $92^{\circ}46' 70''$), (figure13) and that of Mama cement factory ($23^{\circ}55'22.6''$: $92^{\circ}39'25.3''$), (figure14). At Variengte a small (600 sq m) but prominent rock slide initiated in 2013 within the variably weathered interbedded sequence of sandstone was identified. The disposition of the discontinuity with respect to the slope is responsible for both planar and wedge failure. The rock slide is interpreted to be suspended one and is both retrogressive and enlarging. Since the rock slide is adjacent to National Highway and it is found that accumulated debris mass released during mass movement contain big size boulder, therefore in the event of subsequent surface runoff, the same may come down suddenly and may strike the Silchar bound vehicular traffic and consequent hazard. Above the crown there is human settlement in the form of few hutments. In the event of further retrogression of the rock slide, the habitation will be affected. Therefore the road bench, the Silchar bound traffic and the hutments are the elements at risk. Though the dimension of the rock slide is not significant, however, due to its susceptibility for further reactivation within a short period and influencing the element of risk, makes it a threat and therefore need to be mitigated at the earliest.

Figure 13 Prominent rock slide showing released boulder at vulnerable slope, Variengte

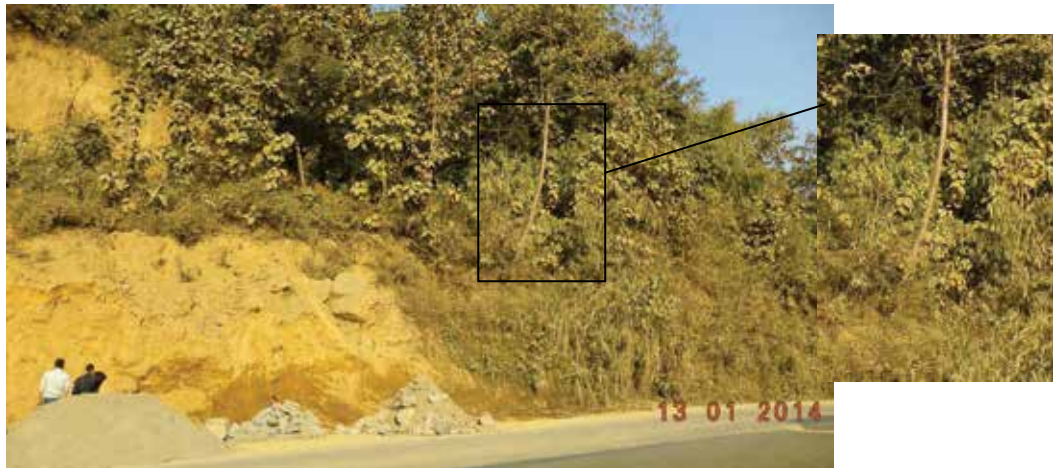
The slope failures near Mama cement factory (figure 14) is a reactivated one involving 2080 sq m area and an estimated volume of 12480 cu m affecting the insitu silty soil and older debris material. Rotational failures were identified and the failure plane is found to be both retrogressive and enlarging. Adjacent to the sites of active mass movement prominent creep movement was identified through differential bending of tree trunk. The slope mass exhibited prominent seepage condition even during the dry month of January. Both active hydrological condition and anthropogenic interferences on slope mass are accounted for the failure. Apart from the sites of prominent past mass movements at a number of locations creep movements in side slope and prominent subsidence of road bench were also seen and documented.

Figure 14 Rotational failure in the cut slope near Mama Cement Factory
(Identifiable creep movement in the adjoining slope evident from bending of tree trunk)

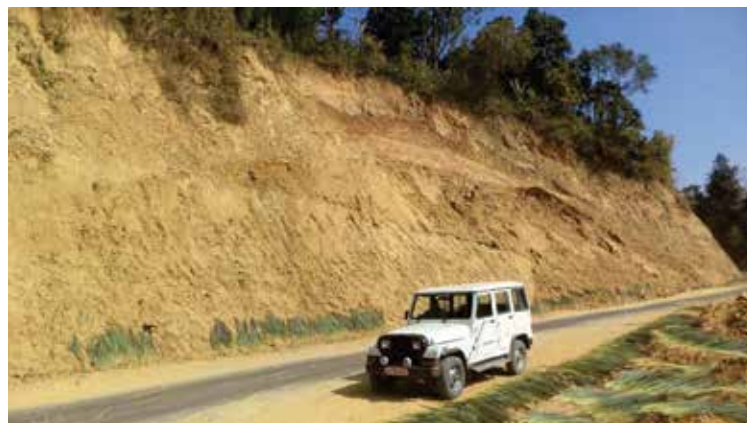
The study further reveals that there are locations along the studied corridor where predisposing condition in the slope indicates probable initiation of failure in the event of triggering either due to anomalous high rainfall or due to seismicity. One such location (23°53'54.6": 23°53'54.6") identified along the road corridor reveals probable shallow translational movement along the interface of weathered bed rock and 4 m thick overburden (figure 15).

Fig. 15 Inclined rock soil interface – a site of probable translation failure during lubrication

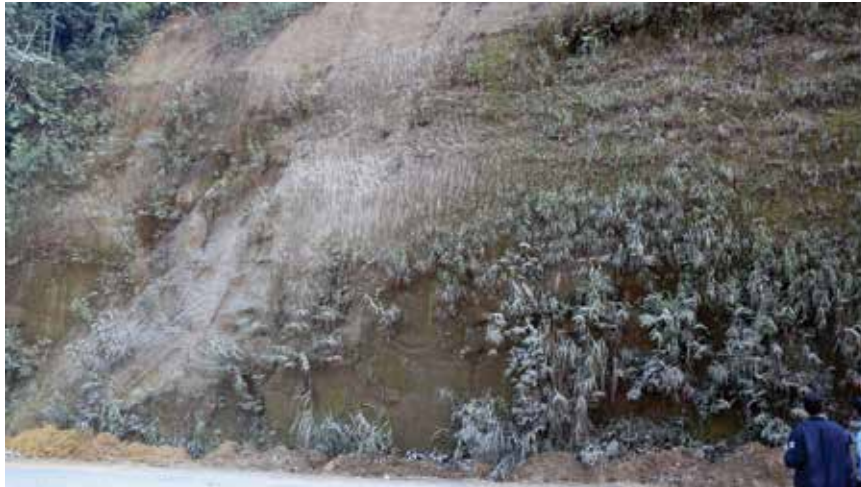
The same is interpreted from the slope features like (a) visible bulging of the slope mass (figure 16). (b) Presence of a number of transverse burrows and discreetly bouldery units facilitating seepage and removal of finer material (c) flowing hydrological condition iv) dampening of the slope, the same dampening of the slope mass even during dry season pointed towards development of pore water pressure at the back of the rock face. d) Prominent curvilinear fractures, (e) well defined irregular furrows.

Figure 16 Prominent bulging of slope probably indicating pore water pressure development

There is no history of failure in the area as of now. But the increase of pore pressure as evidenced by bulging of the lower slope and the flowing condition in parts of the slope even during driest month of January suggests that it is prone to failure, especially if interfered by anthropogenic activity such as cutting of the toe of the slope. Presently the slope is self supporting however in the event of any small/large scale anthropogenic intervention, the slope failure is expected. The slope attribute documented may suggest that the slope face may experience failure during next five years naturally and if interfered further in the next monsoon. Therefore, probability of the occurrence of failure is 20%. Apart from the above, due to the action of subsurface water at a number of places removal and deposition of fine clay fractions at the base of the cut slope and also in vegetated natural slope were observed.
