Detailed field-based geotechnical characterization of the two conspicuous rockslides affecting the strategic Hayuliang -Metengliang-Chaglogam (H-M-C) Road corridor, Anjaw district, Arunachal Pradesh

*Chasie, Megotsohe, Theophilus, P. K. & * Sarkar, Niroj Kumar
Geological Survey of India, NER, Shillong.
Corresponding author: Niroj Kumar Sarkar, email: niroj4@gmail.com*

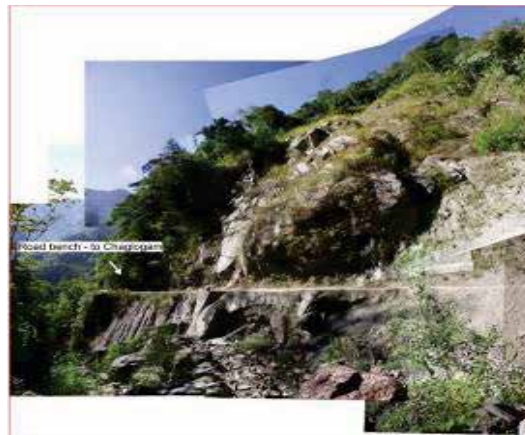
Figure 1 Perspective view of rock slide (Mosaic photo)

About 75 m of the road stretch has been affected by the prominent rock slides (figure 1) due to the slided rock mass, toppled rock boulders and rock falls. The slope forming material is dominantly feldspathic schist with quartz-muscovite-sericite as other mineral constituents present in varying volumetric proportion. The feldspathic schist is found inter-banded at places with quartzo feldspathic gneisses. The weathering grade of the rockmass found varies from slightly weathered (W_1) to moderately weathered (W_2) category. In the last few years, descended dislodged rock boulders from the near-vertical up-slope, has reported to pound and severely affect the road bench for a number of occasion. The road stretch for a length of 25 m - 30 m proximal to the stream channel is found to be most affected. The dimensions of the active part of rockslide is estimated to be 40 m along slope, 45 m along road with a depth of failure surface varying between 4 to 5 m.

- i. Removal of the unstable rock overhangs (figure 1&2) above the identified discontinuity plane J_1 $N55^\circ/64^\circ \rightarrow N145^\circ$ (J_1) along which the planar failure is anticipated.
- ii. Consolidation of the profusely jointed rock mass (figure 2) both on the upslope and down slope of the road bench through the use of steel fibre reinforced shotcrete (SFRS).
- iii. Systematic bolting in staggered fashion in the down slope rock-mass, spot bolting in the massive rock-mass to the up-slope of the road bench (figure 3). The rock bolts to be driven at $25^\circ-30^\circ \rightarrow N320^\circ-N330^\circ$ (at/or near orthogonal relation to the J_1 plane)

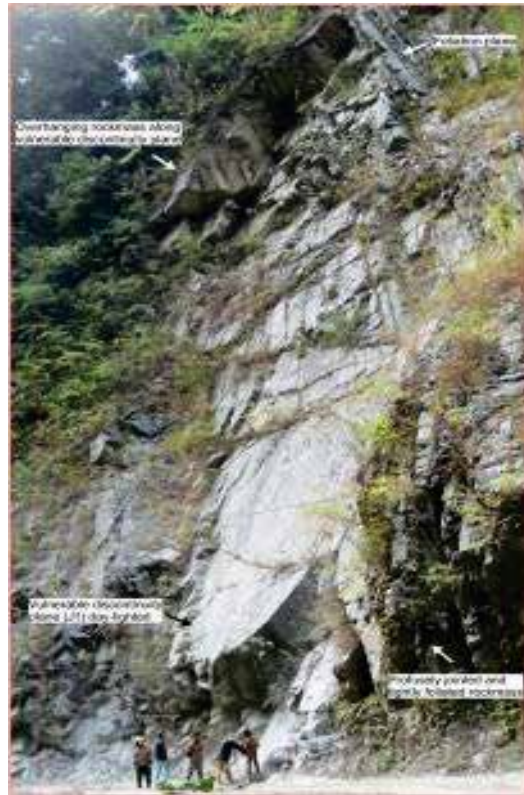
The slope face is sub vertical (69° - 75°) and directed towards $S20^\circ E$. Foliation, the most pervasive planar element disposed $77^\circ \rightarrow N33^\circ$ and is found to be tightly spaced (figure 2 & figure 3). Besides the foliation, the rock-mass is found to be variably traversed by a number of other discontinuities having varying disposition and persistence (table 1). Apart from the jointed rock mass, somehow massive variety is also documented in the slope. Among the identified discontinuities (table 1), the steeply dipping joint (J_1 : $64^\circ \rightarrow N145^\circ$) is found to have its strike disposed at a low angle (10° to 15°) to the slope direction and therefore is vulnerable (figure 2). The attitude and attributes (persistence, spacing, aperture, roughness and weathering condition) of all the discontinuities were documented and presented in (table 1). RMR basic values of the rock mass were estimated following (Beiniawski, Z. T. (1973 & 1979), using (i) UCS (average value determined in the field using Schmidt Hammer) ii) RQD determined using Palmstrong formula ($115 - 3.3 * J_v$) and relevant joint attributes listed in table 1. The estimated RMR_b value designates the rock as class III category (fair rock). The input parameters for estimation of RMR basic, their rating, the RMR value and corresponding C and Φ value of the rock-mass is presented in table 2.

Figure 2 Prominent vulnerable discontinuity

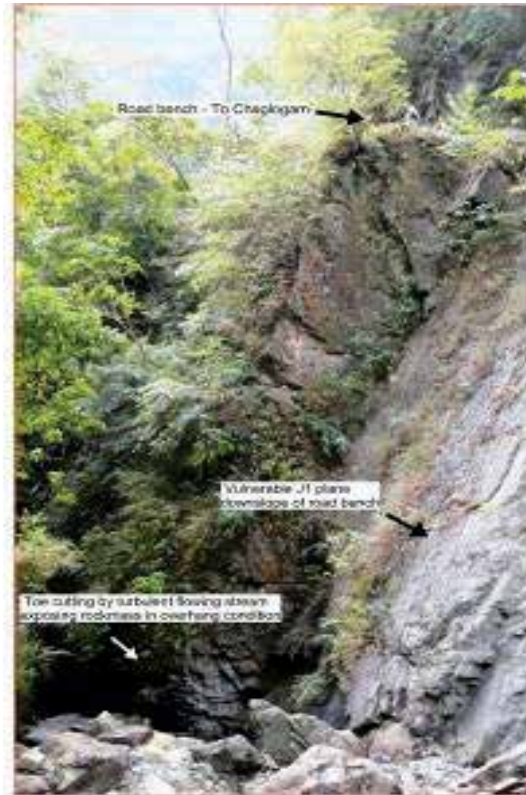
Figure 3 Down slope of road bench, toe erosion and vulnerable discontinuity plane.

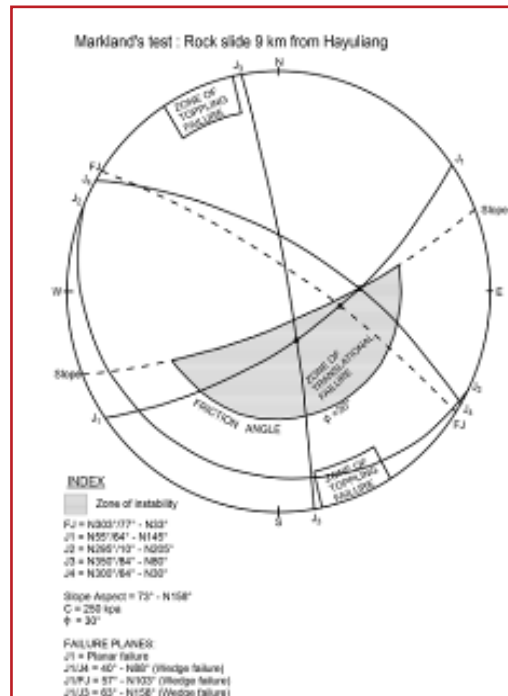
The SMR value estimated from empirical approach proposed by Romana (1985) is found to be 23. The said value categorized the slope mass as Class IV (Bad) and therefore has higher probability of failure. Kinematic analysis of the rock slope (figure 4) was carried out using the geometrical disposition of the slope, discontinuities and angle of internal friction estimated from RMR basic value. The same is done to examine the modes of failure that can possibly occur in the rock mass and is done through Stereographic representation (stereo nets) of the discontinuity planes, slopes and intersecting lines. The kinematic analysis (figure 4) indicates that prominent planar failure along J_1 discontinuity and insipient wedge failure along intersection of J_1 and foliation and J_1 and J_4 which is collaborated by field documentation. (figures 1 to 3).

Figure 4 Markland's test of 9 km rock slide

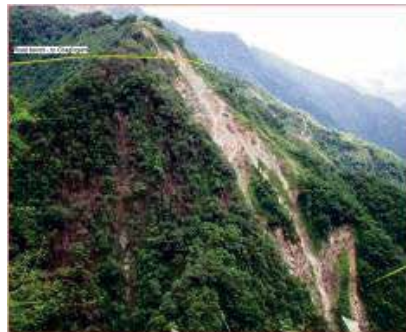
The prominent rockslide in the specified location affecting nearly 80 m of the road bench. The rockslide reported to be initiated in the steep slope in 2010, reactivated during the successive monsoon, is responsible for destruction of the road bench at some specified stretch (figure 5). The rock slide is accompanied by rock falls which has completely destroyed a few constructed retaining structures due to the impact of large falling rock boulders from the up slope. The dimension of the rockslide measured is 170 m in length, 90 m in width and having a total run-out distance of 150 m. The slope forming material is

Figure 5 Perspective view of 29.9 km rock slide, view from opposite slope

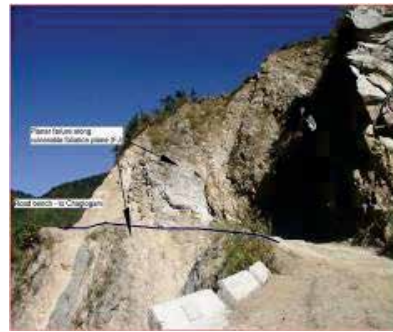
dominantly quartzo-feldspathic gneiss inter-banded at places with relatively mica-rich layers. In terms of weathering grade, the rock mass is observed to be slightly (W_1) to moderately weathered (W_2). The penetrative planar fabric in the rock mass is defined by foliation along gneissic bands which is found disposed $68^\circ \rightarrow N200^\circ$. Beside the same, the rock-mass across the distressed slope face, is also found variably traversed by recognizable discontinuities, attitude and attributes of which are presented in table 3. To maintain the operability of the road bench, the very steep rocky slope was successively shifted towards the hill side with a near V-shaped alignment (figure 6), the apex of which is aligned towards the hill side.

Figure 6 Perspective view of rockslide, visible prominent vulnerable discontinuity plane

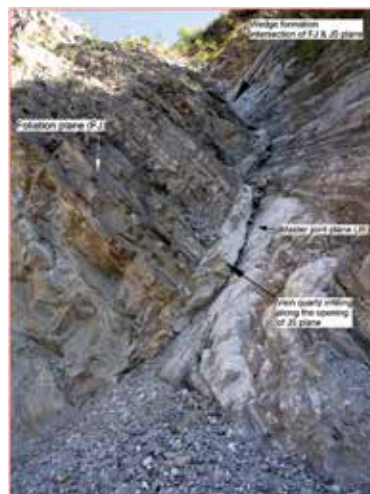
The rock slope, accordingly described as left and right slope in respect of the prominent central depressions located at maximum curvature of V. The left slope is found inclined 56° - 60° towards $N315^\circ$ - $N320^\circ$. The right slope is oriented 60° towards $N215^\circ$ direction. Planar (along foliation) and toppling failure along steep discontinuity has been observed in the left slope. The central depression is found oriented along a vulnerable wedge formed due to the intersection of the foliation and a prominent discontinuity dipping 48° towards 320° (figure 7).

Figure 7 Prominent vulnerable discontinuity planes along the central depression

At the central depression: i) Removal of the overhanging rock-mass to the up-slope of the road bench through controlled blasting ii) Provision of multilevel transverse structures across the central depression and to the upslope of the road bench to dissipate and channelize the surface run-off iii) provision of a culvert at the road bench level for draining-out the surface run-off descending from the upslope iv) construction of retaining walls to the down slope of the road bench, the foundation of the retaining walls are to be stitched/anchored to the bedrock through horizontal as well as vertical bolts/rods/dowels.

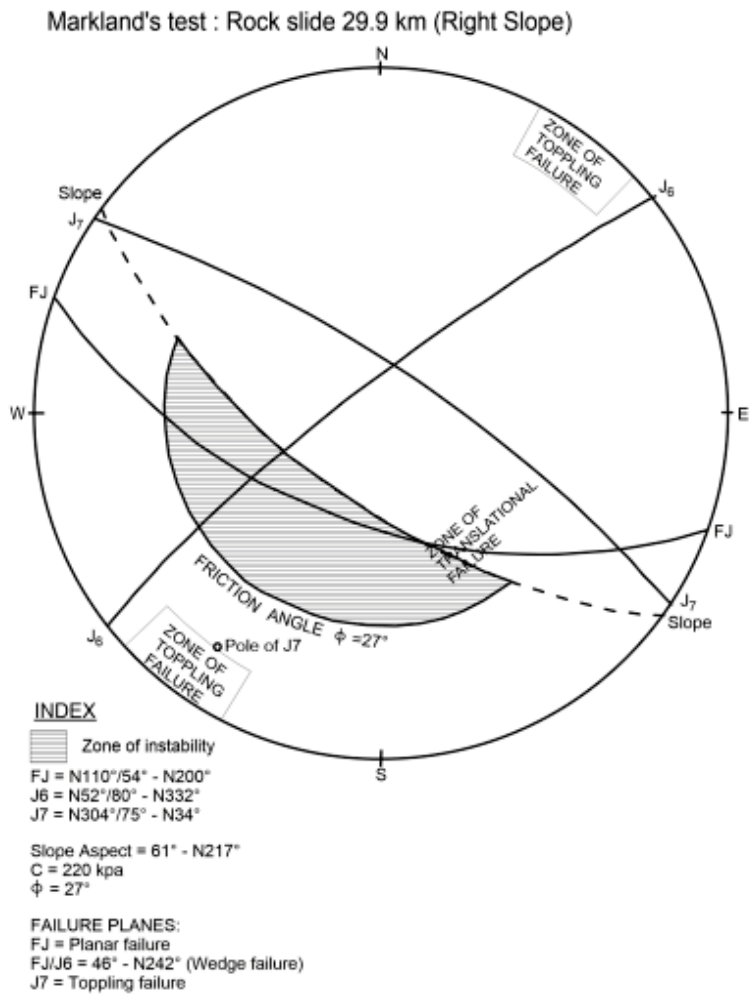
Figure 8 Markland's test, right slope

The kinematic analysis for right slope (figure 8) reveals planar failure along the foliation plane (F_1), probable wedge failure along the intersection plane of F_1 & J_6 and toppling failure along J_7 (the pole falling near the boundary of the zone of toppling failure). Similarly the same for left slope (figure 9) indicate planar failure along the J_2 plane and possible toppling failures along the J_1 plane (the pole falling at the boundary of the zone of toppling failure). In the central depression (figure 10) prominent wedge failure interpreted along the intersection plane of F_1 & J_5 , which is well corroborated from the field observation. Therefore, it emerges, that the rockslide exhibit combination of planar, wedge as well as toppling failure modes.

On the right slope face: i) Complete removal of the rock mass resting on/above the intersecting plane of F_j . ii) The trimmed slope may be further treated with SFRS (Steel Fibre Reinforced Shotcrete). iii) Provision of rock bolting (staggered), the bolts to be driven at $45^\circ-50^\circ \rightarrow N20^\circ-N25^\circ$. iv) Construction of lined hillside drains.

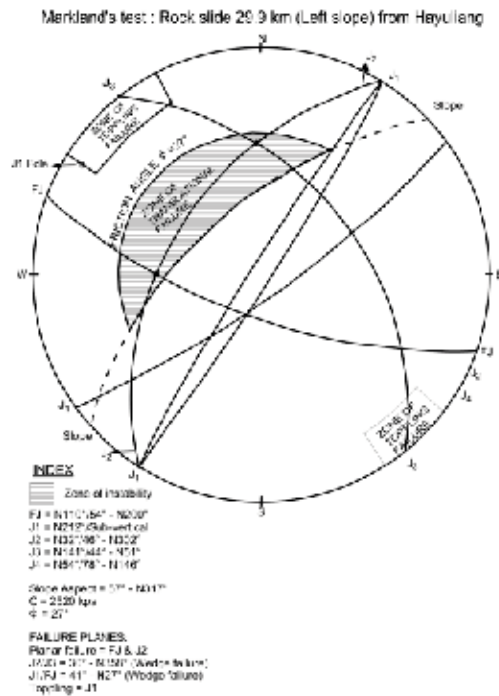
Figure 9 Markland's test, (left slope) indicated vulnerable planar and toppling failure

On the left slope face: i) Removal of the unstable rock overhangs (figure 3) above the identified discontinuity plane J_2 and at places above J_1 and toppling along which the planar failure is anticipated. Once the overhang is removed, the slope may be further treated with SFRS (Steel Fibre Reinforced Shotcrete). The same is required considering quality of the rock mass (Class-III). Construction of a lined hillside drains.

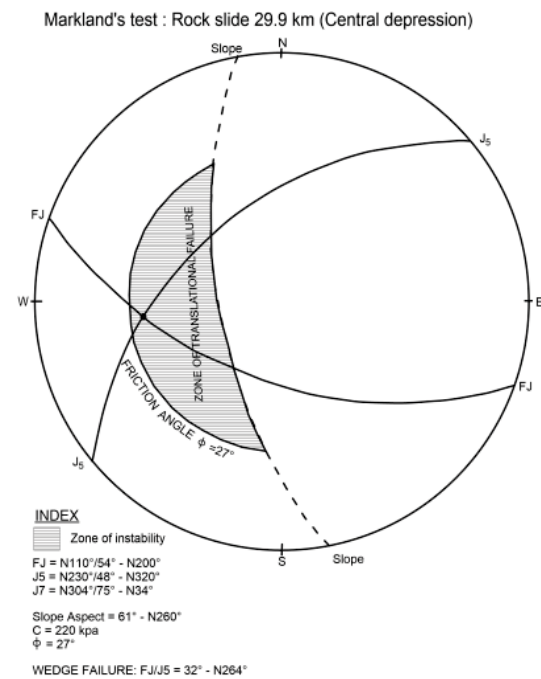
Figure 10 Markland's test, Central depression, indicated vulnerable planar failure
