# **Geotechnical Problem Encountered in HRT of Pallivasal Extension Scheme, Idukki District, Kerala**

*K. Aravind,*

## **Abstract**

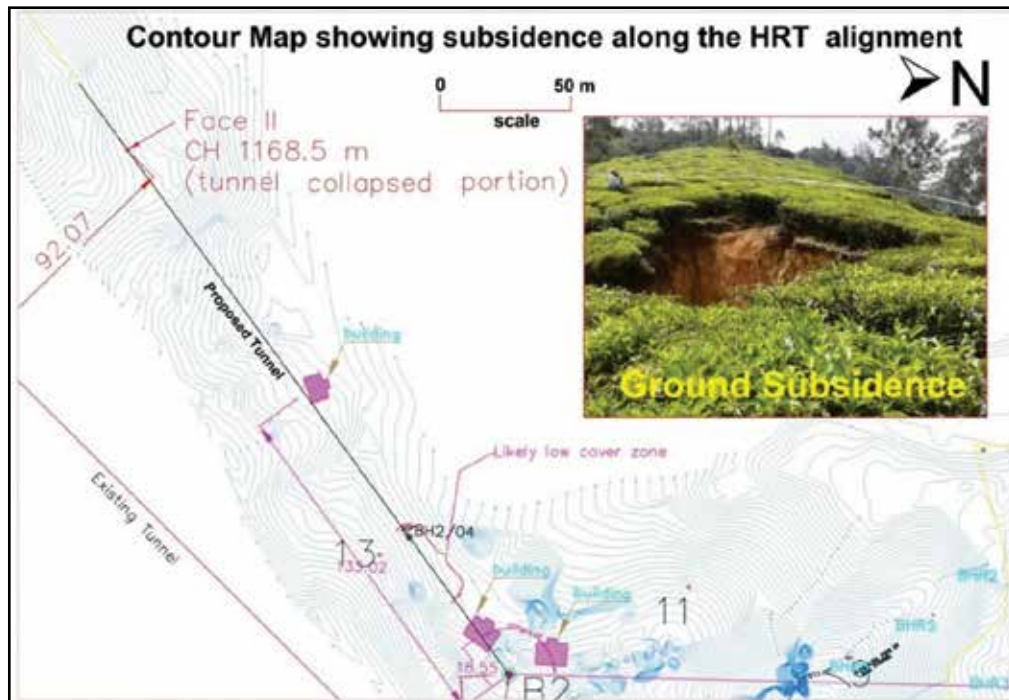
Plate 3 Contour Map showing Subsidence along HRT alignment

Seismic refraction survey carried out by NIRM along the tunnel alignment, for a length of 230m, from close to the present face and B<sub>2</sub> Bend (plate 3), suggest very undulating profiles of velocity layers. Though the location of cavity, at the present face and surface depression, is not represented (Ch 1168.5m) in the velocity section, it is however, evident that close to this location, the low velocity layer with  $V_p = 350 - 1500$  m/sec considerable falls down by >24m, thus suggesting a high grade of weathering and open jointing.

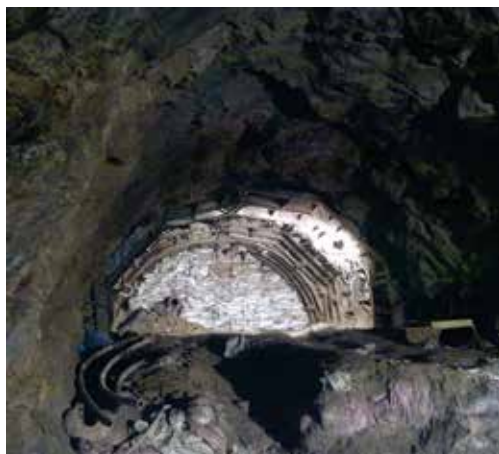
Picture 1 Photograph of HRT- Face 2 at ch.1170 m taken during site inspection

At the tunnel grade, cavity formation beyond Ch. 1165 (figure1) was reported, which however, could not be seen as the face was plugged by gunny bags filled with muck. Geotechnical assessment of the section between ch.1148 and 1165m, which is unsupported, has revealed exposure of fresh to slightly weathered hornblende biotite gneiss and pink granite gneiss. Foliation trending N 80°E – S80°W, with 30°-50° dip due N10°W, strikes sub-parallel to the tunnel axis (heading due N70°E). The other prominent joints being:

Since the reach beyond ch.1165m was already supported by steel ribs and therefore could not be assessed, it is quite likely that rock mass conditions are severely deteriorated. Structural wedges formed at the crown due to intersection of 3 joints in the water charged zone, possibly contributed in cavity formation.

Figure 1 Cavity formation in HRT Face 2 at ch.1170 m

- i. G.I. pipes of 6-9m length were suggested to be pushed into the cavity for grouting. Then, cement-sand grouts (1:1) were suggested to be injected to consolidate the water saturated mass. This is necessary to consolidate the loose dead rock mass (and debris) above the crown in the cavity zone to enable advance by providing steel rib-support at 40cm c/c spacing, with proper lagging and drain holes. It was also recommended for grouting the face for strengthening

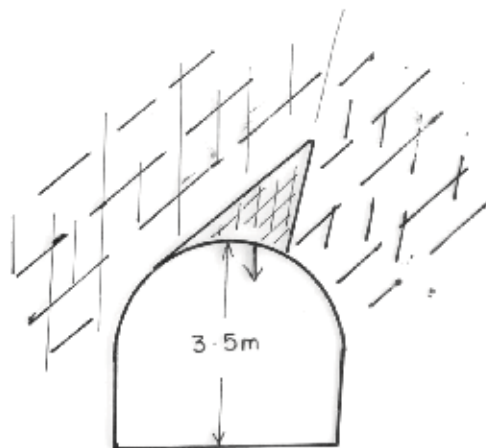
The section close to the formed cavity is marked by blocky jointed rocks. The instability has arisen due to gravity falls of the jointed rock blocks from the crown. The falling blocks are separated from the surrounding rock mass by at least 3 intersecting joints to form a free falling wedge (figure 2). The vertical line drawn through the apex of the wedge falls within the base of the wedge, thus satisfying the condition of wedge failure. The 3 great circles plotted in a stereo net (figure 3) representing 3 joint planes, form a closed figure surrounding the centre of the net (representing apex of the wedge).

Figure 2 Wedge failure from the crown of HRT Face-2, at ch. 1170 m

Ever since the initial failure from the crown (before October 2011), much deformation of the rock mass has already taken place and the initial support pressure provided by steel ribs failed to sustain the load imposed by the distressed jointed and weathered mass. Removal of the accumulated rock debris from below the cavity also facilitated further

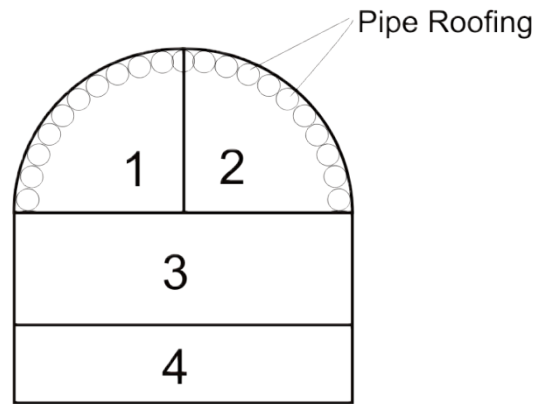
Figure 3 Proposed Excavation Sequence

- ii. To further strengthen the crown and facilitate a safe advance, pipe roofing or pipe umbrella system was recommended (figure 3). This is felt necessary as earlier attempts to provide pre-support by fore poling failed to succeed, perhaps due to lack of suitable machines for installation. Conventional drill jumbos or special machines were suggested for deployment to install the pipes. The steel pipes were suggested to be installed from the tunnel face in the crown to the front, directed at 5° to 10° upwards, in an umbrella or canopy like arrangement, preferably with the following specifications.

- a. Spacing – 0.30m or even less.
  - b. Diameter of pipe – 60 – 150mm
  - c. Wall thickness – 4 to 8 mm
  - d. Length – 9 to 12m
  - e. Overlap- 3-4m
- iii. Subsequently, the face needs to be driven through the grouted mass sequentially, in compartments from the top, as depicted in figure 3

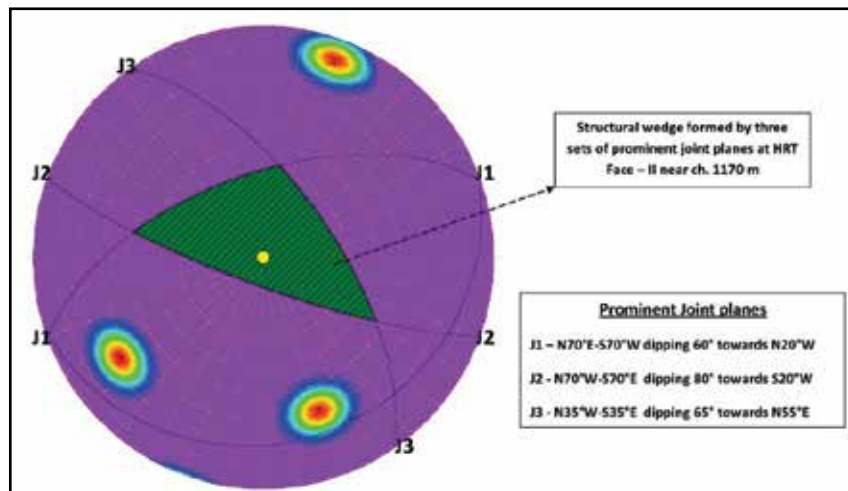
Figure 4 Stereo net showing formation of Wedge with its vertex at the centre

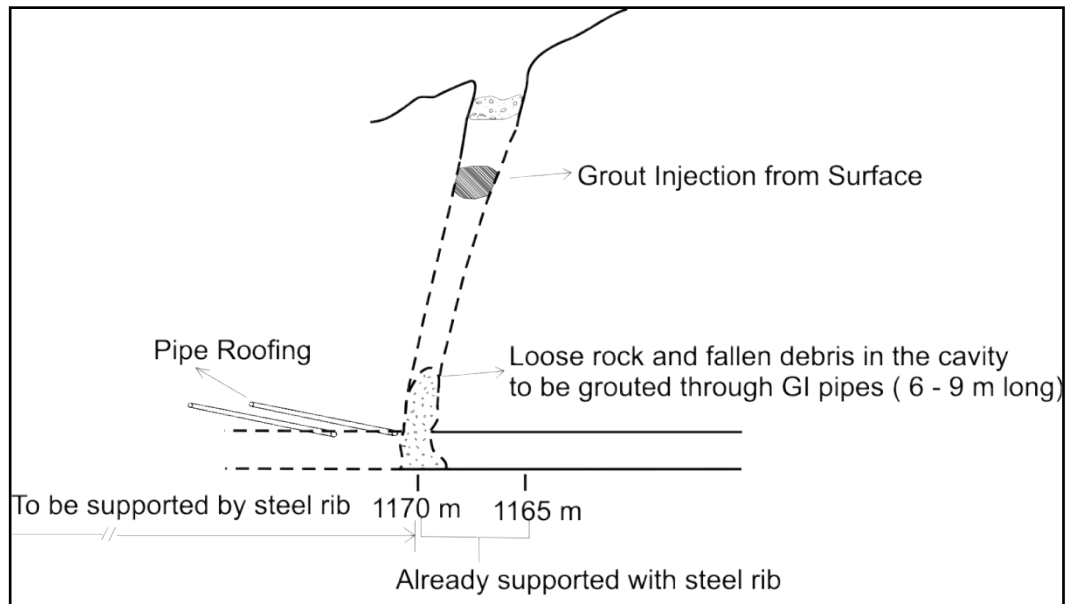
Figure 5 Proposed Support Measures

- iv. Support assembly were said to be made ready since it would require concurrently to be placed behind the advancing face, as stand up time in the distressed, weathered and saturated zone would be limited. Any delaying in giving support would only allow deformation to take place.

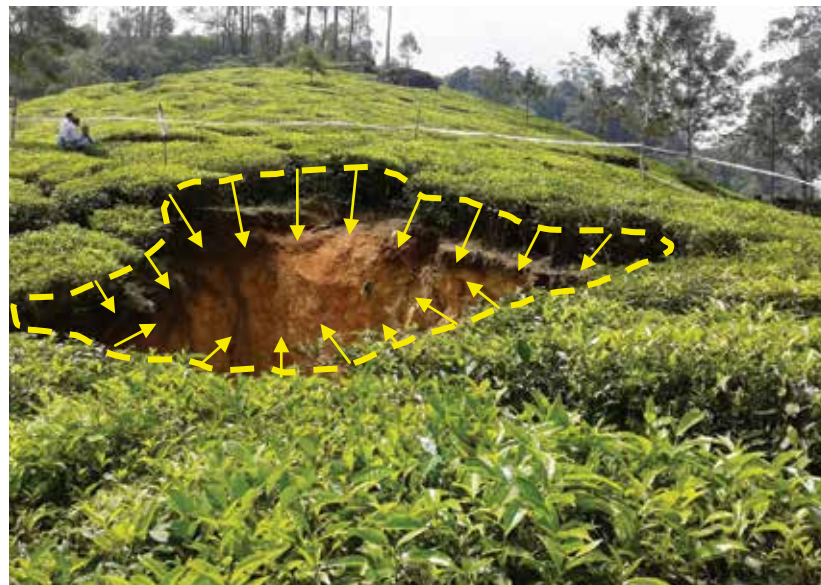
The surface depression was formed along the HRT Face II alignment at ch.1170.50 m ( $10^{\circ} 03' 57''\text{E}$ ,  $77^{\circ} 03' 32''\text{N}$ ). The depression is observed with highly weathered rocks ( $W_3 - W_4$  grade) affected by at least 3 sets of joints and overlain by 1-3 m of overburden are involved in land subsidence creating a depression (8x8x12m), on a  $N75^{\circ}\text{E}$  facing slope of Tata Tea Estate (plate 2) At this location, total vertical cover is said to be 80m approx. above the tunnel. In the lower topographic levels, water saturated conditions are evident showing signs of subsidence.

Picture 2 Surface depression at ch.1170.50 along HRT – Face II alignment

The failure in the tunnel and subsequent development of ground subsidence on the surface above the tunnel cavity warrants a systematic approach in giving suitable treatment. Therefore, in order to arrest further sinking of the ground surface and its attendant impact on the tunnelling condition, beneath the surface, grouting from the surface is advised. As part of this process, grout is to be injected from the surface, at an intermediated level between the tunnel crown and the ground surface (figure 5). The grout is intended to mainly support overburden and to impart homogeneity to an otherwise block, weathered and highly jointed rock mass. Grout material may comprise of slurry of suspended particles (silica flour, cement, bentonite etc) which would behave as a viscous fluid during injection.
