# **Geological investigation, a necessity in every stage of project advancement- A case study, Punasi reservoir scheme, Deoghar district, Jharkhand**

*Basu Roy, S.  
Geological Consultant*

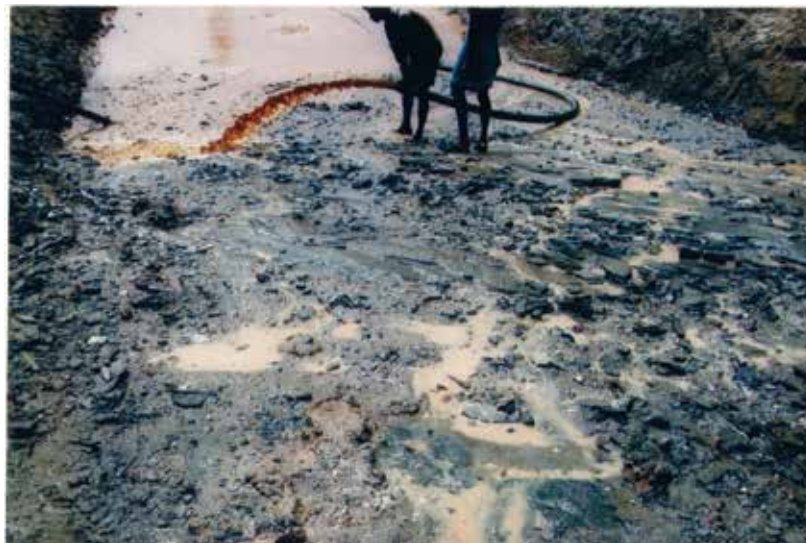
Picture 1 Hornblende gneiss rock at the cut-off trench bottom at RD 1951m (Ch 64) on right bank

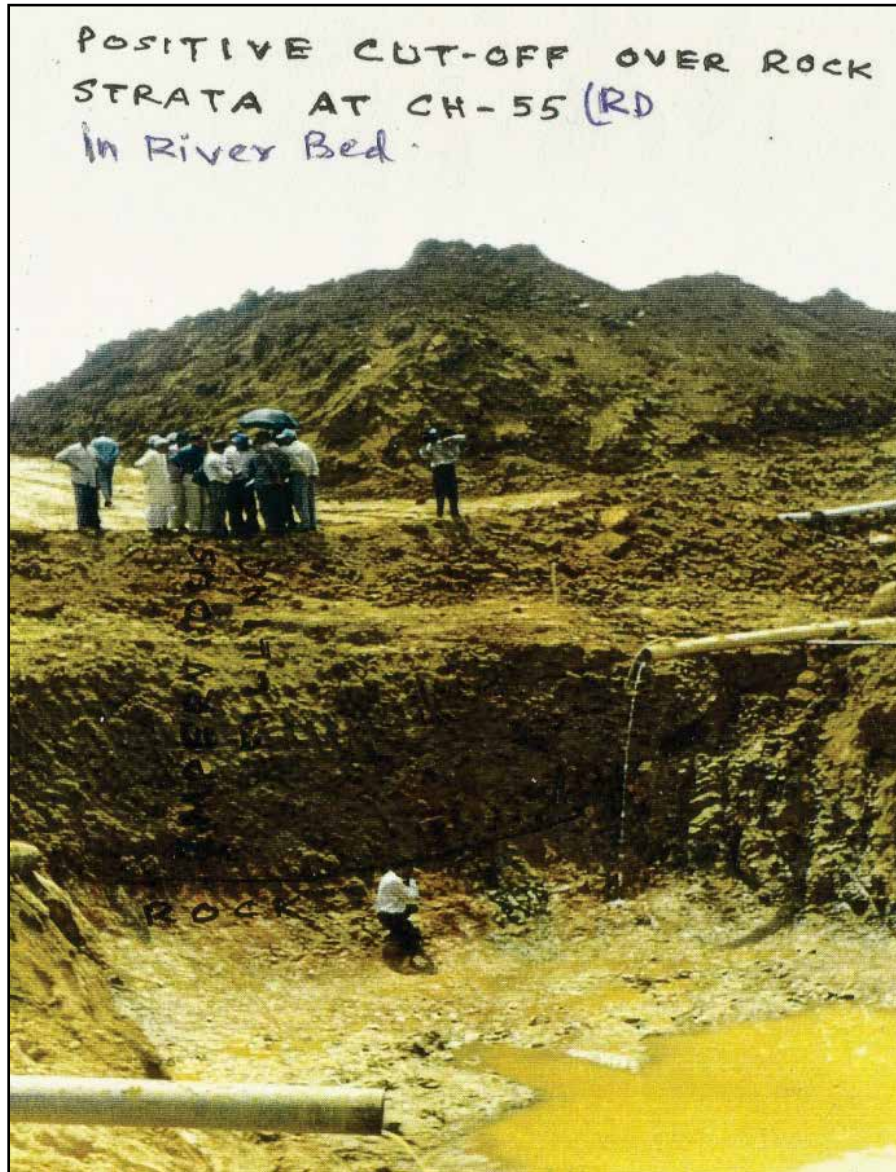
Picture 2 Cut-off bottom on granite gneiss & hornblende gneiss strata at RD 1677m (Ch 55) in river bed left bank dam filling can be seen beyond the cut off.

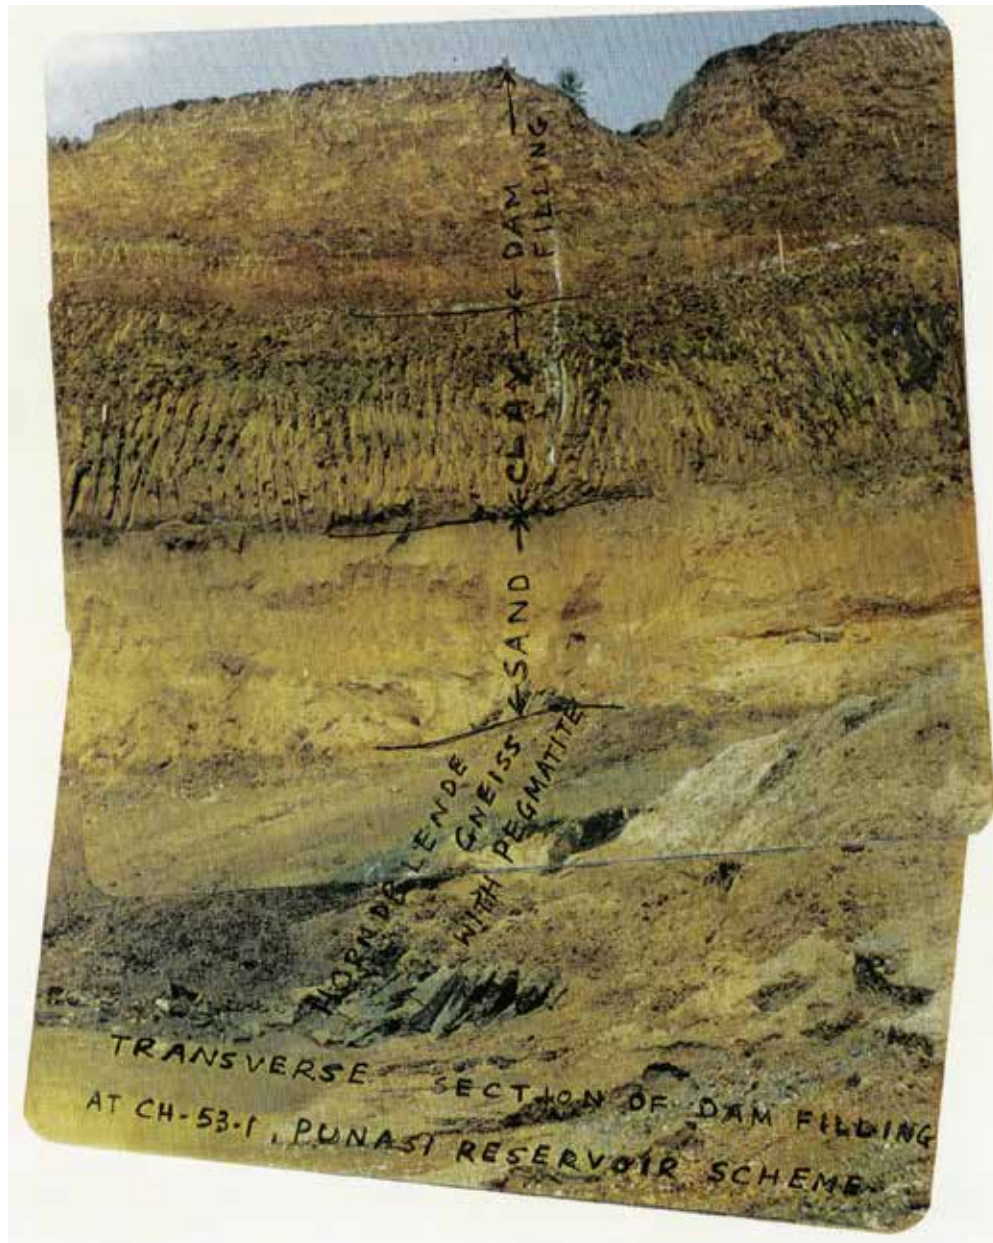
The vertical cross section encountered at RD 1616m (Ch53) on the left bank from the cut-off level at river bed reveals presence of nearly 4.45m river sand below the cut-off filling where dam has been raised to full height up to E.L 260m where NSL being E.L.242.86m.(picture 3). The sand layer at the base of the COT has an upstream to downstream connection which will invariably be a easy path of seepage after reservoir impounding, leading to piping ,differential settlement and ultimately failure of the dam. The drifted trees were also embedded in the sand. The natural clay layer above the sand layer and below the impervious filling is seen to pinch out upstream as seen in the vertical section. Pinching out of the natural clay layer is also observed in river bed section during cut-off filling.

Picture 3 Vertical cross-sections at RD1616m (Ch 53) on the edge of the left bank showing sand layer underlain by rocky strata below dam filling.

As the dam has been raised almost to full height in the left bank completed with riprap and toe drain etc. it is not possible to dismantle the dam, excavate the filled up material, provide the desired positive cutoff below sand layer and raised it again to desired dam height with new riprap etc. This will involve a huge expenditure. Therefore to minimize the possible leakage problem and considering the economic aspect, a positive cutoff up to bed rock level along the heel portion of the dam on left bank was recommended. It was also suggested to tie up the present dam axis cutoff at riverbed transversely with proposed upstream cutoff at the heel portion as closely as possible near RD1616m (Ch53) by an

impervious core up to NSL to prevent entry of water from the sides through pervious sand layer in between upstream and present dam axis cutoff.

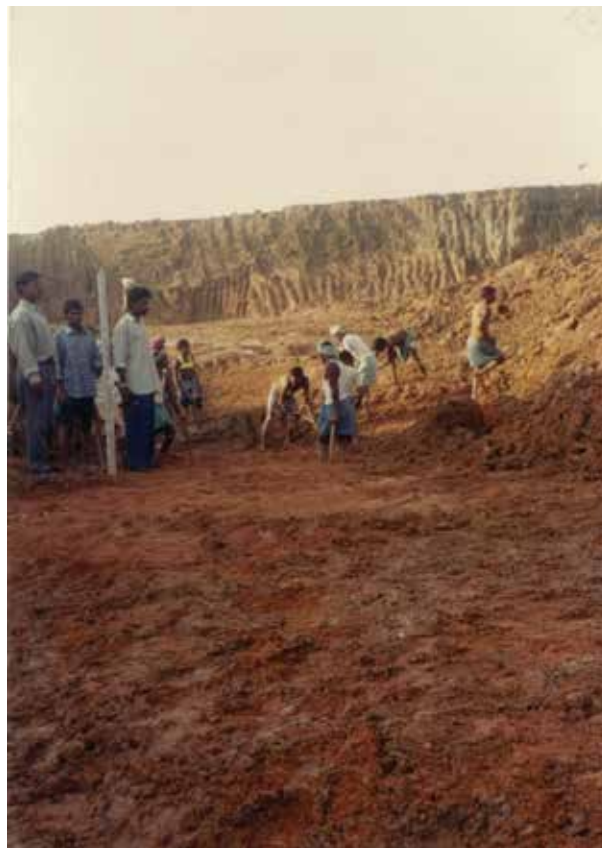
Picture 4 Upstream parallel cut-off bottom showing granite gneiss intruded by pink pegmatite below sand layer at RD 1509m (Ch 49.5) on left bank.

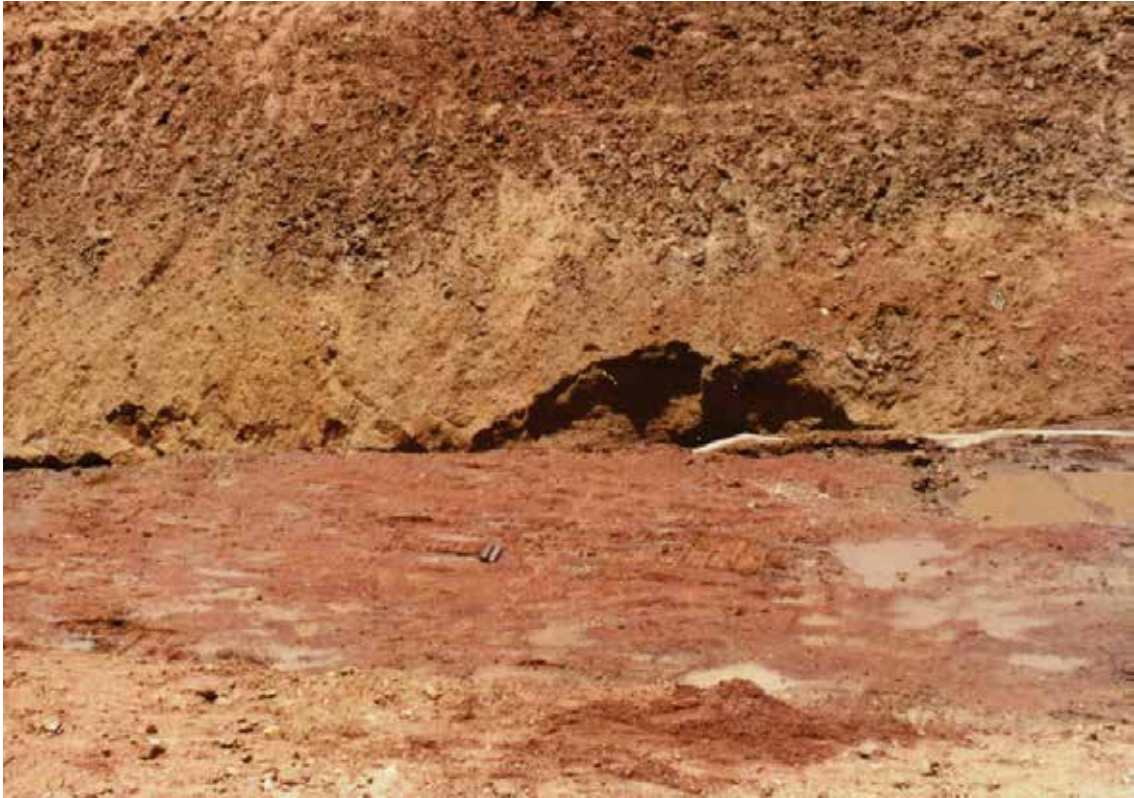
Picture 5 Upstream parallel cut-off bottom showing mainly pink pegmatite below sand layer at RD 1463m (Ch 48) on left bank.

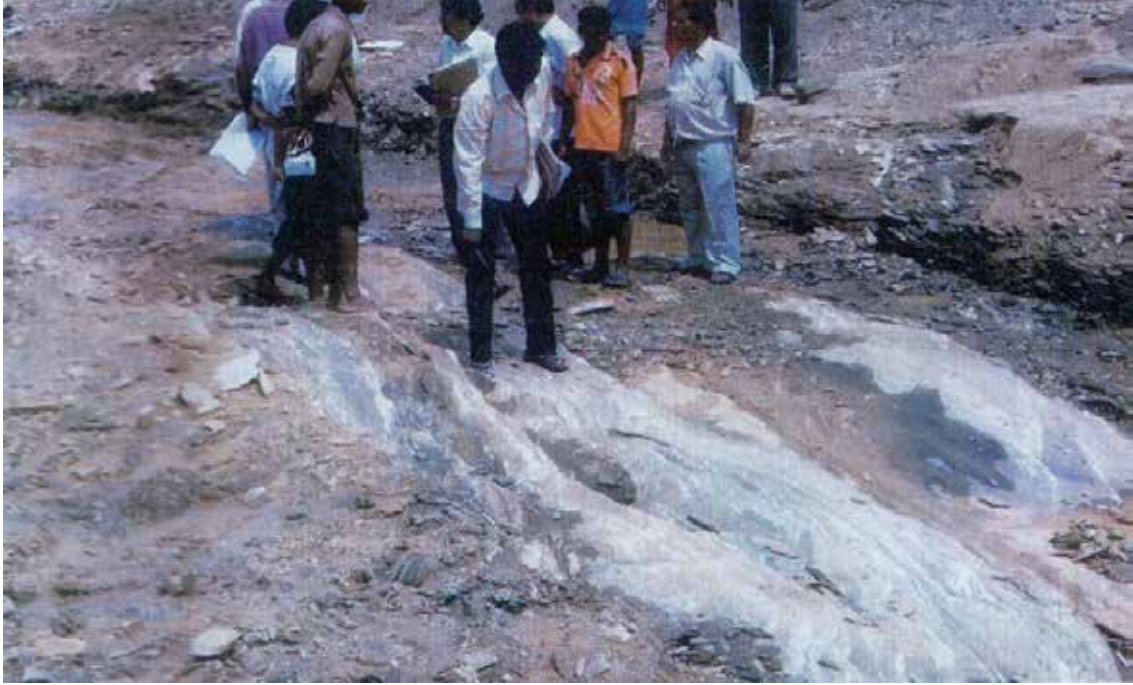
Picture 6 Fresh granite gneiss at C-O-T bed of parallel cut-off on left bank at RD 1265m (Ch 41.5)

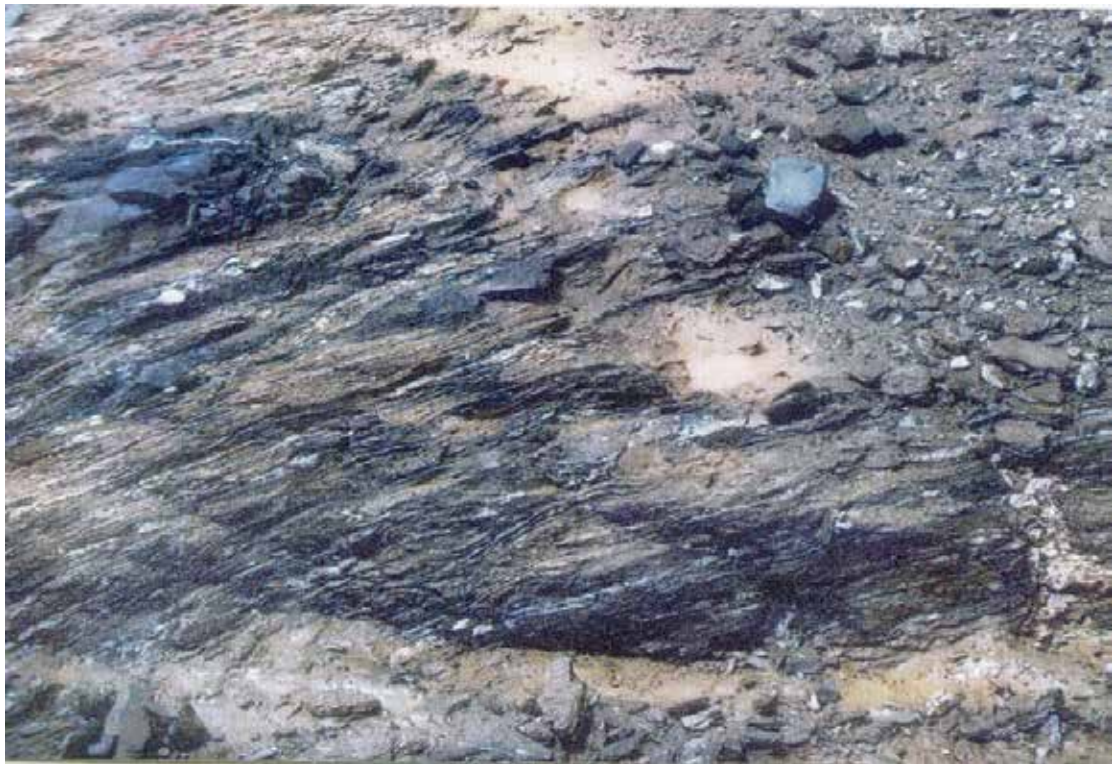
Picture 7 Fresh hornblende gneiss at C-O-T bed of parallel cut-off on left bank at RD 1219.5m (Ch 40)

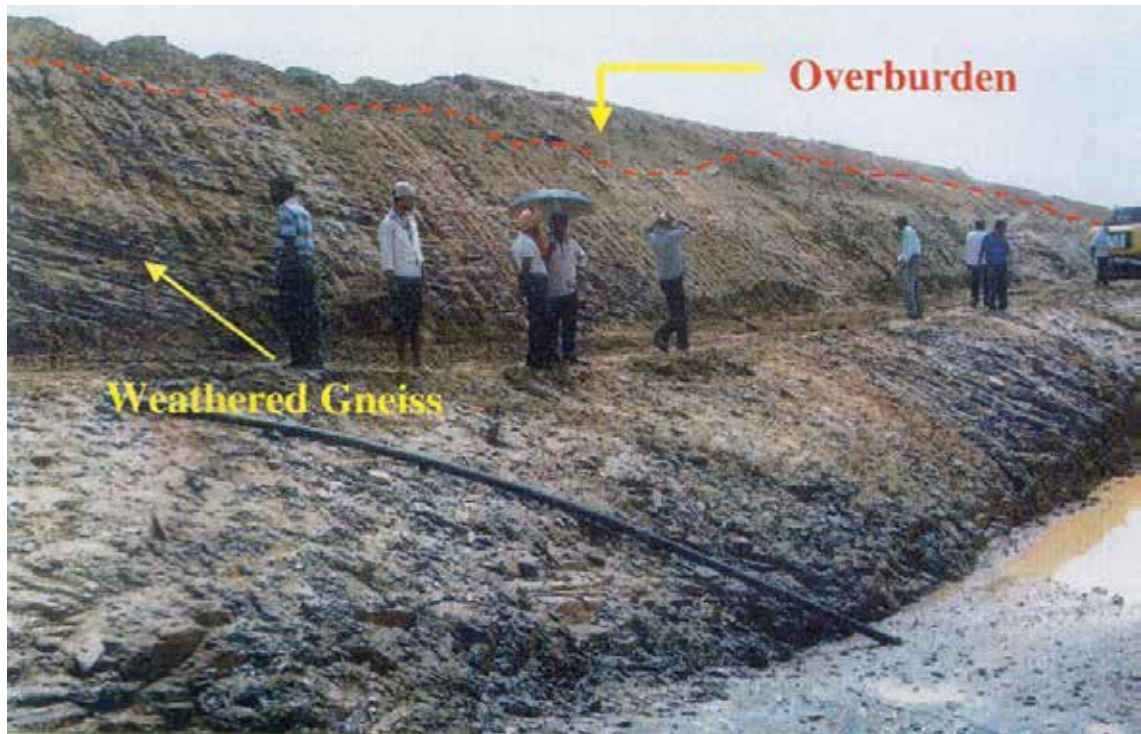
Picture 8 Upstream wall of parallel C-O-T showing weathered granite gneiss below soil overburden without sand layer at RD 1280m (Ch 42)
