Sherwani Landslide Complex, East District, Sikkim – A case study

Abstract

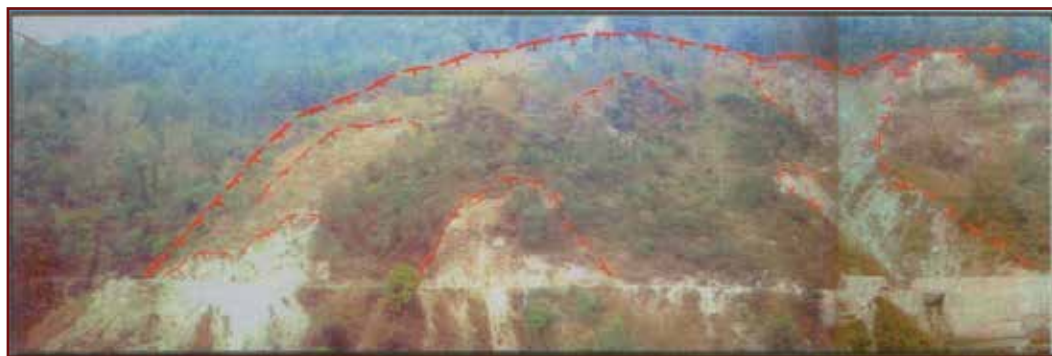
Photograph 1 Sherwani slide showing main slide and recent scars.

Sherwani slide/distress zone is characterized mainly by debris slide and sinking/creeping of the debris material. The top slide scar appears to be stable at present as indicated by thick vegetation. Photograph-1 shows the present active zone of the slide. At the western fringe of the scar, a portion of the slide is reactivated through which debris used to come in recent past (photograph 2, figure 1). Present subsidence/ sliding/ slow mass movement are confined from a portion of the old slide debris. This distressing is observed upto El 500m from Teesta River bed (El 300m) (plate 1). Due to sliding /mass movement from this old debris material, rocks are exposed sporadically throughout the distress slope. Wedge failure and sliding are also noticed in the exposed weathered rock mass (phyllite-quartzite).

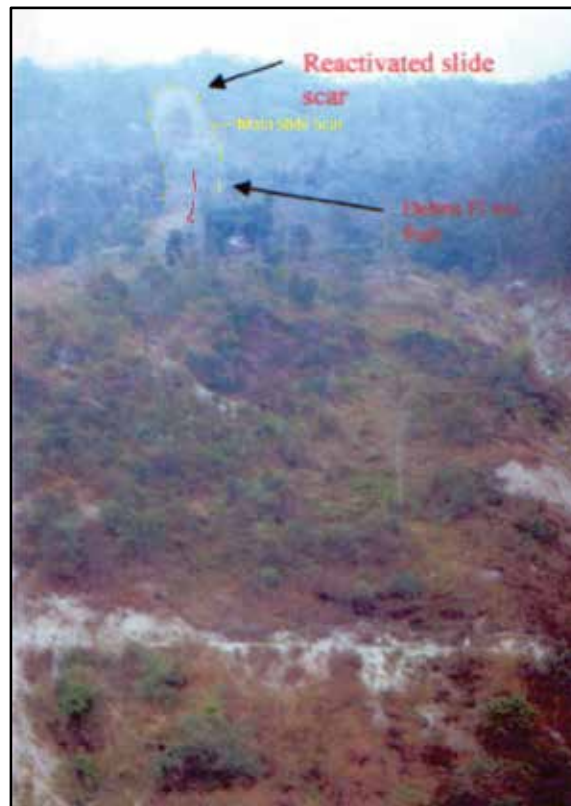
Photograph 2 Reactivation of slide with debris flow path from the main old slide scar above "Zone-C"

Zone C, represented by old slide debris, utilized for cultivation with a few habitats, at present is unaffected (Plate I, IV-VI). A debris flow path initiated from the top most slide scar (EL 1200m) is present at the northwestern portion of this zone, through which debris has come down (plate I).

This zone is under the threat of distressing due to gradual headward movement the slides of Zone B & A, located in the down slope. The physical properties of soil also indicate their susceptibility to sliding. The shearing resistance (sample S1) of the materials is very low making it susceptible to sliding during saturation. A series of catch water drains, preferably at every slope break with construction of chutes along the existing nalas are suggested to improve the stability of the zone.

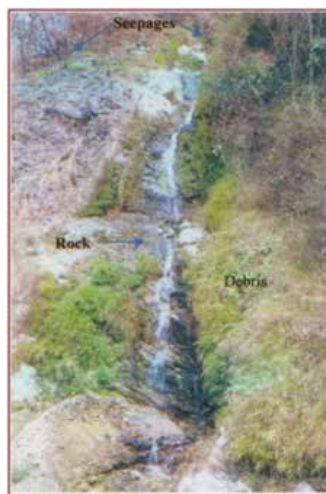
Photograph 3 Nala generated from seepages from debris-rock contact

Reactivation of sliding /subsidence due to reduction of shearing resistance, piping of finer particles and toe erosion along the nalas are the main causative factors. Small wedge failures are also noticed due to adversely oriented joints, though the rock outcrops have been considered relatively stable. Weathering, also play a crucial role for failure.

A number of berms with retaining/breast walls may be provided at this zone. Since, rock is expected at shallow depth, the concrete retaining/ breast walls may be founded on the rock. The walls may be anchored with the rock present below and weep holes be provided. To minimize infiltration (i.e. ingress of water during heavy downpour), catch water drains above the crown, i.e. at the contact of zones B and C and inside the zone B are suggested. Besides, construction of chute along the existing nalas flowing through the distressed surfaces is also required to prevent bank/toe erosion. Training of the two nalas flowing along the eastern and western boundary of the distress zone is also required. Proper maintenance of the drains to avoid blockage and repairing of cracks should be undertaken to avoid overflowing of drains and preventing seepage through cracks, otherwise gushes of water will penetrate into the underlying natural mass, which will deteriorate the shear resistance and cause slide.

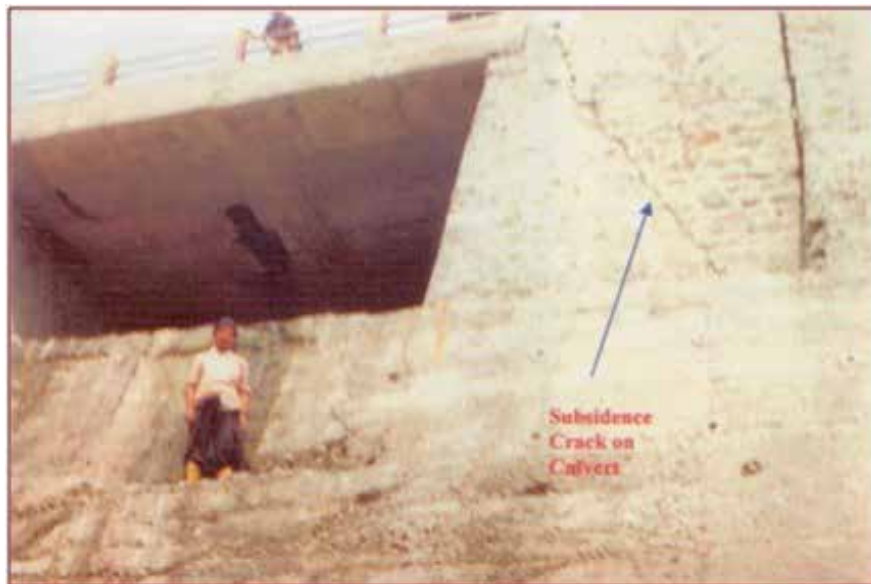
This zone starts below the road bench and extends upto the left bank water edge of Teesta River (plate-I - VI). Average slope is 30^0 . The area is mainly covered by dumped slided muck, which has come down on the road bench and to a lesser extent by river borne material. High and low flood levels are distinctly marked with floodwater scar and vegetation. A small retaining wall is present 30m below the main box culvert whereas a disturbed toe wall is noticed towards Makha. The water from the upslope flows through the culvert and along few untrained nalas. Subsidence is noticed in newly built retaining wall and culverts (photo-4). Seepage is noticed mainly through cracks and not through the weep holes.

Photograph 4 Subsidence cracks developed on the newly constructed box culvert on the road bench

The main causative factors are toe erosion of Teesta River. In addition, water from the upslope flows along few untrained nalas causing slope instabilities.

A toe wall along the Teesta River bank is proposed to prevent toe erosion. The earlier suggested training of nalas flowing on the distressed zone including eastern and western

extremities of the Sherwani slide should be continued upto Teesta riverbed. Suitable plantation within this zone is also required.
