# **Stability analyses of two fresh cut slopes along NH 2, Meriema, Nagaland**

*Supongtemjen*

The National Highway 2 is being widened, and in the process steep slopes have been left without any support, which has led to sliding of debris. Hence, studies were carried out at two selected sites to determine the causes and modes of failure with a view to provide appropriate mitigation measures. This highway has been cut through the Disang Group of rocks, which comprise thick beds of shale intercalated with thin flaggy sandstone. The rocks are sheared and crushed to varying degrees in response to ongoing tectonism. The upper horizons are made up of partially weathered shale capped by debris and loose soils. Two to three prominent sets of joints are noted.

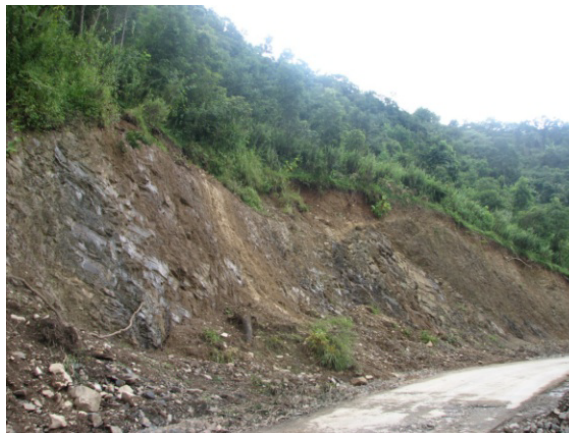
This area is located at 25°44'12.41" N latitude and 94°04'59.52" E longitude (Figure 1). Debris falls and slides are fairly common with about 110 m of the road being affected in 2007 (Figure 2). The area is made up of partially weathered shale capped by weak soil, the thickness of which ranges from 2 to 3 m. The rocks are jointed, fragmented, and weathered due to which debris continuously slides downhill to block the roadside drain and part of the highway. The bedrocks dip about 30° towards 135° SE. Three prominent sets of joints are noted. The first set of joints trends NW-SE dipping at angles of 45° towards SW. The second set trends N-S, dipping towards 270° W and the third set trends NNE-SSW, dipping 72° NNW. The triggering factor for instability in this section of the highway is a combination of steep slope, adverse lithology, and structure. The height of the unstable slope here is about 10 m with an inclination of 75°. Such slopes made up of partially weathered shale overlain by loose debris and soil are highly prone to slope failure.

Figure 2 Weak slope material

The liquid limit value (Table 1) indicates that the soils are weak and unstable. The plasticity index suggests that the soils are plastic. The liquidity and consistency indices indicate a semisolid state. Toughness index values between 0 and 3, according to Murthy (2001), indicate clayey soils. The soils may be a natural admixture of inorganic clays and silts of medium plasticity. Any disturbance with increase in the natural moisture content can therefore cause the soil to flow. Hence, this area is unstable, especially during the monsoon when the amount of rainfall is high.

Forty five rock samples were collected from the site for determination of their strengths. The RMR value of 39 (Table 2) obtained indicates weak rock. SMR values fall in Class IV indicating unstable slope conditions. This also indicates potential planar or wedge failure.

- a. Reduction of slope angle in the upper soil horizon and removal of 3 m of the top soil is recommended (Figure 4).
- b. A geotextile cover and grass plantation on the excavated soil will greatly help.
- c. About 100 m length of the rock section treated with GI wire netting will provide stability to the slope.
- d. Proper roadside drainage is necessary.

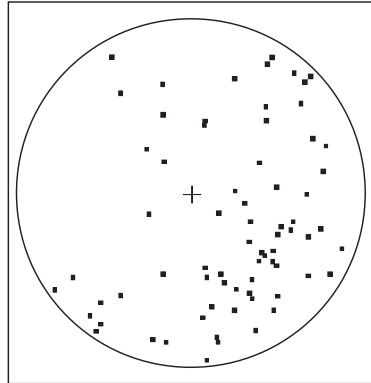
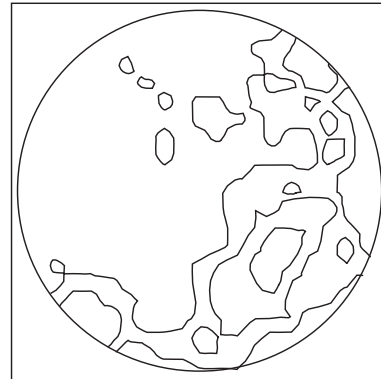
200 joint attitudes taken in the field were used to construct pole density (Fig. 3a) and contour diagrams (Fig. 3b) and from which two dominant joint sets that lend instability to

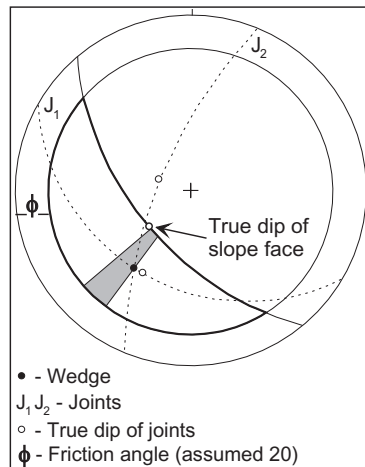
Figure 3c Stereogram

The figure shows the development of a distinct wedge due to the intersection of these two joint sets. Both the true dips of these joints lie outside the shaded area. The intersection of  $J_1$  and  $J_2$  forms a double plane wedge. A rose diagram (Fig. 3d) indicates thrusts (NE-SW) and possible tensile fractures (NW-SE) affecting the rocks.

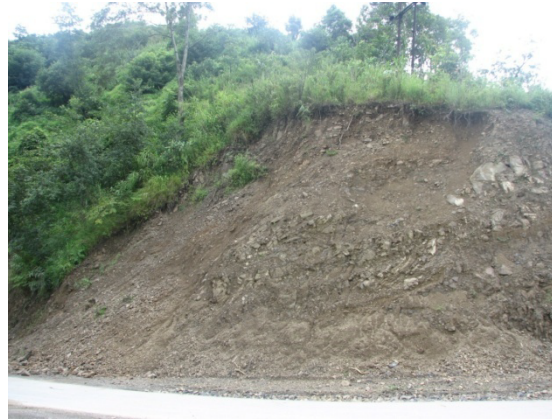
This area located at 25°44'18.08" N latitudes and 94°05'1.05" E longitudes (Fig. 1 - 2) was affected by minor but continuous debris slides (Fig. 5). The slope materials making up the area are crumpled Disang shale. The upper horizons comprise debris and loose soil. Bedrocks are not exposed along the section but outcrops in the vicinity show a number of joints. Two prominent sets of joints control rock behavior. The first set of joints trends ENE-WSW, dipping at an angle of 54° towards NNW. The second set trends N-S and dips 53° towards the west. The cause of this instability is due to weak lithology on a high (10 m) and steep slope with a gradient of 70°.

Figure 5 Weak hill slope

The liquid limit (Table 3) indicates that the soils are weak and unstable. The plasticity index indicates that the soils are in a highly plastic state. Such soils are vulnerable to plastic deformation, which can cause slope failure as mudflows. The liquidity and consistency indices indicate soft and plastic soils. The toughness index indicates clayey soils. Hence, when the moisture content, such as during the monsoon increases, any disturbance, including steep slopes, can cause the soil to flow.

Forty rock samples were collected from the site for strength determination. The RMR value of 46 indicates fair weak rock. SMR values fall in Class III, which indicates partially stable conditions (Table 4).

- a. The free face of the slope is steeply inclined hence, benching along a length of about 80 m is recommended to increase stability (Fig. 7).
- b. A carpet of grass planted on the exposed surface will help hold the soil and prevent excess seepage of water into the soil.

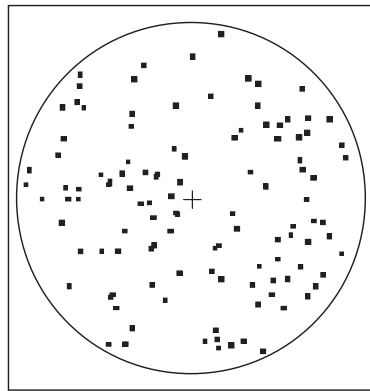
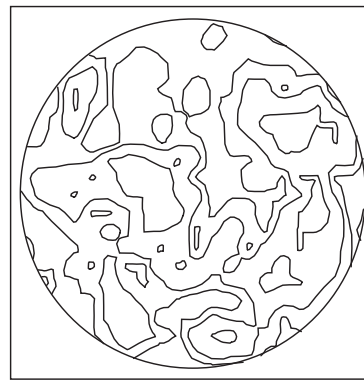
200 joint attitudes were analyzed and two sets of joints deciphered from the pole (Fig. 6a) and contour diagrams (Fig. 6b) to cause instability to the slope, due to interference.

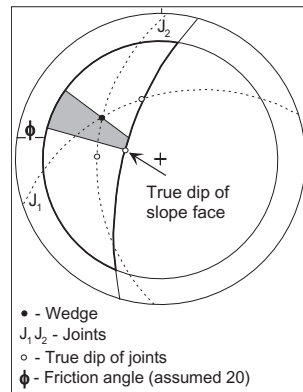
Figure 6c Stereogram

The stereographic projection shows the development of a distinct wedge due to the intersection of these two joint sets. The true dips of both  $J_1$  and  $J_2$  lie outside the slide envelope (Fig. 6c). Cruden (1978) suggests double plane wedge failure in such cases. The rose diagram (Fig. 6d) suggests complex deformation, including shearing of the rocks.
