Geotechnical assessment regarding feasibility of proposed additional spillway site, Hirakud dam project, Sambalpur district, Odisha

Geological Survey of India, Eastern Region, State Unit: Odisha, Bhubaneswar

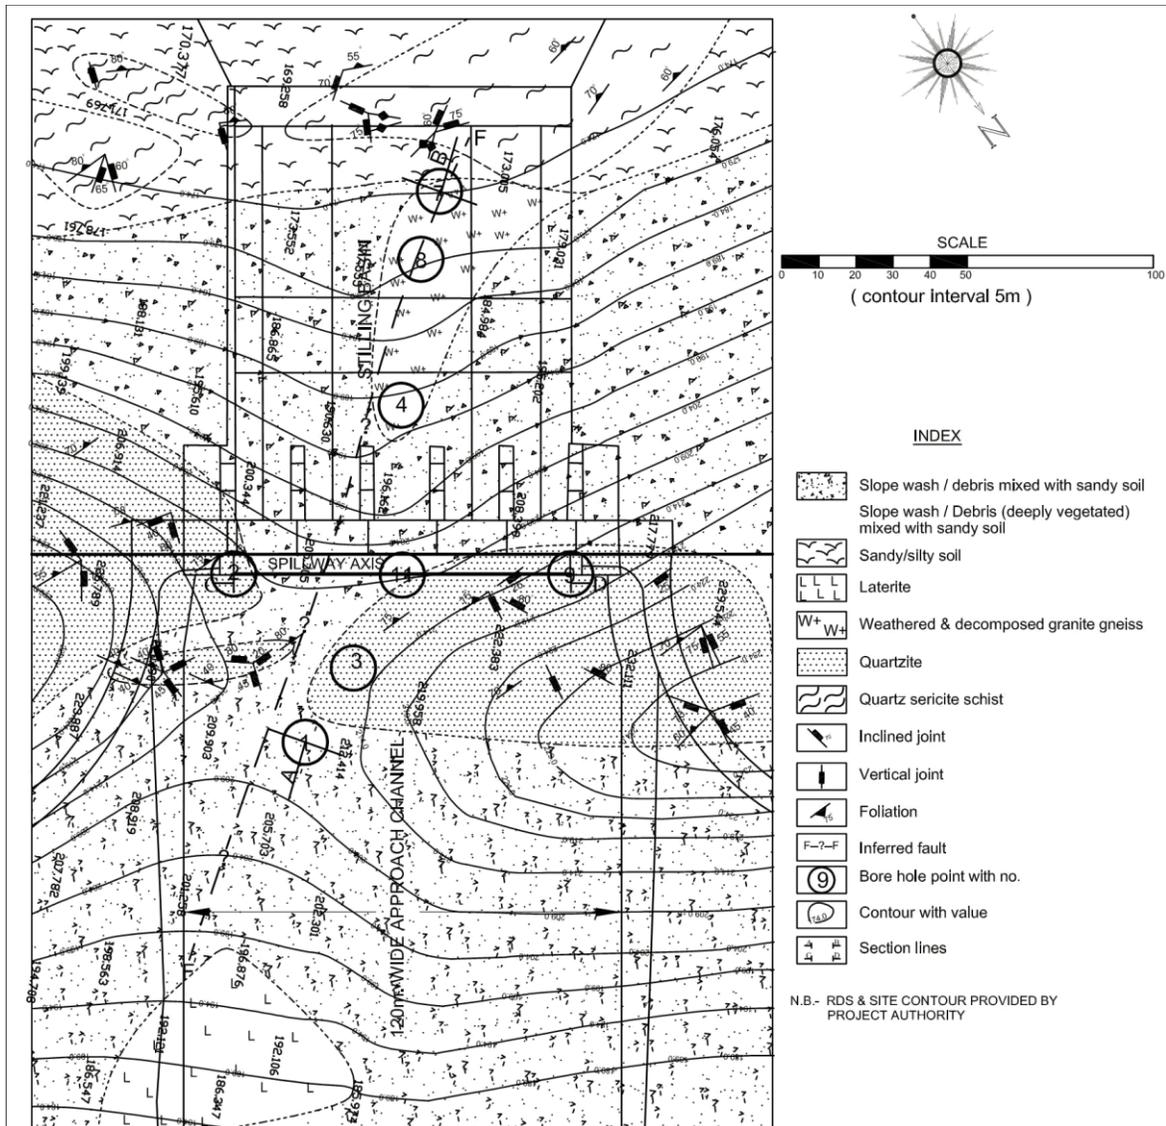
Figure 4 Detailed Geological map of additional spillway site.
 (Bore holes are also plotted in map)

Detailed surface geological mapping (Figure 4) of the proposed additional spillway aligned in N40°W-S40°E covering 200 m across x 300 m along flow direction reflects presence of quartzite and quartz-sericite schist occupying the ridges and granite/ granite gneisses exposed in the low lying areas (Figure 5). Fresh & hard ferruginous cherty quartzite was exposed along the left flank of the saddle at proposed spillway site (Figure-6). The quartzite is intensively fractured, highly sheared, brecciated and deeply iron stained in nature and silicified in later phase. Upstream part of saddle (NE face of ridge) is covered with sandy soil and slope wash material. At the downstream foothill of the ridge, brecciated mass and gougy material has been observed. At the right ridge hillock, highly weathered & decomposed quartzite forming powdery rock mass was also observed (Figure 7). Seepage was observed at the foothill in both sides of the ridge along the saddle. Towards the downstream i.e. at the proposed stilling basin area, highly weathered, decomposed and sheared quartz-sericite schist and granite gneiss has been exposed.

Surface geological studies of the proposed additional spillway site, located on a NW-SE trending linear ridge indicate presence of intensively fractured, shattered and pulverized quartzites. The rock mass have been dissected by three sets of joints along with foliation joint. A NE-SW trending structurally weak zone runs along the central part of the NW-SE trending saddle (NE-SW trending sub vertical fault?). Due to the presence of these two cross linear structural features, rock mass become intensively shattered, pulverized, sheared and at places brecciated forming small fractured core pieces along with rock powder (gougy mass/ rock flour) showing both poor core recovery and RQD which points to the fact of likely presence of faults along & across fridge.

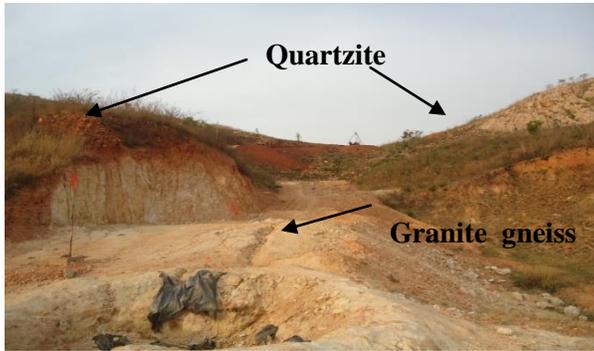
Figure 5 A close view of the proposed additional spillway site exposing presence of quartzite ridge and granite gneiss exposed at the base. (Photo facing downstream).

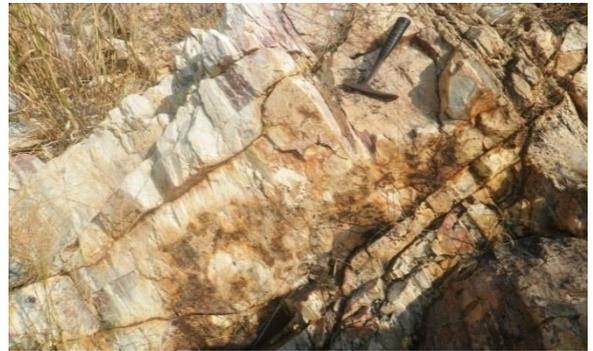
Figure 6 Exposure of fresh & hard ferruginous cherty quartzite along the left flank of the saddle at proposed spillway site.

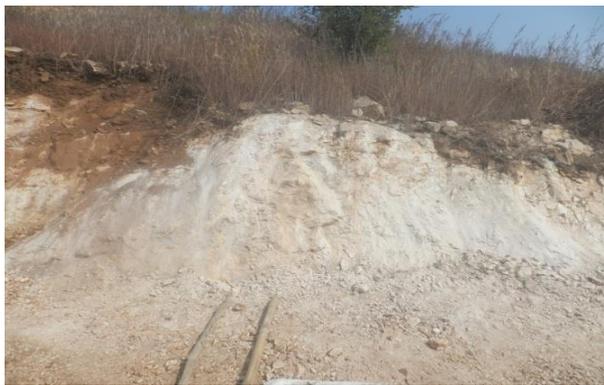
Figure 7 Highly weathered & decomposed quartzite forming powdery rock mass at the downstream slope of the ridge.

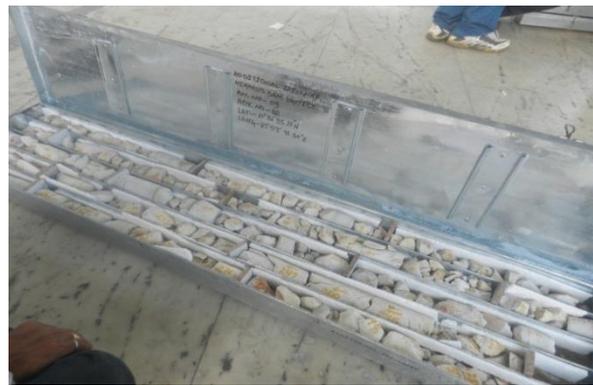
The exploratory bore holes drilled at the left abutment and right abutment shows presence of fresh but intensively fractured quartzite at 7.47 m and 0.52 m depth respectively below ground surface, whereas at the centre of the spillway fresh quartzite occurs at 15.39 m depth. The bore holes drilled along the centre of upstream and downstream also did not intercept fresh rock up to a reasonable depth. At the proposed stilling basin, fresh rock was not intercepted up to reasonable depth (33.5 m -45 m) (Figures 8, 9 & 10)

Core logging of bore holes no. 1 & 3 drilled at the u/s part of the proposed additional spillway site indicates presence of intensively fractured, brecciated & sheared quartzite with low core recovery & very poor to poor RQD. Based on drill core log data geological cross section and longitudinal sections were prepared and geotechnical parameter values are plotted on the map to understand the subsurface condition of the site. (Figures 11, 12, 13 & 14). Brecciated quartzite (angular to sub angular rock fragments of quartzite set in siliceous & /or pulverized rock mass, fault gouge), highly porous and friable rock mass extends up to drilled depth. Occurrence of highly fractured (brecciated) & sheared core pieces from surface level up to drilled depth with intermittent interception of sludge of gougy/ pulverized rock mass etc. conforms likely presence of a structurally weak zone. Three drill holes (drill hole no. 2, 11 & 9) drilled on the proposed spillway alignment intersected fresh but intensively fractured quartzite rock at depth 7.47 m at the left side & 0.52 m at the right side and at depth rock becomes highly pulverized and forms powdery mass. Study of geotechnical parameters also indicate a very poor quality of rock mass in terms of competency as reflected from low uniaxial compressive strength (17.77-78.15 N/mm²).

Figure 8 Highly fractured and crushed quartzite in hole no.3.

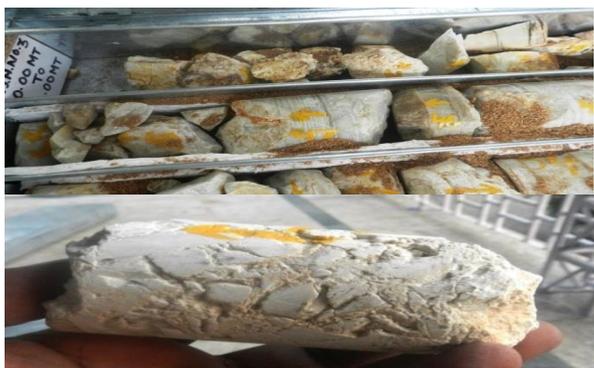
Figure 9 Drill cores of brecciated quartzite in hole no. 3.

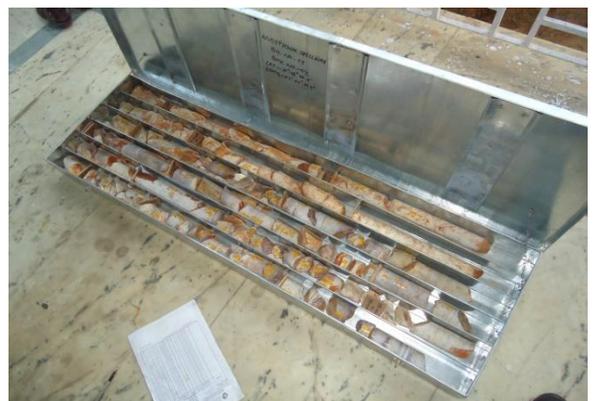
9	13.0-18.0 23.0-25.0 27.0-29.0 32-33 35-48 49-55 58-61 61-64 64-66 67-73 77-79	56-71 59-61 63-69 29 27-52 23-43 30-45 47-56 36-41 33-71 50-63	0-27 38-42 0 0 0 0 10-11 0 0-12 0 0 0	-	0-33 36-54 66-72 78-80	40.09-71.69 27.85-47.28 44.49-45.12 43.79
10	3-6.1 6.1-7.1 7.1-13.1 13.1-16.1 19.1-27.1 27.1-44.1	0 31 19-28 29-34 22-55 12-29	0 10 0 0-21 0 0	19.1-44.1	-	Test result not available
11	2.5-12.5 18.5-20.5 20.5-27.5 32.5-37.5 37.5-39.5 39.5-40.5 45.5-46.5 46.5-59.5	0 47-56 21-33 30-68 54-64 78 52 23-64	0 0 0 0 10 12 0 0	55.5-59.5 59.5-75.5	-	Test result not available

Figure 10 Low core recovery & low RQD zone in hole no. 9.

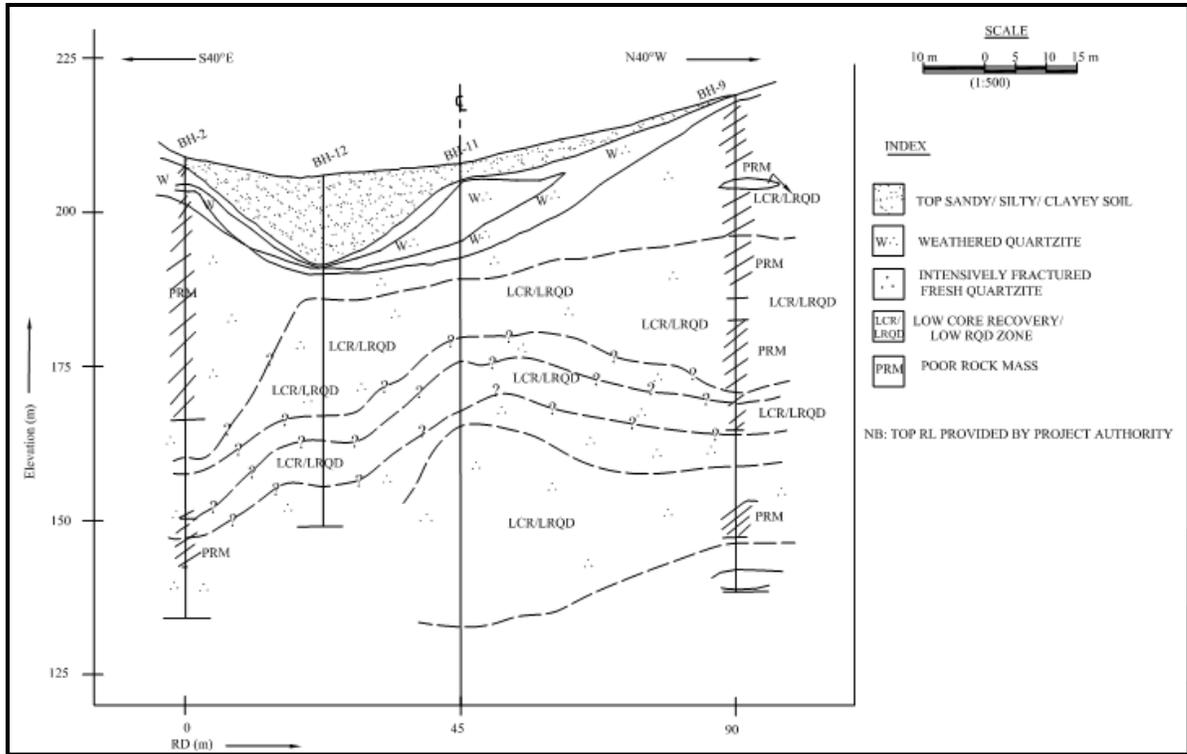
Figure 13 Geological L-section along proposed spillway alignment. Low RQD & low UCS portions are plotted in the map.

Based on the above facts, the site does not appear to be suitable for a spillway site from geological point of view and search for alternative site has been recommended.

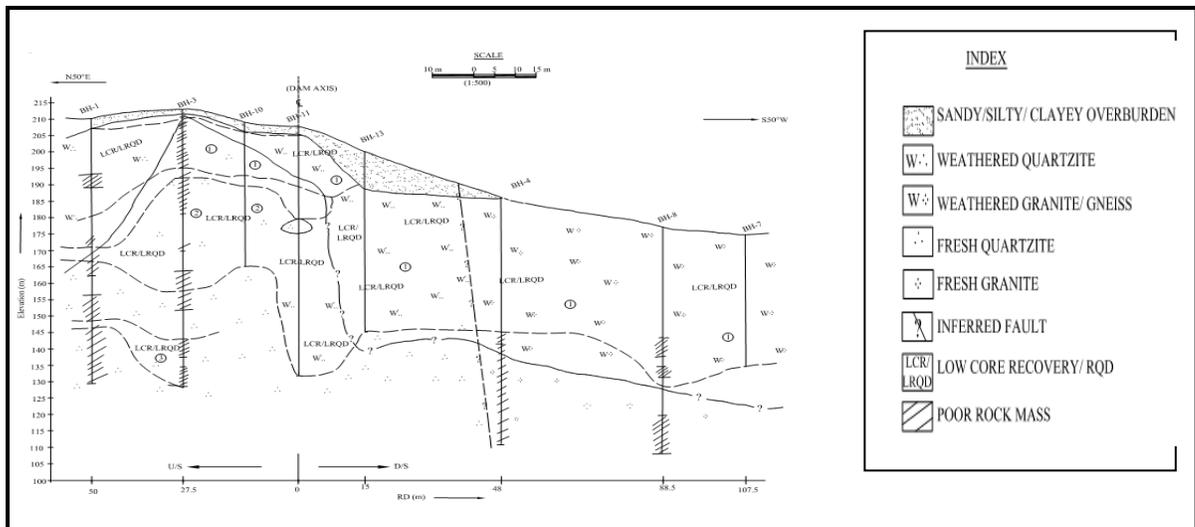
Figure 14 Geological L-section along proposed spillway alignment. Low RQD & low UCS portions are plotted in the map.
