Geological investigation on the causes of collapse of irrigation tunnel. -a case study from Hulikere, Mandya district, Karnataka

Abstract

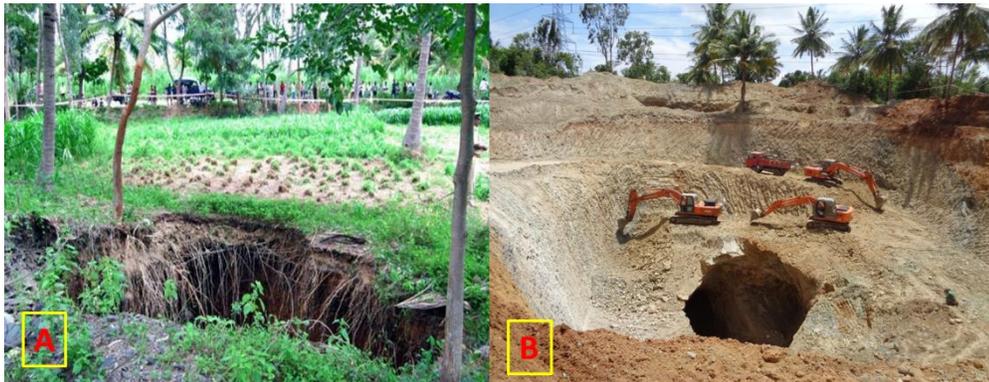
The crown portion of the tunnel was collapsed at ch 2060 m, on 15-03-2012, at 6.30 A.M. along with the over burden, and also the masonry lining constructed earlier with surki mortar was also damaged and collapsed, thereby the vent of the tunnel was completely blocked with the fallen muck and masonry. The collapsed cavern is about 15 m length, 5 m width and about 14 m height above the crown. At the top of the cavern, disintegrated rock mass and reddish soil are exposed. Fig. 2 (A & B) shows cave-in portion and damaged portion very near to crown portion of the tunnel.

Figure 2 A) Overview of the collapsed zone (Just after the collapse) and B) Damaged portion near to the crown portion

- The ultimate and permanent solution to give life for the tunnel is to go for segmental lining throughout the length of tunnel though it is costly. This is inevitable because if there is continuous seepage of water in this tunnel the whole district will become a dry land.

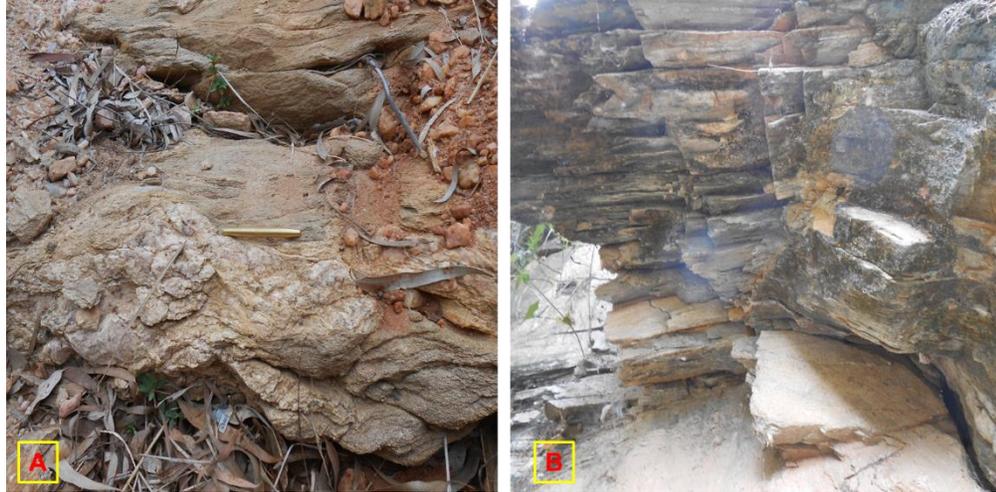
gneisses and seepage was observed. The N-S trending gneiss is highly fractured and weathered and the joints are well exhibited and joint plane thickness ranges from 0.5 cm to 20 cm [Fig.3 (A & B)].

Figure 3A) Field photograph showing the outcrop of weathered gneiss.
 B) Highly jointed gneissic rock

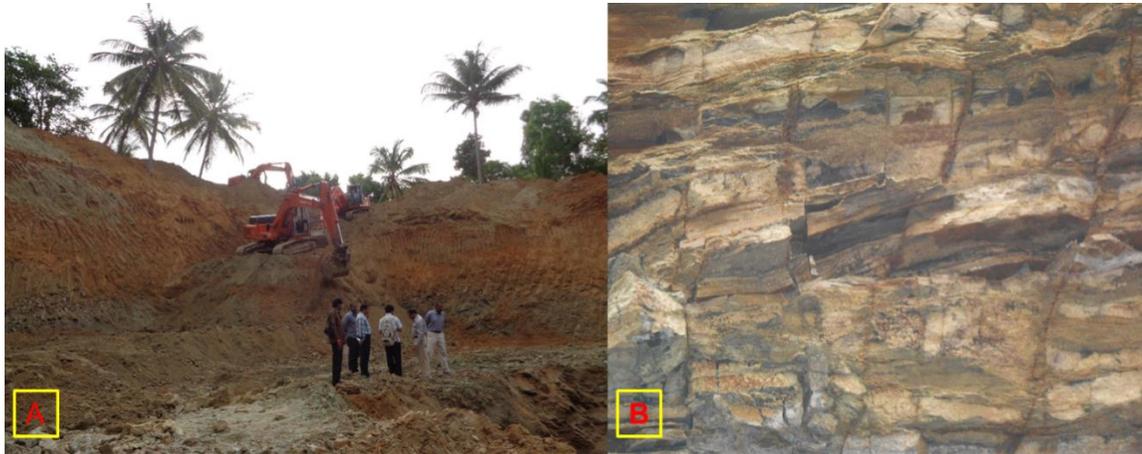
The major rock having one set of joint trending almost EW has spacing of 10-20 cm, which allowed water to infiltrate and due to slow seepage the underlying schistose and amphibolite rocks weathered resulting in hydrous/anhydrous minerals like chlorite, epidote, sericite and clay minerals formation. Joints controls the water leakage and as rocks at the surface are more jointed large leakage through open and permeable joints present in the gneisses causing instability due to weakening and disintegration of weak rock mass strata consisting of mica schist (12) The slow accumulation of these minerals and high stress produced squeezing effect which resulted in gradual weakening of the rock mass in the tunnel and finally crushed and weathered rocks mass came from the crown went through invert. The residual soil zone above the crown and nature of joints inside the tunnel are shown in Fig.4 (A & B).

Figure 4 A) Residual soil zone (approximate 14 Mt) just above the collapsed area.
B) Multiple joints in gneisses at the crown portion of tunnel (inside)

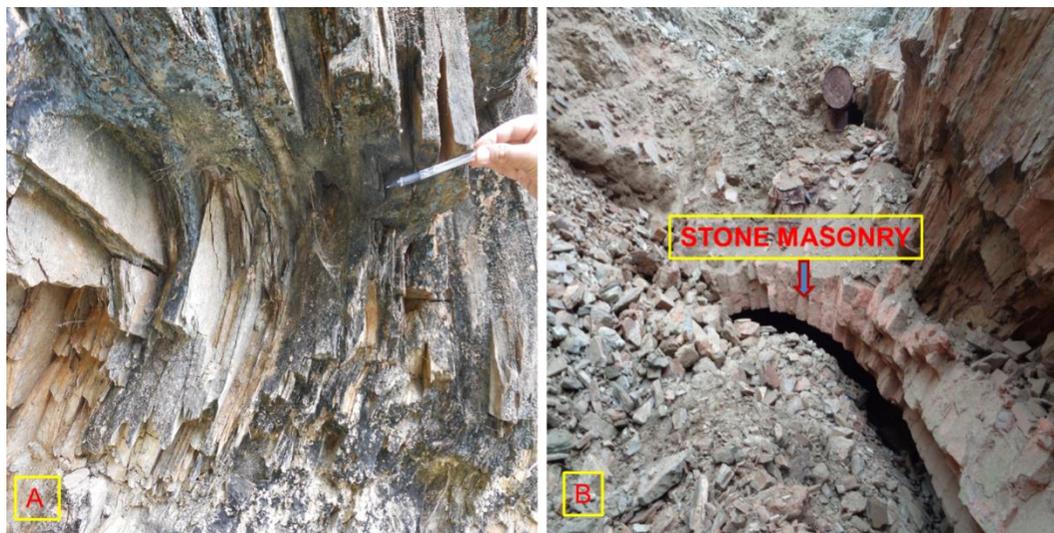
Highly deformed and buckled nature of rocks were noticed near to the collapsed (in inclined shaft), which indicated the rocks have been sheared (Fig.5A) and in such cases reinforced structural elements are very much required as permanent support. But, just a stone masonry arch and lining support were constructed (UCSR masonry) at the time of tunneling which was not sufficient to take the load of entire overburden (Fig.5B).

Figure A) Deformed and swerved weathered gneissic rock with divisional planes of joints.
B) Stone masonry arch construction at the collapsed zone.
