## **Geotechnical evaluation of spillway structures at Tehri Dam Project, Uttaranchal**

S.K. Ghildyal, Bhupendra Singh, P.K. Gajbhiye and D.P. Dangwal

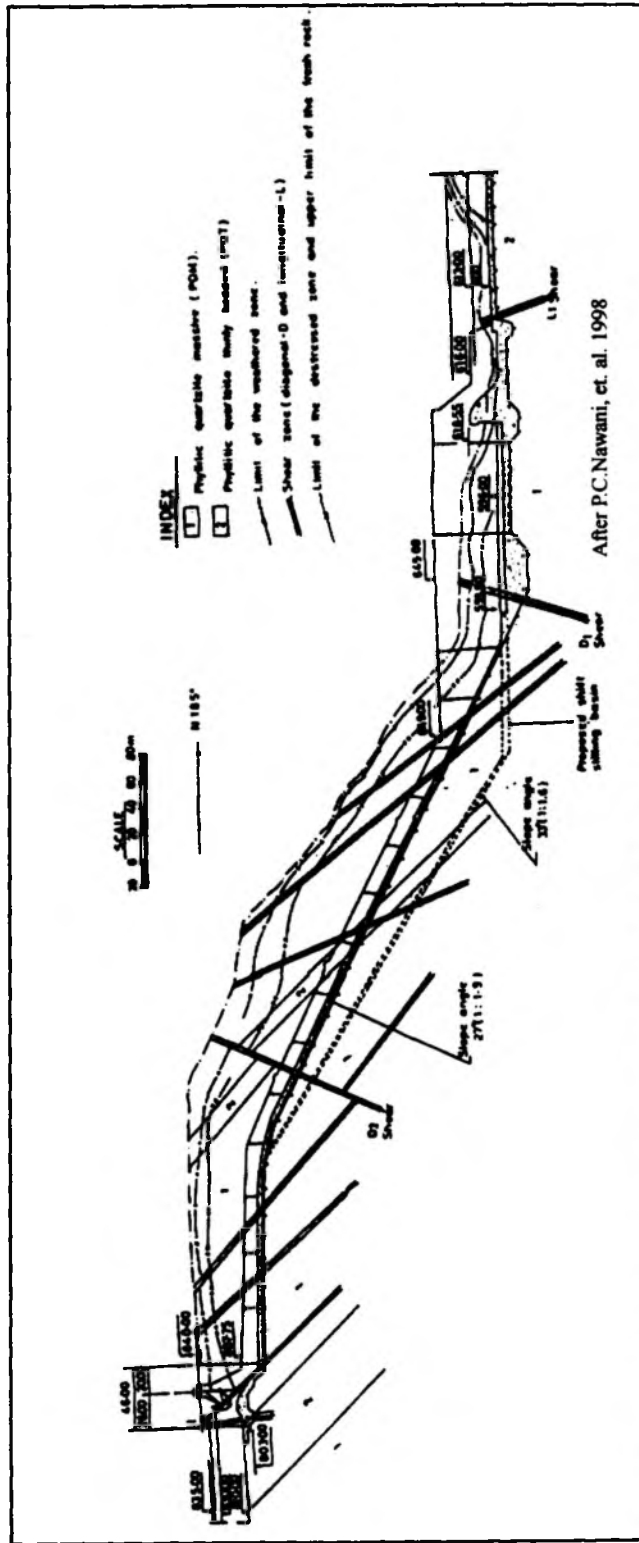
Fig. 1: Geological section along centre line of the Chute Spillway

Location of the discharge carrier has been preferred on the right bank to avoid over crowding of structures on left abutment, where underground power house complex is located. The topography of the area on the right bank necessitated removal of enormous quantity of overburden and weathered rock down to a depth of about 200m, so as to reach desired foundation grade. Earlier the Russian consultant of THDC had proposed to slope the spillway at 35° but subsequently on the advice of GSI (Nawani & Sanwal, 1998) the slope was changed to 27° to avoid location of D1 and L1 shear at junction of chute and stilling basin. The accepted foundation level and disposition of various shears and joints present in the area are depicted in Fig 1.

During the progressive excavation in chute spillway area, overburden mass and distressed/highly weathered rock mass were removed and acceptable foundation grade was achieved, more or less, coinciding with the anticipated foundation level as projected by G.S.I. Excavation confirmed more or less interpreted assessment and the foundation exposed predominantly phyllitic quartzite massive (PQM), phyllitic quartzite thinly bedded (PQT) sequence with a few isolated sheared phyllite (SP) patches. Foundation

grade was accepted at  $W_0$ - $W_1$  (fresh) rock in area where  $W_2$  grade was exposed, the foundation was lowered to  $W_0$ - $W_1$  grade. Foundation of the control structure and the left guide wall where rock mass was found to be of  $W_1$  grade of weathering after excavation, need for strengthening the rock mass was recommended by GSI through consolidation grouting. Five prominent joint sets were identified traversing the foundation and numerous L and D type shears of different orders have also been identified and were provided with dental treatment. The bedding and foliation joints which are dipping at 38°-65°/S10°-40°W and 30°-48°/S10°E to S05°W and are moderately smooth were found to be responsible for planar failure in the inclined portion. The joints dipping in northwesterly direction (38°-60°/N10°-65°W) and the joints dipping in northeasterly direction (25°-73°/N20°E to E) were found unfavourable and caused wedge failure in combination with the bedding/foliation joints. These joints were found more susceptible to failure in the wet zones. The bedding joints which were found to get transformed into bedding (L) shears were also considered as unfavourable discontinuities leading to planar failure.

- Consolidation grouting was carried out in the foundation of the control structure and the left guide wall, where rock mass was found to be of  $W_1$  grade weathering. The rock mass at the foundation grade was further strengthened by consolidation grouting through 6 m deep, 3 m c/c spaced holes using 2.5 to 3 Kg/cm<sup>2</sup> pressure (A.K. Jain et.al., 2002).
- Sloping areas where designed slope exceeds 27° was strengthened by timely installation of the rock bolts of 12m length and 40mm/36mm dia, provided at 3m c/c spacing and the rest including aerator part was provided

- with tensioned rock bolts of 25mm dia and 6m length at 2m c/c spacing.
- All major shears and selected minor shears with wide affected zones were rendered dental treatment.
- Drainage pipes were provided in water charged shear zones and other water seepage areas, to discharge the collected water in the central drainage gallery.
- In the stilling basin the design thickness of concrete has been increased and silica cement lining is proposed in order to decrease erodibility of material.
- The design consultants (Anon., 2002) have prescribed M60 concrete, high performance concrete (HPC), in combination with Micro silica fumes have been proposed in stilling basin/energy dissipation components take care of abrasion resistance.
