## **Tunnelling at Ranjit Sagar Dam Project - A case study**

Sanjiv Kumar

Large diameter tunnels have been excavated through young sedimentary rocks of Lower Siwaliks at Ranjit Sagar Dam Project, a multipurpose scheme across the river Ravi in the outer Himalayas. This paper discusses in brief the tunnel support system and the major problems faced during tunnelling and reservoir impoundment. Causes of distress and remedial measures have also been outlined in brief.

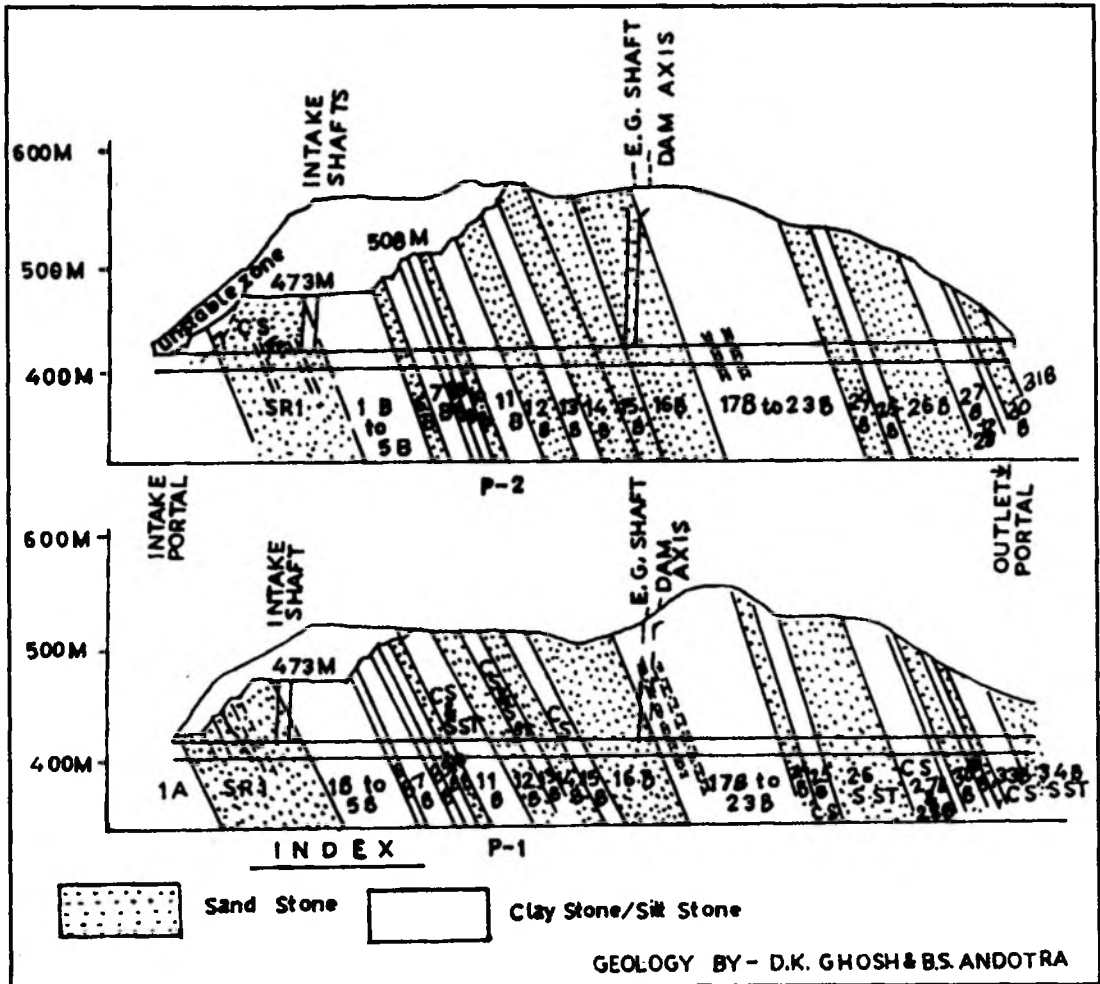
Fig. 3 Geological section along Power Tunnels P-1 and P-2.

With snags in emergency gate shaft reach of both the power tunnels, project authorities and some of the Board of Consultants' members apprehended some geotechnical problem. P1 E.G. reach is located on sandstone band 16B and claystone/siltstone band 17B (Fig. 3). The proportion of sandstone and claystone/siltstone in distress reach is 3:1. In P2 E.G. reach, claystone/siltstone band 15B and sandstone band 16B are present. The proportion of sandstone and claystone/ siltstone in distress reach is 9:11. The disposition of bands is about 40% askew to the tunnel alignment. There is no adverse geological feature present in the P1 and P2 emergency gate reach or around it. As already discussed, the tunnel support system is based on Terzaghi's classification, which is very conservative. Apart from steel rib supports back filled with lean concrete, heavily reinforced (40 mm dia) concrete lining has been provided with thickness of concrete varying from 3 m± to more than 5 m in the E.G. reach. With such heavy support system, the possibility of rock failure can easily be ruled out. Moreover, the tunnel behaved normally during diversion stage since 1992 onwards. The problem seems to have resulted due to direct water pressure acting behind steel liners. As evident during the repairs, the water seeped through the gaps and honeycomb in second stage concrete from the pressured upstream (of emergency gate) to the downstream of emergency gate.

P1 and P2 power tunnels, as investigated during repairs, is interpreted to be due to external water pressure acting immediately behind steel liner, which in turn may be due to following reasons (Kumar, 1998-99):

- The emergency gates of P1 and P2 were in closed portion due to which half of the tunnel was pressurised while that downstream of gate was not.
- Hollow spaces behind steel liner and concrete in the emergency reach.
- The second stage concrete in the emergency reach was not properly placed as evident from the gaps and honeycomb features reported during repair stage. This

provided paths of seepage of water from upstream of emergency gate to the downstream liner.

- Improper bond between first and second stage concrete.
- Improper grouting after placement of concrete.
- Drainage system behind steel liner did not function properly.
- The rectangular section is more vulnerable against external water pressure as compared to circular section.
