On the Development of Slump Slide around Reasi end Portal (P2) of Tunnel no. 1, Udhampur - Srinagar - Baramulla Railway Line Project

*B.D. Mal Barna

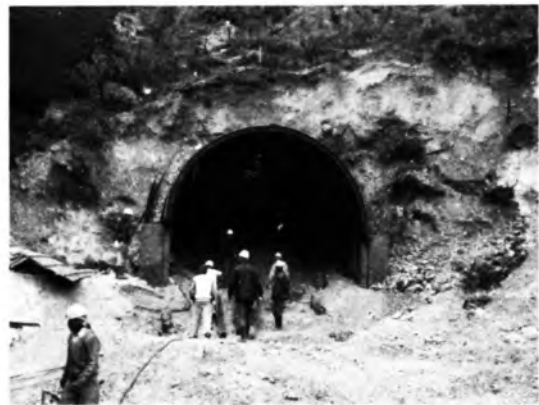
Photo 1

Reasi end portal (P2) of the tunnel was proposed at km. 32.685 but when excavation for approach to portal point was started, it was apprehended that high cuts in loose crushed dolomite may not remain stable. Hence, it was decided to erect a 18.50 m long false portal and shift the portal location from 32.685 to 33.000 m. After the construction of 18.50m long false portal, excavation of the tunnel was taken up (Photo 1) and about 236m tunnel was excavated within a period of one year. During tunnelling, heavy over-break and cavity formation was recorded due to the presence of crushed rock charged with water.

During the construction of the portal, excavation for working platforms to keep machine, office sheds, etc. was done in crushed dolomite. Due to the presence of loose rock mass, slowly cut slopes came under distress resulting in slope failure.

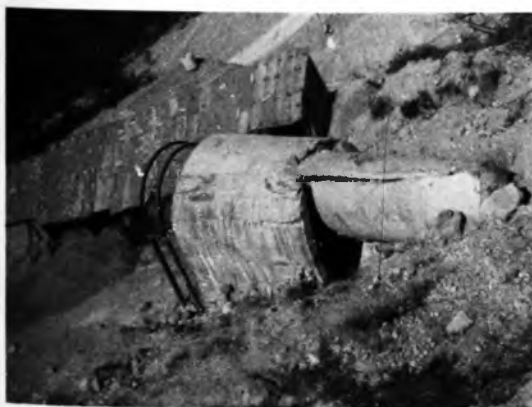
Photo 2

During the first week of Feb. '05, when heavy and continuous rains lashed the area, a major slide developed on the intervening night of 9th & 10th (Photo 2). The slide scar is located about 67 m from tunnel portal face. The maximum width of the slide zone is about 90 m. Besides arcuate cracks, mostly developed beyond the slide scar, tension cracks have prominently and developed at many places between toe of the slide and portal face. The impact of the slide was so strong that 18.75 m long face portal got partly twisted and partly collapsed. It appeared that most of the pressure came from right side. Right side ribs along with top concrete, got crushed and joined with left side erected rib. The false portal got detached from main tunnel. Beyond the false portal, about 40 m tunnel length was also expected to be damaged. In addition to above damage, post survey of the area revealed the tunnel including the false portal had got shifted about 8.50 m along the alignment and 5.50 m towards right side. During the excavation of false portal area in June '06, it was noticed old ribs 4-5 m in height had got thrust into the ground during slump slide.

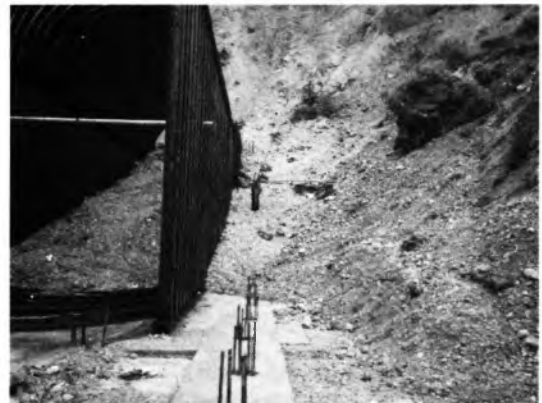
Photo 3

slope, excavation for false portal proposed between km. 32.700 & km 32.780 as shown in Photo-3, was taken up and steel ribs at 0.50 m apart were erected in entire 30 m length. When the preparations for 1m thick RCC raft were being made, monsoon rains started and further work was abandoned. Due to rains, boulder crated walls provided to prevent slope failure ahead of false portal, collapsed and loose material deposited over the erected ribs (Photo 4). Now, the loose material has almost covered the entire length of false portal erected ribs. Steel arch ribs for a length of 5-6 m got damaged. Part of drain constructed above the slide scar has also come down.

After great deliberations, M/s Sohams Foundation Engg. Pvt. Ltd. came out in March '06 with the proposal of soil-nailing and pile grouting along the alignment between km. 32.700 to km. 32.730. Factor of safety, with various alternatives were studied with micro-piles. Finally, factor of safety was worked out as 1.462 with the following micro-piles schemes, which includes 300 mm micro-piles in staggered fashion 2.0m centre to centre.
