## Impact of Landslides on the Construction Schedule of a Major Hydro Power Project in the Lesser Himalayas, Jammu & Kashmir, India

### Abstract

*The unprecedented snow fall and rains in Chenab valley and the following floods generated a series of landslides in the project area, jeopardizing the river diversion system and concrete pouring system; besides the approach roads and bridge etc. The paper enumerates the colossal loss and generates a discussion on the site specific studies and measures needed for mass movements in hydro power projects.*

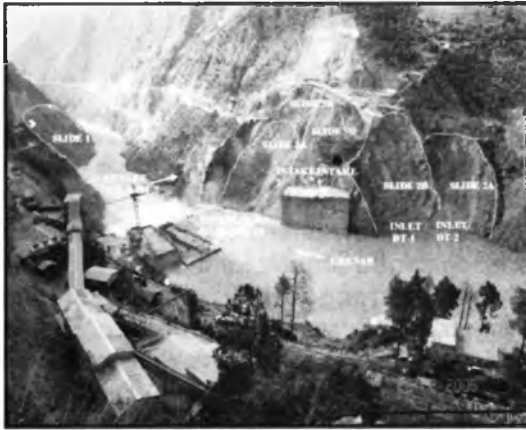
- On 3<sup>rd</sup> July '05 the water level in the river rose up to about El 763m which went down by about 29m to El 734m in the following few days.
- On 5<sup>th</sup> July '05 the subsequent sudden drawdown of 24m in the reservoir level (from El 758m to 734m) in a short span of just 24 hours caused a landslide (2A) of about 50,000 m<sup>3</sup> over the intake portal of diversion tunnel 2 (DT-2), causing blockade/ choking of the intake of DT-2 on the right bank (Photo-1).

Photo-1: Panoramic view of dam site showing the recent landslides

- The created water fall of about 45m due to overtopping eroded the toe of the right abutment hill slope, as a result, a huge landslide (Slide-3A) of over 1 lakh m<sup>3</sup> occurred with a crest at a height of about 110m above the river bed level (Photo-1).

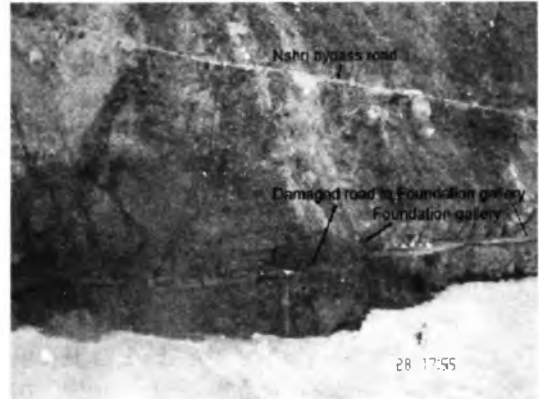
- In June 2005, the flood discharge at the Dam site was recorded as 3900 cumecs which rose to 6000 cumecs for a short duration.
- On 1<sup>st</sup> July' 05 the river water rose to El 762.8m from the river bed causing large scale landslides on right bank slopes (Slide 1) and road failures due to under scouring and erosion of the left bank along the river section (Photo-2, 2.a).
- On 2<sup>nd</sup> July' 05 the floods by-passed the left abutment of the steel bridge located 500 m downstream of the dam leading to its collapse (Photo 2.a).

Photo 2.a: Damage to road and bridge

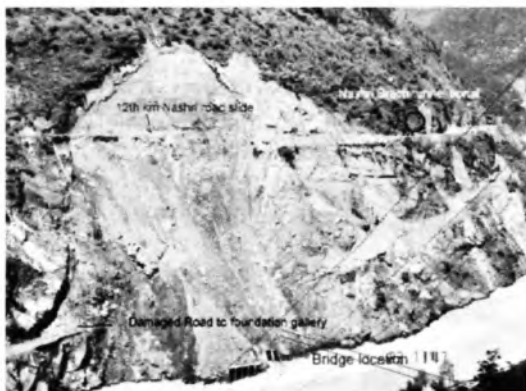
Photo-2: Damages to roads left bank

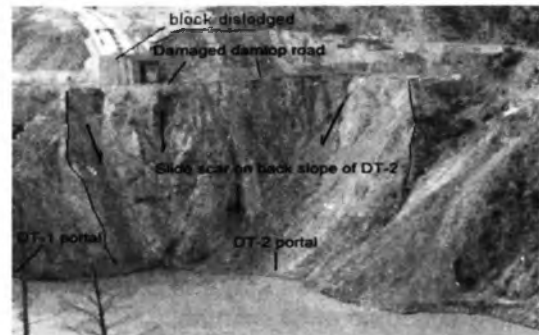
- On 14<sup>th</sup> August '05 another slide, of over 1 lakh m<sup>3</sup>, (Slide-2B) occurred in the quartzite rocks. As a result, the U/S end of tail track concrete block got detached and slid down blocking the portal of DT-1 (Photos-1 & 3).

Photo-3: Right bank - Back slope of DT inlet portals with multiple slides

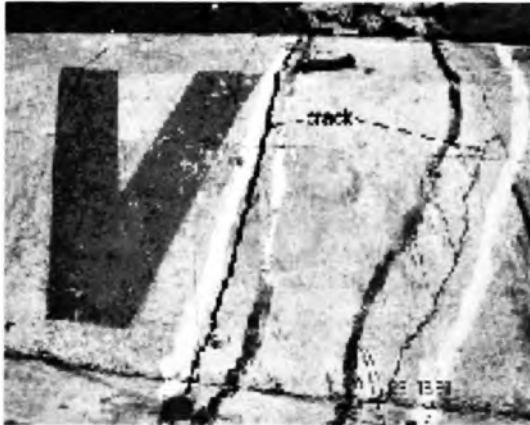
The slide (Slide-3B) undermined the foundation for the tail track of the concrete pouring system with 3 cable cranes. Transverse cracks in the concrete (Photo-4) and longitudinal cracks on the hill side/ behind the track were developed due to settlement in debris reach (Slide-3C).

Photo-4: Transverse cracks in the tail-track

Besides, movements of the track towards valley side were also noticed. The increasing displacements of the track, monitored with precision instruments, endangered the track getting pulled in to the valley, i.e. over the dam, under the pulling effect of the sagging cables with buckets; and also endangered the material and equipments on the dam body. Two cable cranes had to be dismantled immediately to avert the eventuality of a collapse of the track.

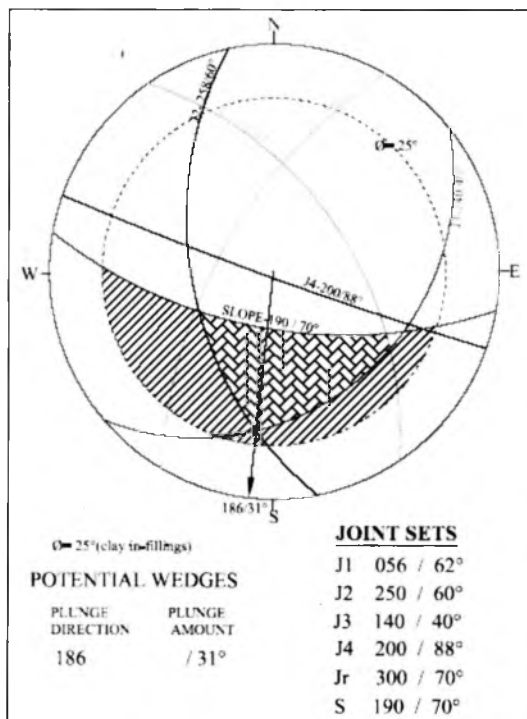
The dam seat rests partly on a 80 m wide quartzite band cutting skew to the dam axis by about  $20^\circ$  and partly on the thinly foliated/ phyllitic quartzite with slate bands exposed on the left abutment, in a ratio of 65:35 respectively. Four plus two random sets (Fig 1) of joints noticed at the dam site render a high degree of jointing ( $J_v$ ) of +20 to the rock

Fig. 1: Stereoplot of joint sets showing potential wedges

The right abutment with predominantly Rm -1 rock mass had a natural slope angle of  $\pm 75^\circ$ . The  $J_2$ ,  $J_3$  &  $J_4$  joints form wedges (Fig. 1) with a plunge of  $+31^\circ$  towards the valley. Any excavation at the toe of the slope day lighting the  $J_2$  shear joint with slate partings affected the stability of the slope. In order to maintain the stability of the cut slopes, measures like mesh reinforced shotcrete and tensioned rock bolts were taken up progressively with excavation. The right abutment, excavated for housing the auxiliary channels and trough, was fully protected, based on the stability analysis carried out during excavation, with 6 - 8m long Fe 415 and 18m & 25m long high tensile (DWYDAG), pre-stressed, rock bolts in the intake area, downstream reach of dam and higher reaches of abutment (Photo -6).

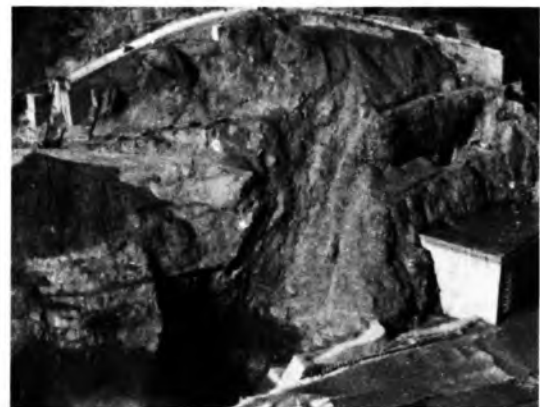
Photo 6: View of right abutment showing slide scars and effects on tail track
