High wall slope stability assessment of open pit coal mine- A case study

National Institute of Rock Mechanics (NIRM), Bengaluru-560070

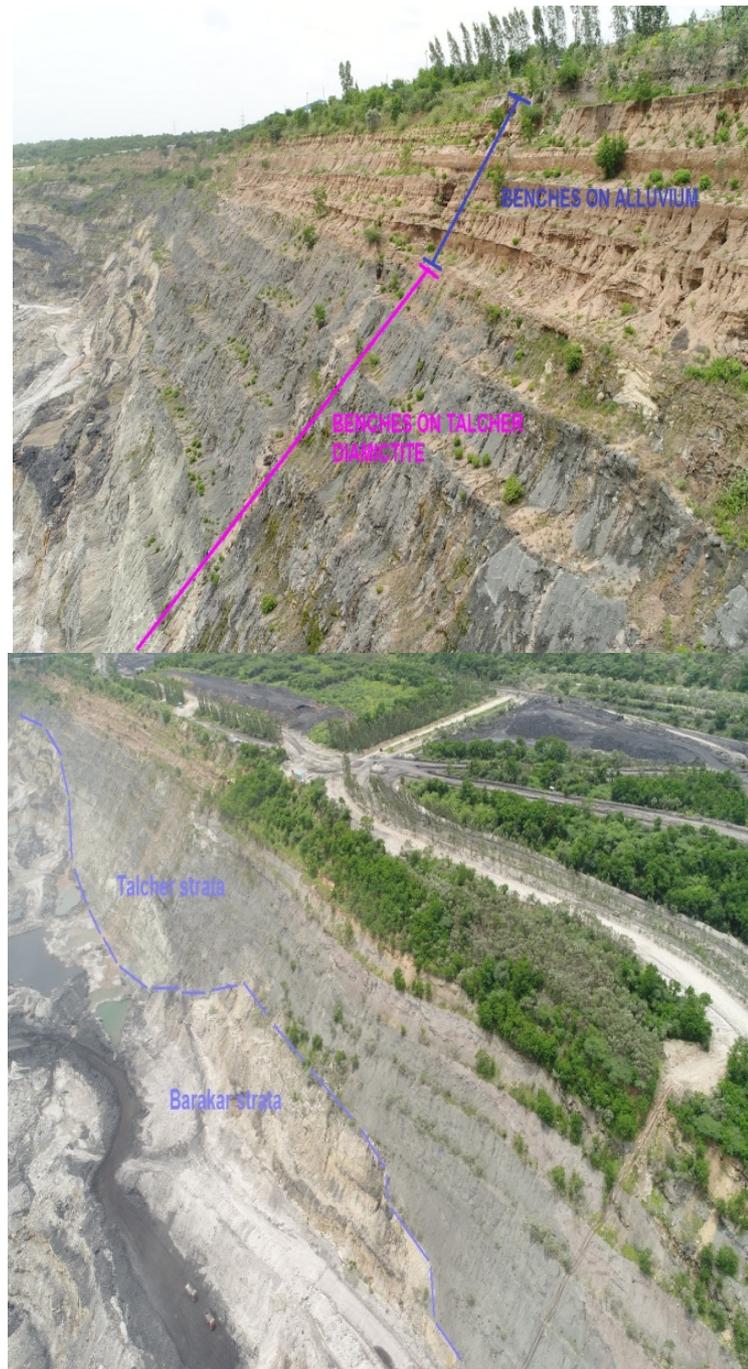
Geological mapping is carried out in the quarry where disturbed area is present (Figure 2). It is observed that top benches were developed on Talcher formation and the bottom benches were carved on Barakar formation (Table-1).

Figure 2 South side high wall benches in the mine

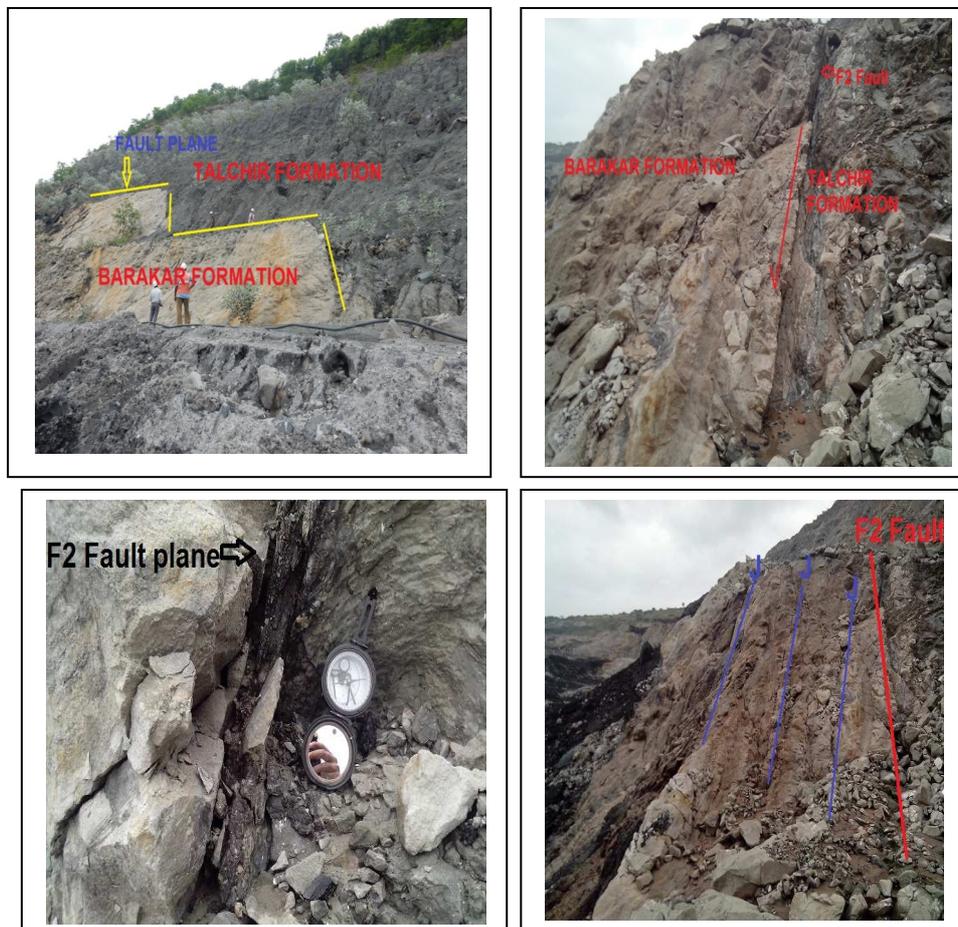
While mapping the high wall benches, the exposed fault plane was traced. From the geological mapping, the measured dip angle of the fault is taken as 65°. Along the fault plane, clay occurred as predominant infilling material and infilling material got eroded where water seepage is noticed (Figures 3 & 4).

Figure 3 Shows fault plane condition in the disturbed area

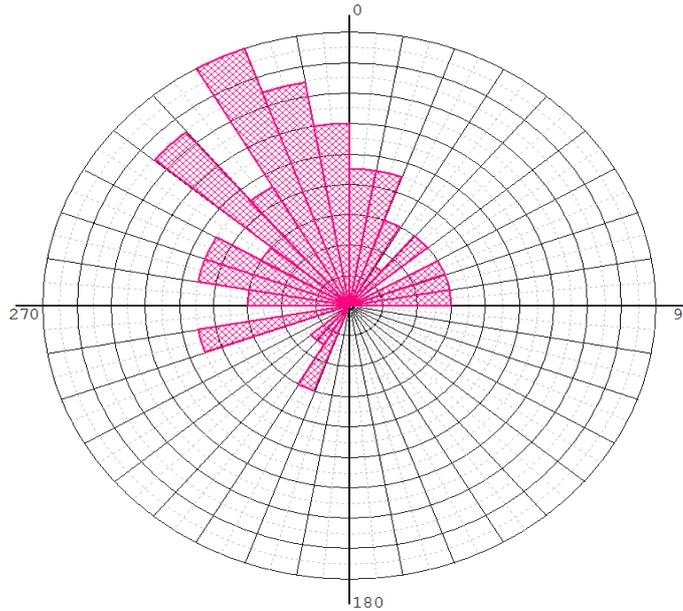
In the vicinity of fault, numerous minor faults\slips and joints were noticed and they are more or less parallel to fault. Two shear zones were also mapped with 2m width and striking in N40°E direction traversing across the benches.

Figure 4 Rose Diagram showing trend of the joints measured on the high wall slopes

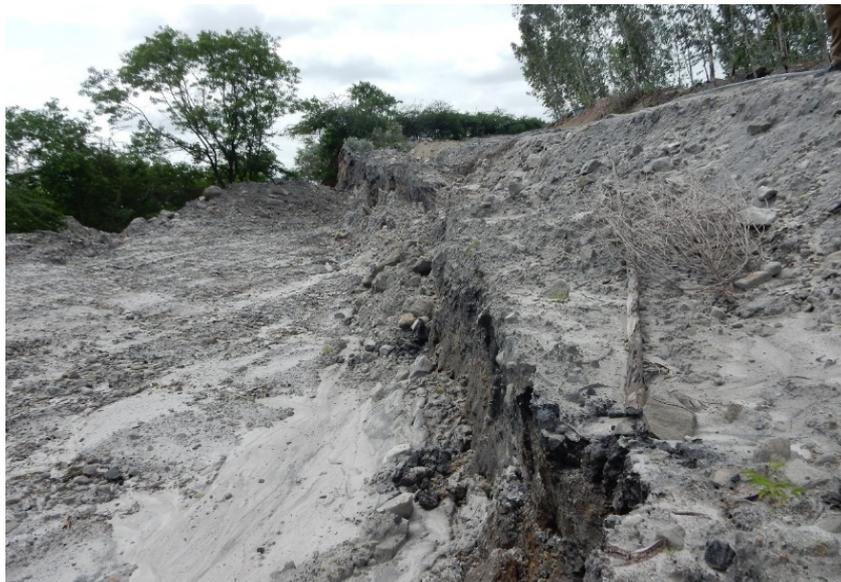
The cracks and vertical displacement observed in this area having alluvium cover of 25m which is part of Talcher formations (Figure 5). Immediately below the disturbed surface, only 3 seam, 4 seam, Index seam and 5 seams are left for extraction and all the top seams were mined out.

Figure 5 Tensile cracks and vertical subsidence at surface level of high wall slope

The possible reason of the cracks and vertical subsidence is a fault was present in the disturbed zone. The steeper slope between 835m RL and 735m RL, weak and weathered lithology, improper drainage, and regular production blast in close proximity of fault would most likely have initiated cracks and vertical subsidence along fault. The chances of undercutting/ day lighting of the fault plane along steep dip of bench slope would be high. The day lighting fault plane under undrained condition cause slope failure in weak lithology.

The mapping of weak zones, faults and bedding planes should be a regular process in the mining area. The generated data will be used as an input parameter to reanalyze the stability to get the realistic picture of the mine slopes in different geo-mining conditions. It will help to detect any unfavourable conditions at different stages of mining at the earliest possible.

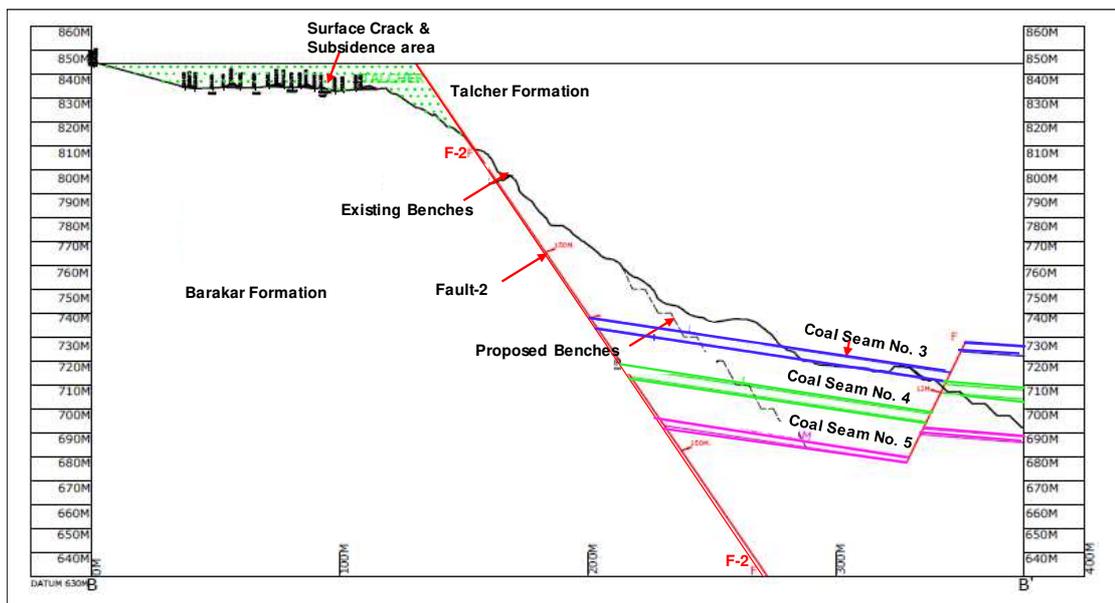
Figure 6 Disturbed area sections towards south side high wall benches

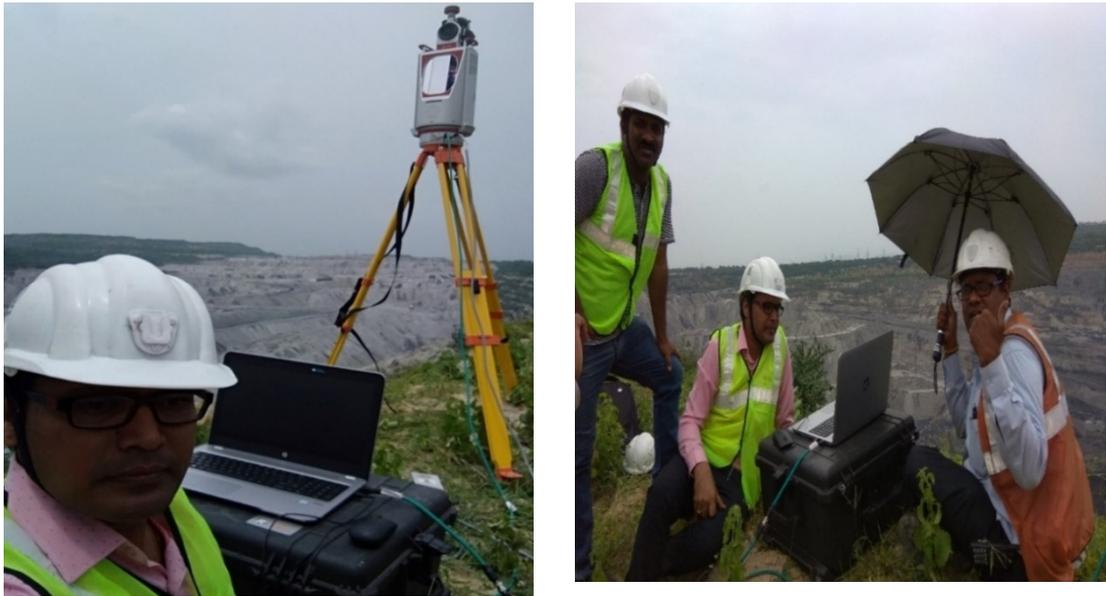
Figure 7 Lidar laser scanning survey towards south side high wall benches

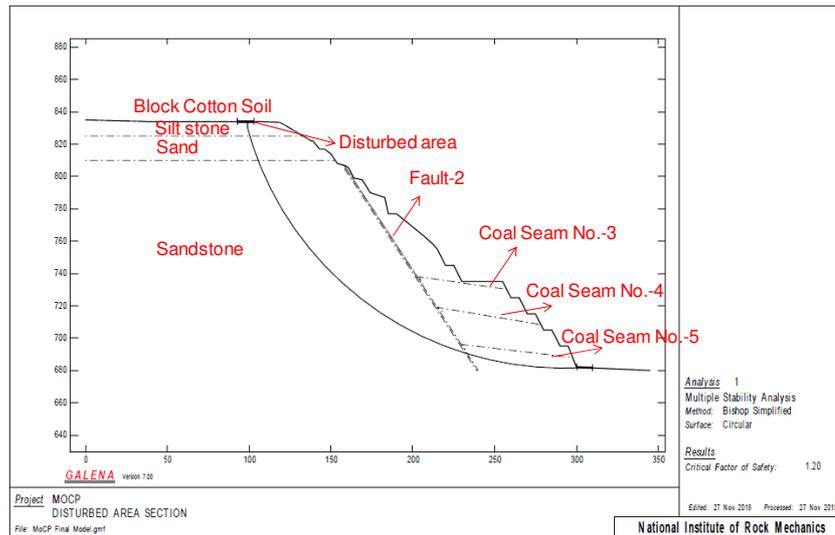
The stability analysis of south side high wall benches from 835m RL to 680mRL with a platform of 25m at 735m RL found a factor of safety of 1.20 (Figure 8). The platform need to be provide a berm with broken materials along the crest. The berm serves the function of forming a ‘ditch’ between the berm and the toe of the slope to catch falling rocks. The platform berm for disturbed area of south side high wall should be 2.5m height by 6m width.

Figure 8 Disturbed area high wall slope stability analysis (NIRM Report, 2018)

The high wall benches should be maintained 10m height by 5m width with a slope angle of 65° . The recommended top and bottom inter ramp angle is 42° and 48° with a platform of 25m at 735mRL, and final overall slope angle is 40° for high wall slope.

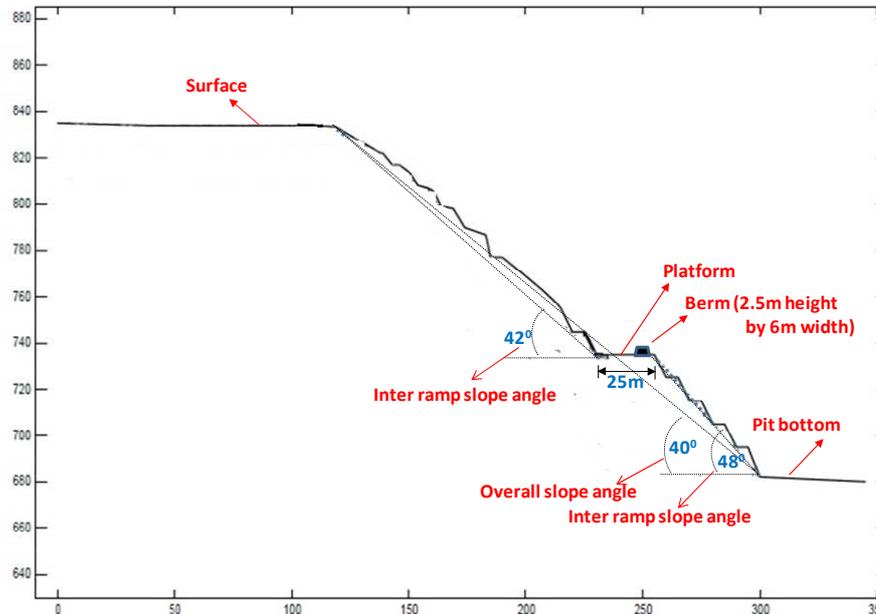
Figure 9 Final configuration of high wall benches (NIRM Report, 2018)

The recommended final slope for disturbed area of south side high wall benches is as shown in Figure 9. The part of the pit with final slope geometry should be backfilled immediately or there should not be any active mining near the final slopes. The final slopes should be formed at pit cessation stage.

These recommendations are valid with well-developed drainage system and controlled blasting. If any observance is made for the occurrence of adverse hydrological condition or the remedial measures are not effective then this slope angle has to be corrected accordingly. The slope monitoring should be done for active/ultimate mine slope to detect any instability well in advance.
