# Slope stability assessment of Hathi Parvat landslide along Badrinath route on National highway-58

Geologist, State Unit: Uttarakhand, Geological Survey of India-248001, Dehradun, India Kumar, Dharmendra Geologist, State Unit: Uttarakhand, Geological Survey of India-248001, Dehradun, India Singh, Bhupendra Superintending Geologist, State Unit: Uttarakhand, Geological Survey of India-248001, Dehradun, India

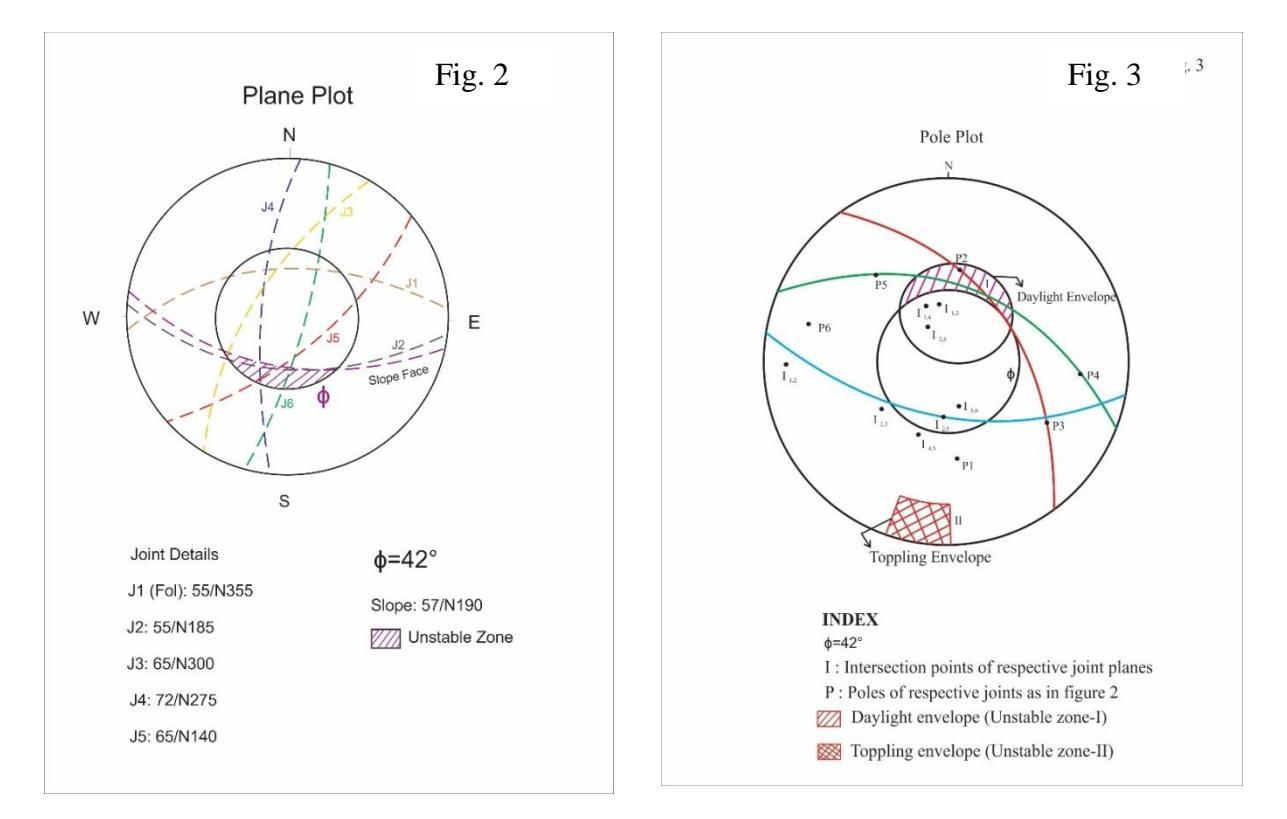
The kinematic analysis shows that, the joint J2 is most crucial planar fabric in rock mass which attributed to planar failure in unstable Zone-I. This has also been observed in field, along which the rock mass got slided. In addition to this marginal wedge failure has also been observed due to intersections of some other prominent joint planes. The stereographic projection (Fig. 2) shows that the intersections of joints J4 & J5 and Joints J2 & J3 are falling on margin of unstable zone. However, the analysis shows no toppling failure (Fig. 3). Since, rock mass is jointed, having opening more than 5 cm at places and dislodged, the valley dipping joints are loosened further due to blasting, fluctuation in temperature and ingress of water due to sudden spurt in rainfall in the area. The surface runoff while passing through these joint planes results in decrease of shear strength of rock mass, which leads to sliding along unfavorably oriented joint planes (Figs. 2 & 3).

Figure 2 and 3 Stereographic projections of Joint planes and Topography showing their mutual kinematic relations.

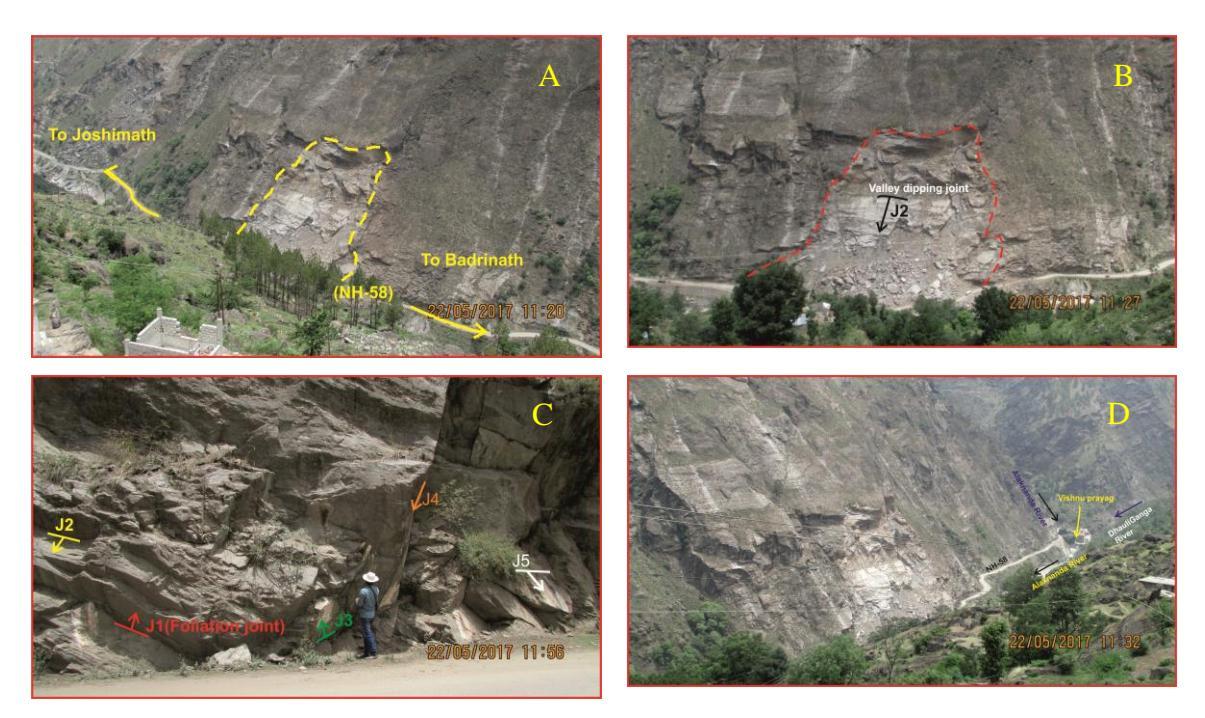
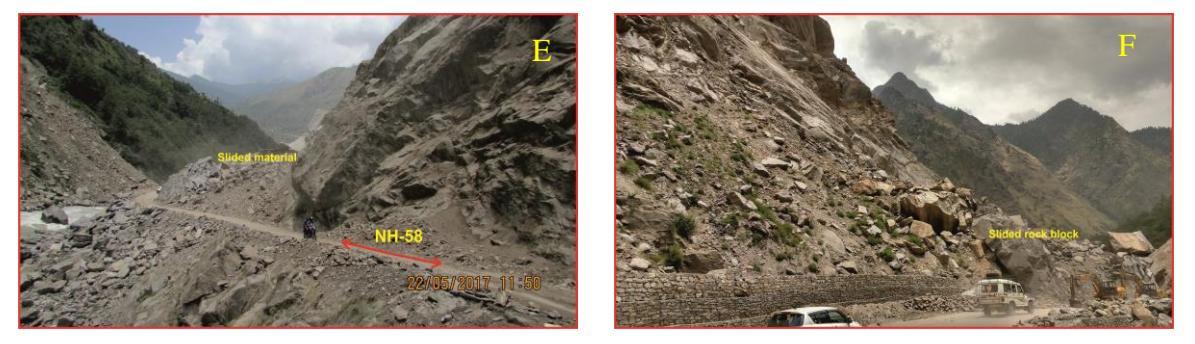
The landslide (Fig.4C) is a rock slide, occurred along steep/ escarpment having angle more than  $45^{\circ}$ . The general ground slope in the area is about  $57^{\circ}$  toward  $S10^{\circ}$ W. The rock slide has a width of about 100 m, length ~150 m and height ~80 m (Fig.4A). The area is barren with sparse vegetation cover at places. The gneissic rock mass is exposed all along the road section as well as in upper reach with thin mica schist bands. The material involved in the slide comprises of angular rock blocks and fragments of gneisses and mica schist. The slided

materials are accumulated on road side as well as below the road level i.e. on right bank of river (Fig. 4E, F).

The triggering factor seems to be rainfall and uncontrolled blasting, un-scientific and unplanned road widening activities without any proper slope protection measures have loosened the rock mass and reduced its shearing strength which accentuated the failure during first phase of heavy rainfall there. As per media report, the area has been receiving moderate to heavy rainfall and hailstorm intermittently.

Figure 4 (A) Hathi Parvat slide along National highway (NH-58), (B) Synoptic view of Hathi Parvat slide (from opposite end), (C) Different Jointsets observed at Hathi Parvat slide, (D) Upstream view of the Hathi Parvat slide, (E) View of the slidedrock blocks and (F) Closer view of the Hathi Parvat slide.

Based on analysis of the structural data, effective solutions to tackle slide would be rock bolts at right angle to the foliation joints and valley dipping joint planes, shotcrete with wire mesh to prevent weathering, construction of concrete breast wall and flood protection wall etc. As the area exhibits steep topography with jointed rock mass uncontrolled blasting would lead to widening of joints and detachment of distressed rock mass, therefore controlled and designed blasting techniques needs to be adopted.
