Slope Stability Analysis of Narayanbagar Landslide on Karnaprayag - Gwaldam Road, Uttarakhand Himalaya

R. Anbalagan*, Atul Kohli* and D. Chakraborty*

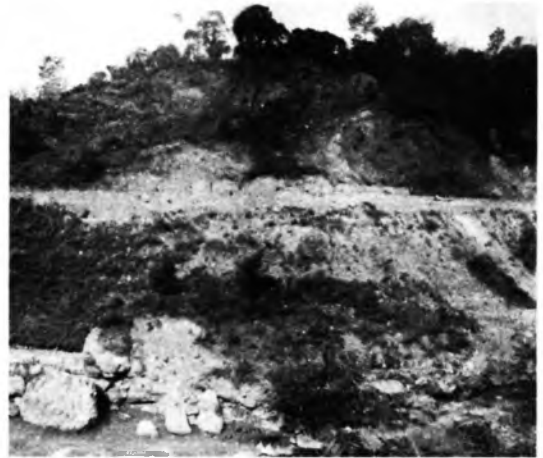
Fig. 2: Panoramic view of Narayanbagar landslide showing toe erosion of slope

The Narayanbagar landslide is located on a steep, left bank slope of Pinder River which is a tributary of Alaknanda River. Physiographically the slide area is located above the road with a thin cover of debris (Fig 2). The river Pinder, originating from Pindari glacier, flows in a roughly WNW direction close to the toe of the slide. In the landslide zone, the water flow shifts within 40 to 50m wide river course. Close to the toe of Narayanbagar landslide, the Pinder River takes an arcuate turn leading to toe erosion (Fig 2). The landslide is confined to, two minor spurs running roughly in E-W. The landslide extends over a distance of about 100m along the road. The general slope is around 40° - 42° . The slide scarps are visible as barren patches close to crown area of the slide.

Due to repeated slope movements in the past, the Karnaprayag - Gwaldam road passing through the slide zone is affected, causing traffic disruption especially during rainy seasons. A thin debris cover of about 3m is seen on the entire slope on either side of the road. During rains, the impervious rock

surface below the debris causes saturation leading to a temporary phreatic surface within the debris material. The pore pressure exerted by this subsurface water leads to slope failure along the debris bed rock interface leading to planar debris (Talus) slide. This is a typical failure, common in Himalyan terrain. However this type of failure does not find a mention by workers like Hoek and Bray (1981), Wyllie and Mah (2004). As a first step a geological map of the slide area was prepared on 1:1,000 scale with a cross section passing through the centre of landslide (Fig 3 & 4).
