Geo-environmental Assessment for Determining Suitability of Buildable Land in Context of a Hill Town

Pushplata* and R. Anbalagan**

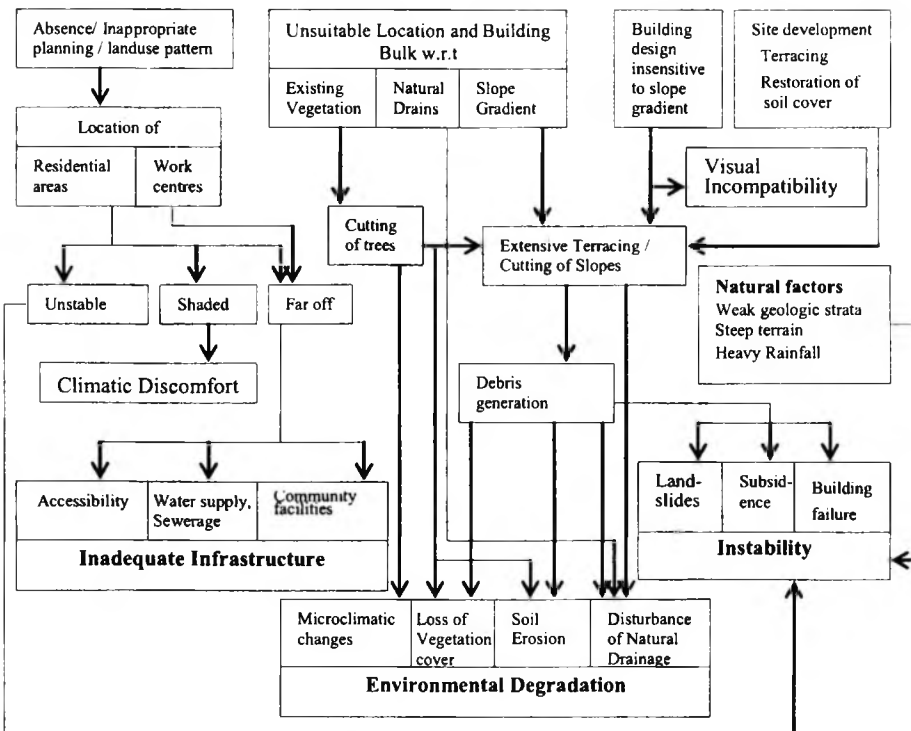
Fig. 1: Inter-relationship between Planning of Built Environment and Various Problems in Hill Towns

of hill slopes/roads and failures/ cracks in buildings. In some cases natural drainage courses are also disturbed leading to further instability. In addition, buildings with greater bulk are built on steeper slopes requiring extensive cutting of slopes/ development of large terraces for functional and economic reasons, which result not only in disturbances to slope stability and ecology of the areas, but in these buildings looking out of place as well. Provision of roads, parking and other infrastructure required for these buildings/ uses further aggravates the problems. All these not only disturb the slope stability but also disturb the vegetation cover and natural drainage patterns leading to environmental problems as shown in Fig.1 below.

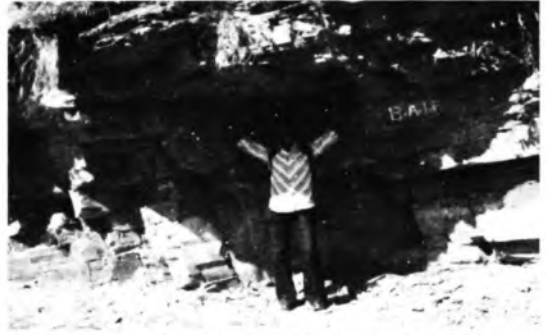
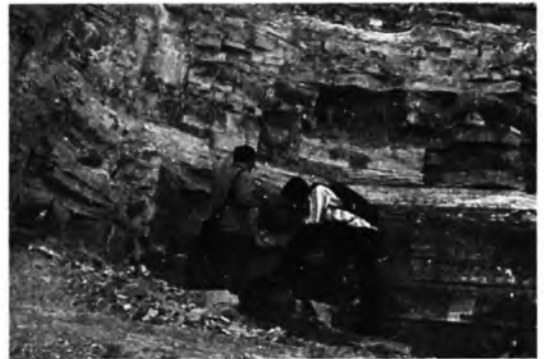
Fig. 4: Salient lithological features

The lithology exposed in the area on the opposite south-eastern slopes is phyllites and schists which are interbedded with micaceous quartzites of Almora group (Fig. 5). Intrusion of granite and granodiorite are also observed at places as shown in fig.4

below. The quartzites in the area mainly occur as interbedded with schists. The quartzites are highly micaceous in nature, at places where they show well developed foliation planes. They are fine to medium grained and are thickly bedded. They are slightly weathered on the surface and along the joint

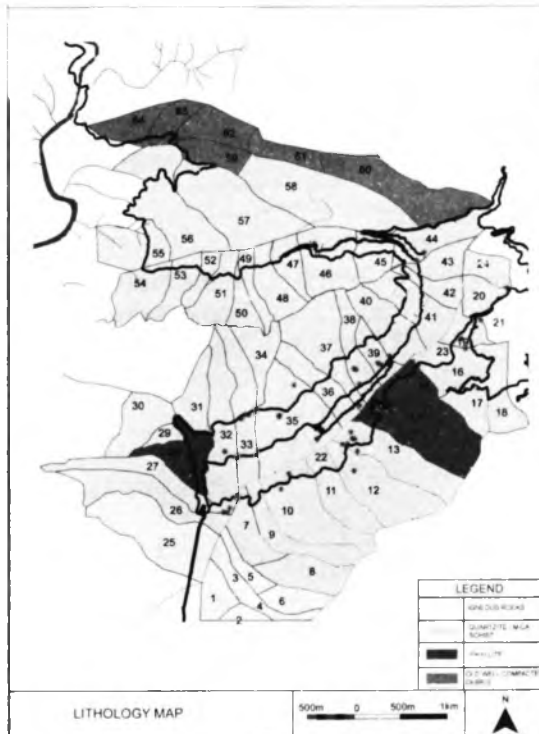
Fig. 5: Lithology map of the town

planes which are two to three sets in number. The schists are interbedded with quartzite and are also micaceous in nature. These are fine grained rocks with well developed schistosity planes. They are moderately to highly weathered. At places Phyllite are interbedded with quartzite. They are also fine to medium grained but having relatively less mica content as compared to the schist. The foliations are well developed but the foliation surfaces are rough in nature. The southern part of the study area consists of igneous intrusions like granite and granodiorite. They are in general massive in nature but are fractured at places and are moderately to highly weathered along the fractures resulting

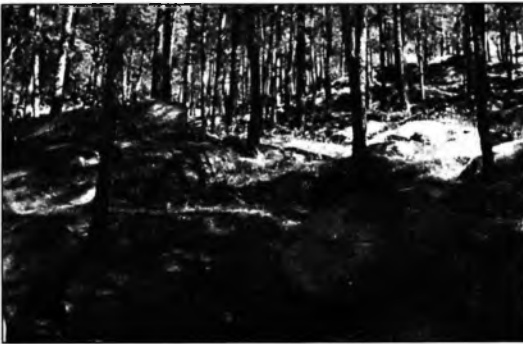
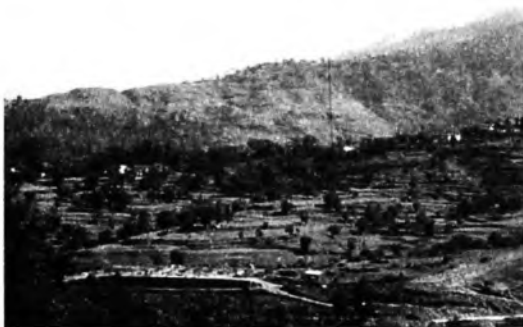
Fig. 7: Detailed study area

The study area lies between the Toll at Syali Dhar and Matela village at a distance of 10 km from Almora along the Bareilly-Bageshwar road. The area is delineated by the ridges on south and east side, Khankal ka Ghadehra on the north and the road on the west. Kosi river flows on the west close by below the study area. Part of the area consists of agricultural fields with sparse vegetation and scattered houses, and the remaining is covered by Sitoli reserve forest (Fig. 7)
