# Foundation Problems and Remedial Measures for Power House and Four Diversion Tunnels of Gangrel Hydro Electric Project Across Mahanadi River Dhamtari, District Chattisgarh

I.B. Chhibber\* and G.Ramesh\*\*

## Abstract

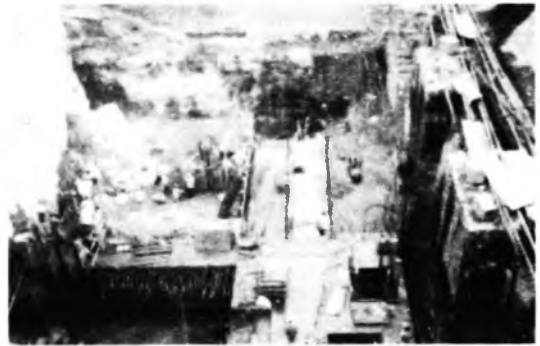
The foundations of the power house (1- 4 blocks) were been examined during the construction. There are four units; each one is located in fresh, hard, well – bedded, grey to greenish layers of Quartzitic sandstones. The power house wall will provide toe support to the already constructed dam. Foundations of each block have been laid on fresh and hard rock as accepted for laying concrete (Fig.1).

Fig. 1. Photo showing the power house foundation blocks 1-4 under construction

The consolidation grouting carried out appears to have strengthened the rock below the foundation grade as required to withstand the load and vibrations of the power house. A total of 487 bags of cement have been consumed for grouting of the foundation in

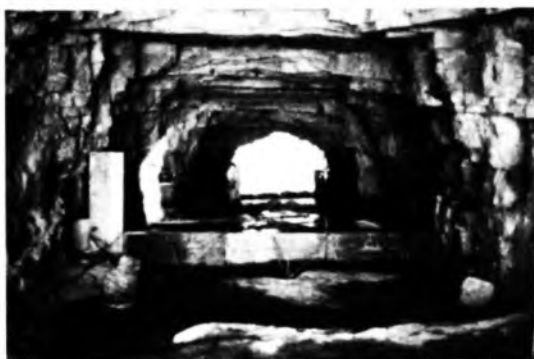
Fig. 4. Photo showing the disposition of the sandstones at the downstream portal of Tunnel I

These sandstone beds are seen extending in the side walls of the tunnel. At the crown thick sandstone beds varying in thickness from 50 cm – 70 cm were noticed which have been provided with the rock bolts by drilling vertical / steep angled holes towards the roof of the tunnel so that maximum beds above the crown of the tunnel as well as along the spring line are tied. The bedding dip is shallow ( $5^\circ$  to  $7^\circ$ ). The attitude of the beds and the orientation of discontinuities, spacing and nature of joints are noted. The joint patterns observed during construction stage are:

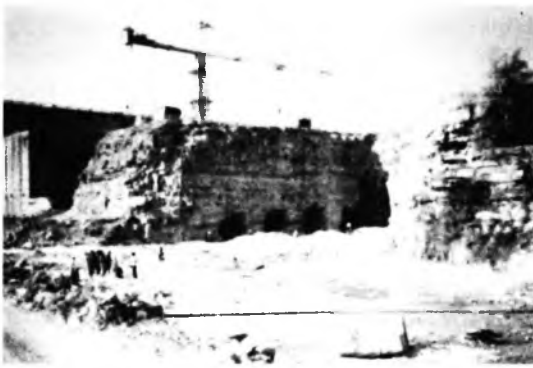
Fig. 5. Photo showing the downstream portal of the tunnels I, II, III & IV

length. The joint spacing and the nature of joints have been studied and examined. These are same as in Tunnel -I, as all the four tunnels are excavated in the same formations (Fig. nos. 5 & 6).
