Geotechnical Evaluation of Stability of Slopes - Mutrah and Mirani Forts, Muscat, Sultanate of Oman

Dr. Barin Chatterjee,
Er. Badri Narayan Basak and Er. Pradip Sengupta**

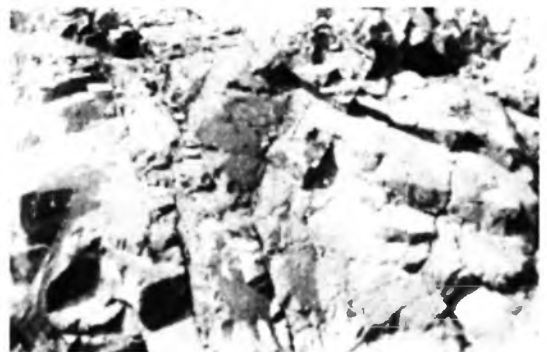
The detailed structural analysis with the data on joint systems has been carried out by plotting the rose diagram, three dimensional representation of the joint planes on Stereographic Net, plotting the δ -poles (projection of the normal to the joint planes) on equal area nets and then contouring these points by Gaussian method and by Schmidt's

method for evaluating the cluster of poles with a view to enumerating the direction of rock bolting/ doweling/rock anchoring in a multi-directional environment. From the rose diagram of the directions of joint dips, Photo 2: Muthra Fort- Rock mass condition it is evident that there are five predominant sets of joints.

(i) dipping northerly, (ii) dipping towards N30°E, (iii) dipping toward S20°E, (iv) dipping toward S30°W and (v) dipping towards Westerly. Out of these five sets, only three sets are vulnerable as these dip in the direction of slope. These are
