Power house cavern stability monitoring using microseismics at Tala hydropower project, Bhutan

National Institute of Rock Mechanics (NIRM), India

Abstract

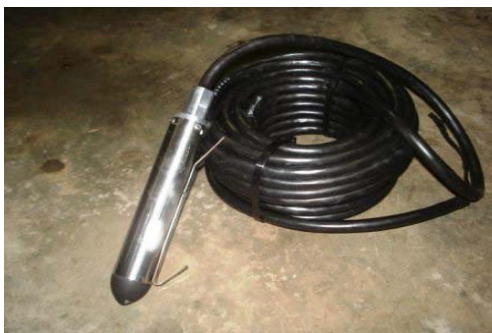
Figure 1 Borehole geophone

The installation of micro seismic sensors network preparation work was started on 12th June 2009 by conducting survey for identifying ideal feasible locations to install the sensors. The locations for six drill holes of (49mm size) for installation of geophones were also decided. Single pair copper cable for extending Geophone's cable to reach GS stations after due estimation of distances from sensors to GS units(data acquisition units) were laid during 12-06-2009 to 19-6-2009. On 20-06-2009 six borehole geophones were installed in 49mm diameter and 1.3m long drilled boreholes on the upstream wall of machine hall and drainage gallery. The geophones were grouted with quick setting cement slurry in order to obtain better coupling with rockmass and given 24 hours for settling time. Figure -1 and Figure -2 show the borehole geophone and along with the borehole installation tool.

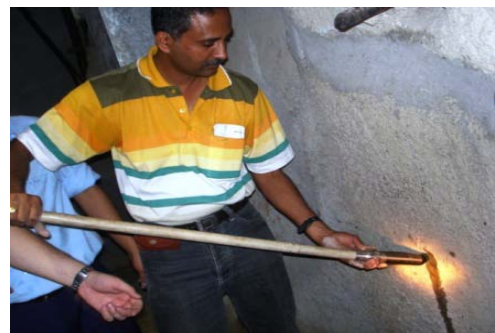
Figure 2 Borehole geophone with installation tool

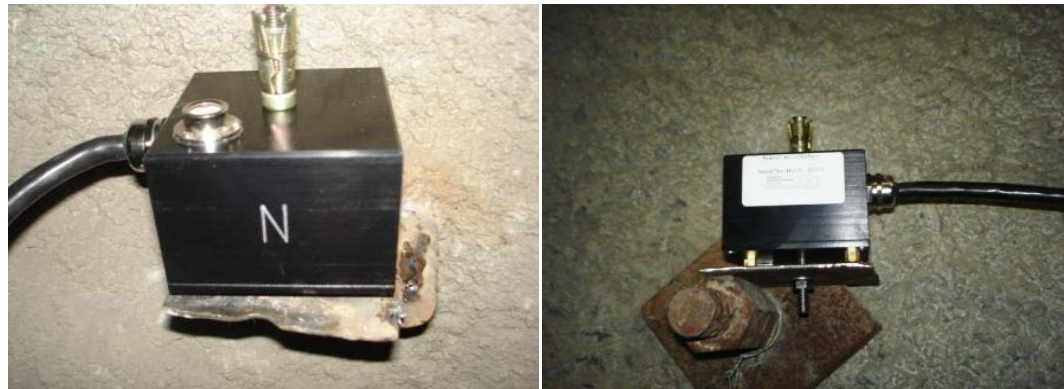
On 21-06-2009 six surface geophones were installed by welding 100mmx100mm size of 6mm thick plate on selected 12m long rock bolts on the upstream and the downstream walls of machine hall as shown in Figure 3.

Figure 3 Surface Sensors mounted on 12m long rock bolts

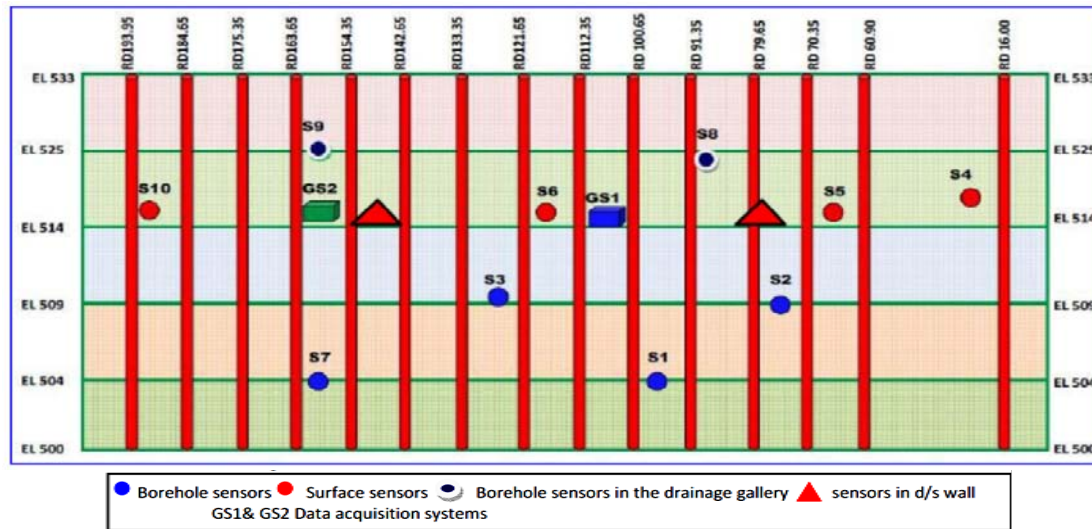
On 21st June 2009 two data acquisition units (GS Units) were commissioned by interfacing the 12 geophones to two portable GS units (24 bit, 6 channel, >115 dynamic range, 10KHz sampling rate and flash drive data storage) and GPS timing unit for time synchronization. System was in observation for about 24 hours for setting optimum threshold levels to detect the micro seismic events/cracks from rockmass. Six short (1.3m) boreholes were drilled into this wall, four from the machine hall itself and two from the drainage gallery behind this wall. Into each of these holes a uni-axial Omni directional 14Hz geophone was permanently grouted. This method provides the best coupling between the rock and the sensors as seen in Figure 2. In addition to borehole geophones six surface-mount 14Hz uni-axial geophones were also used in this experiment. These sensors can be recovered, but do not have as good coupling to the rock. The sensor, as installed for this project, coupled to the rock mass beneath the 100mm shotcrete layer. Though not optimal in terms of resonance effects, this provided the maximum sensitivity to local signals. Two of the surface-mounted sensors were installed on the downstream wall of the machine hall to provide the micro seismic event release rate (ERR) only. Four surface sensors were installed on the upstream wall. The 14Hz geophones have a linear response to vibrations between 14 Hz and 2000 Hz, and were sampled at 6000 Hz by 2 GS seismic stations. This sampling rate provides a 2700 Hz bandwidth, which matches the sensor response. The two seismic stations were synchronized in time by a copper cable link and central time generator. Seismogram data was stored on USB memory disks for later retrieval and analysis. Figure 4 shows the locations of the geophones marked on the cavern 2D cross section and seismic stations.

Figure 4 Sensors locations marked on the cross section of cavern
