## **Geotechnical studies in short wall mining - a case study of RK Tech mine, SCCL**

*Raju, B.Veera*  
*Senior Geologist, BPA*  
*Karunakar, M.*  
*Senior Geologist, BPA*  
*Sharma, D. N.*  
*Deputy General Manager*  
*Singareni Collieries Company Ltd.,*  
*Kothagudem-507101, Telangana, India*  
*E-mail : drdn\_sharma@yahoo.co.in*  
*Rama Rao, K.V. Seeta*  
*Deputy General Manager (Geology), BPA*

### **Abstract**

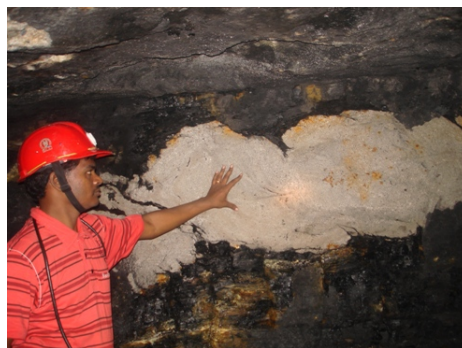
Photograph 1 Sandstone intrusion in coal pillar

Clay veins, clay stone dykes or sandstone filings are wedge shaped masses that occur in crevice of a coal bed. The common feature is that of the "Sandstone Dyke" or "Stone intrusions" or "Stone eye" (irregular masses of sandstone) that occur within the seam or penetrating into the seam. These generally range up to 1m to 2m in width. The pattern and character of these structures suggest that they formed as tension fissures in coal which later filled with clayey/sandy material and then were compacted after burial. The details noticed in the location in panel area and observed feature are listed below.

- a. Sandstone channels are observed within the seam. These generally range from 1m to 3m in width. The pattern and character of these structures suggest that they formed as tension fissures in coal which later filled with sandy material and then were compacted after burial.

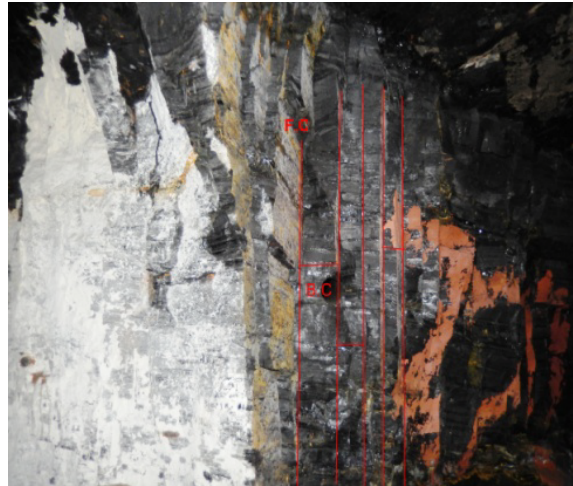
Photograph 3 Face Cleat & Butt Cleat in Coal Pillar

A distinct cleat pattern is developed in the coal bands of IA seam. About 68 readings of Face cleat and Butt cleat are taken. The trend of cleat pattern is mapped constructed a Rose diagram and depicted in Fig-2. Face cleat trends in and  $N15^{\circ}E$  and Butt cleat trends in  $N75^{\circ}W$ . The frequency of both Face cleat and Butt cleat are 30cm and 20cm respectively. In general, the cleat is well defined in vitrain bands and fusain bands. Since roof of working section is sandstone, no influence of Cleat on roof stability is observed. However it helps for easy cutting of seam with shearer.

- c. Cleat pattern is well developed in the coal bands of IA Seam. About 68 readings of Face cleat and Butt cleat each are taken. Face cleat trends in  $N15^{\circ}E$  and Butt cleat trends in  $N75^{\circ}W$ . Since roof of working section is sandstone, no influence of cleat on roof instability is observed.

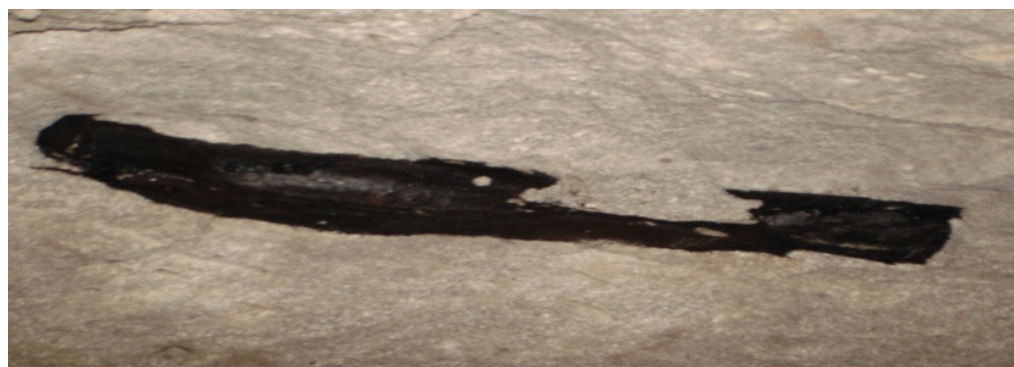
Photograph 5 Plant impression (Trunk structure) in roof sandstone

Leaf impressions are discontinuous planes. Roof strata separate easily along such planes. In the area under reference, roof strata is medium to coarse grained sandstone consisting of leaf impressions. Along the leaf impressions due to weak bonding between over lying and under lying strata, it leads to separation and failure.
