In-situ shear strength parameters- A case study

*Chawre, Bharti, Yadav. R.P. and Mishra, K.K.
Central Soil & Material Research Station, Hauz khas, New Delhi
E-mail: bharti.bhanu.2005@gmail.com*

Kirthai H.E. Project Stage-II is conceived as a run off the-river-scheme with diurnal storage of 8.5 million cumecs to run 6 units of 165 MW each (total generation of 990 MW). The scheme envisages having 121 m high concrete gravity dam, 4.289 km long head race tunnel (HRT), underground power house near Lidrarinala and 352.50 m long tail race tunnel (TRT) with a diameter of 11.25 m. At the Kirthai H. E. Project (Stage-II), all the geological components are in the Pias Granites which is intruded within the Kishtwar Window. The Kishtwar Window is a conspicuous structural element of Higher Himalaya. Kishtwar Window exposes Dul Quartzite enveloped by Salakhala Formation, which is tectonically overlain by the high grade metamorphites along the Trace of Main Central Crystalline Thrust. The rocks of Kishtwar Window are overriding the younger Salakhala Formation along Kiaji Thrust. Geological cross section along the dam axis of Kirthai H. E. Project Stage-II is shown in figure 1.

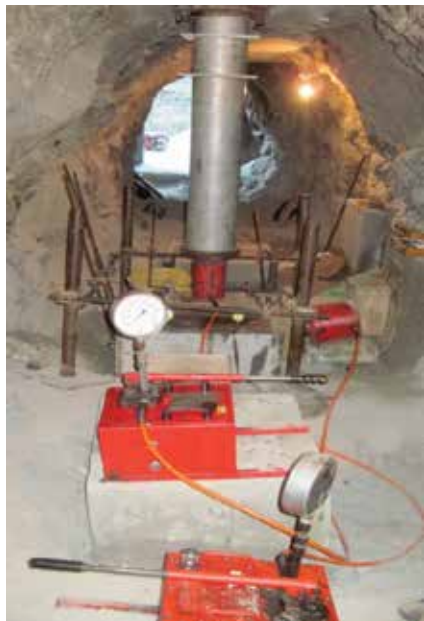
Figure 2 Photograph of shear test set-up Figure 3 Schematic diagram of shear test set up

In-situ shear tests were conducted in the left bank drift site of Kirthai H. E. Project Stage –II. Four set of rock blocks for rock/rock interface has been prepared. The test block shall be cut to the required dimensions (700 mm X 700 mm X300 mm) using methods that avoid disturbance or loosening of the weak discontinuity to be tested (IS 7746:1991, ISRM: 1981). The base of the test block should coincide with the plane to be sheared. Frame consisting of 20 mm thick mild steel plate was used to envelop the prepared rock block to avoid any unwanted failure of rock block other than predefined shear plane during testing. MS plates of 20 mm thickness were used to prepare side and top reaction pads, strengthened by R.C.C. The care is taken to keep the top and side reaction pads concentric with the block. Vertical load is applied by 200T capacity hydraulic jack and aluminium alloy hollow cylinders were used to fill up the gap between the top reaction pad and the hydraulic jack. The shear load is applied by another 200 T capacity hydraulic jack from the side reaction pad, at an angle of 15° with the horizontal in order to pass the resultant force through the centre of the test block. This is achieved by two wooden wedges placed across the jack. The application of shear force is kept until the failure occurs.

Each block is tested for a particular normal stress of rock block which is kept constant during the test. The shear force and displacement of block are measured and recorded during the test. The vertical, horizontal and lateral displacements of the block, produced during the test are measured by nine dial-gauges (four for normal displacement, three for shear displacement and two for lateral displacement) each of 0.01 mm least-count. The observations are recorded till failure and continued even after the failure to the extent possible to get the information regarding residual frictional resistance. Set up of equipment and schematic diagram for in-situ shear test is shown in figure 2 and figure 3 respectively.

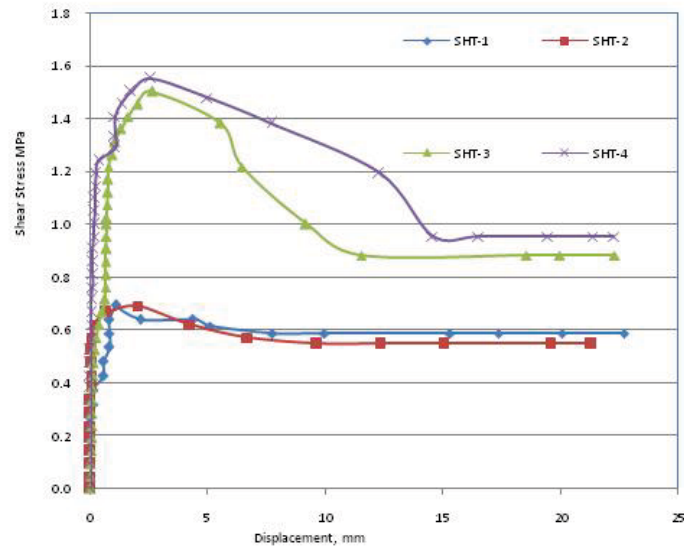
Figure 4 Shear stress v/s displacement curve

Four shear tests on rock to rock interface were conducted in the drift on left bank of the dam axis. The tests were conducted at different but constant normal load. Normal load of the order of 10, 20, 30 and 40 tonnes was applied in these tests. The blocks were overturned after shearing and the actual area of shear was measured. The normal and shear stresses were calculated considering this measured area. Shear stress versus displacement plot is shown in figure 4. Peak and residual shear stresses were plotted against the normal stress to get the peak and residual shear strength parameters of rock to rock interface given in figure 5. From the “curve of best fit” using linear regression, values of peak shear strength parameters viz. cohesion ‘c’ and friction angle ‘ ϕ ’ were found as 0.49MPa and 65.96° , respectively for rock to rock interface. Similarly, residual shear strength parameters ‘ c_r ’ and friction angle ‘ ϕ_r ’ were found to be 0.33MPa and 53.81° respectively.

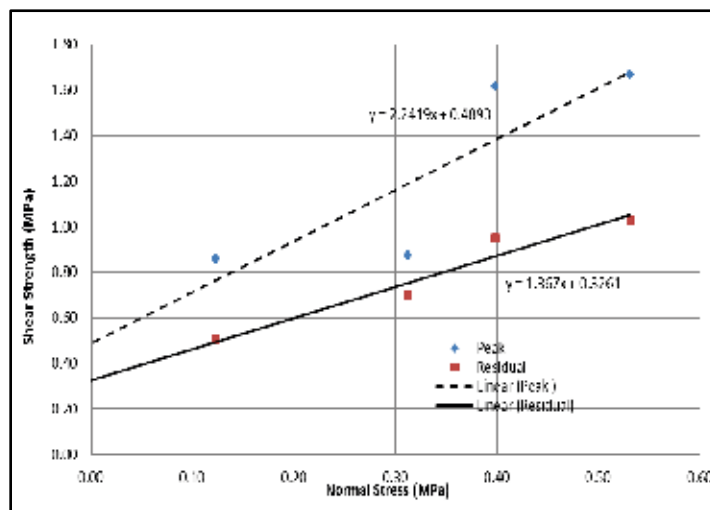
Figure 5 Shear stress v/s normal stress

As α is 15° in this case, the applied normal force is reduced after each increase in shear force by an amount $P_{sa} \sin \alpha$ in order to maintain the normal stress approximately constant. At failure and after failure (residual), the shear stress is plotted against the normal stress for each test and the “curve of best fit” is drawn using linear regression analysis. From the equation of straight line obtained, the intercept on the Y- axis gives cohesion ‘c’ of the rock mass and the slope of the line gives the friction angle ‘ ϕ ’ of the rock mass.

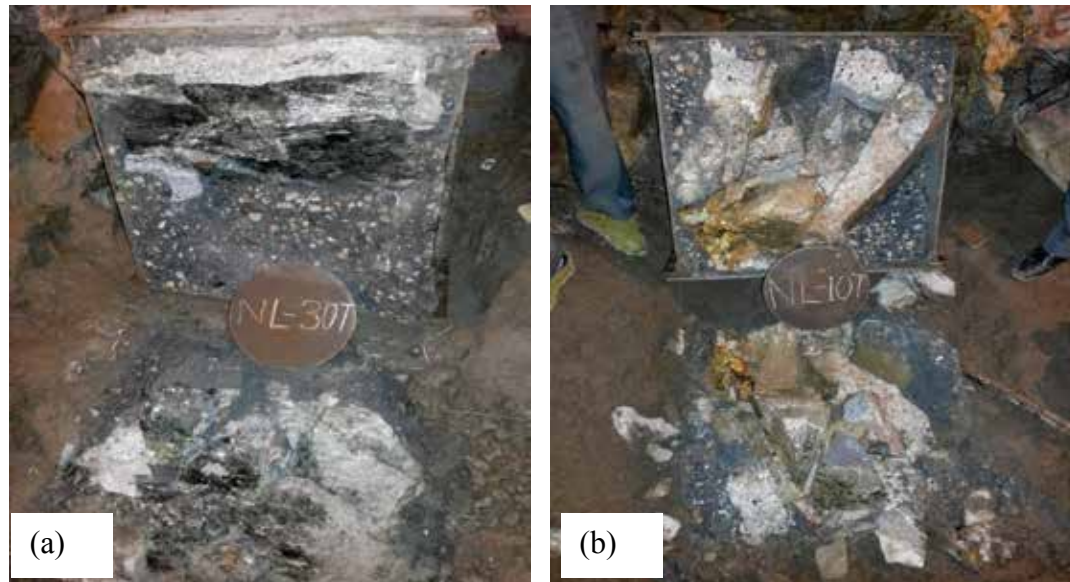
Figure 6 Overturned rock blocks tested at normal load (a) 30T and (b) 10T

Table 1 presents the detailed test results. The photographs of some typical overturned rock blocks are shown in figures 6a and 6b.

Cohesion & angle of friction depend upon the angle of inclination when shearing stress is acting at an angle to bedding. The angle of friction increases as the beds dip in the opposite direction of shearing stress. The cohesion values are higher for the beds dip in the direction of shear stress. In present study it was observed that the beds dip approximately 20° with the direction of shear stress which causing increase in friction angle and lower value of cohesion.
