# Facet based landslide hazard zonation of Kodaikanal hills, Dindigul district, Tamil Nadu

*Thanavelu, C.  
Geological Survey of India  
E-mail:actvelu@gmail.com*

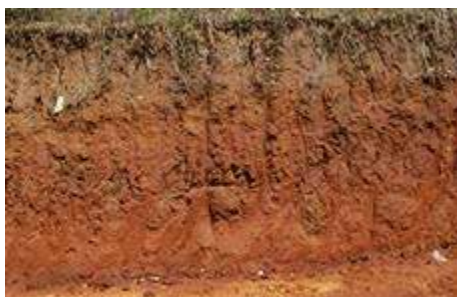
Picture 1 Lithomarge and top soil

The skeletal soils are seen as patches at places in the upper most waxing parts of the slopes. The lowermost parts of the waning slopes and the narrow, linear and flat bottomed valleys are occupied by colluvial and alluvial soils. The visual estimation of thickness of the soil horizon based on the observation on slope cuts and well sections varies from 0.5 to the maximum of 15m. Humus soil (peaty) occurs as top horizon of the soil profile predominantly developed in densely vegetated forest and plantation areas (1 – 1.5 m thick) in the forest areas, whereas it is thin (about 0.5m) or absent in cultivated areas. Lithomargic clay zone is found between lateritic soil and weathered rock. Lithomarge is reddish/pinkish/mottled in colour and mainly developed in the undulating plateau.

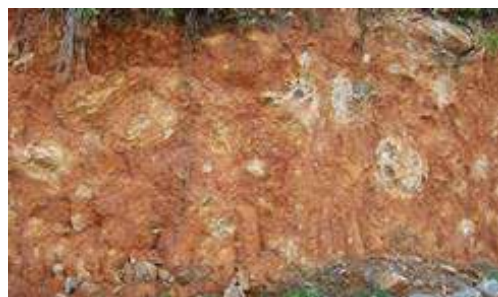
Picture 2 Palaeo /Old Slide Debris

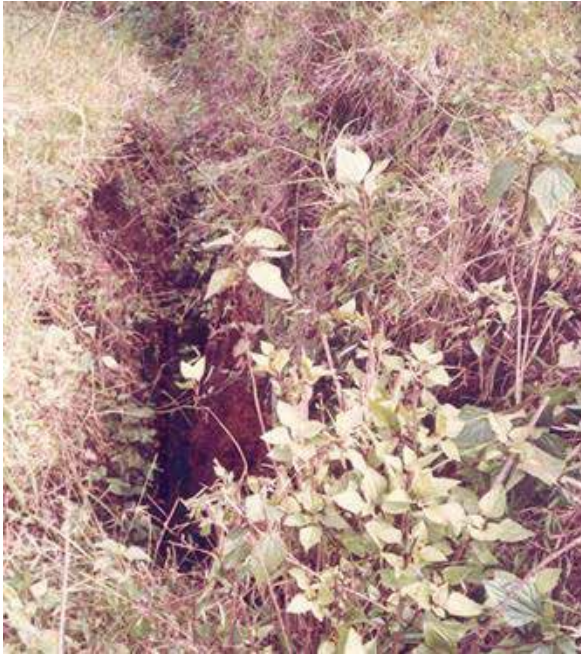
Picture 3 Perumalmalai Subsidence

Based on the studies, it is recommended to carry out landslide hazard zonation mapping of Kodaikanal Town on mesoscale covering the future developmental prospect areas; detailed study of the Mother Teresa College slope, Shanmukhapuram slope and Attuvampatti South and North slopes and detailed study and monitoring of Perumalmai Subsidence above Kodaikanal road near the junction with Palani road.

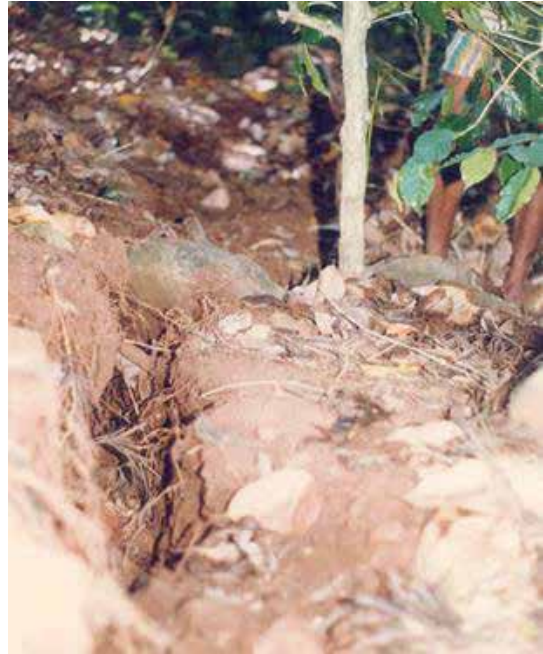
Picture 4 Panrimalai Subsidence

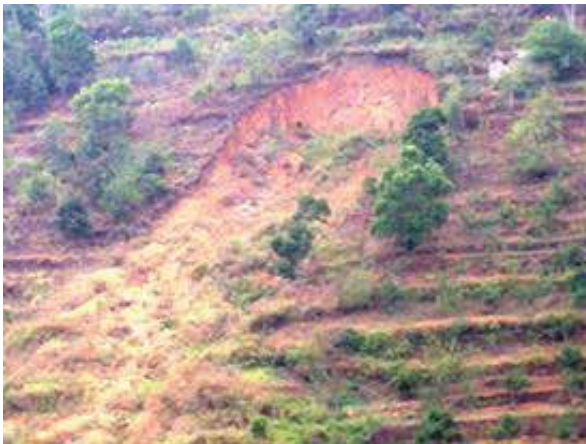
Picture 5 Panneer Thottam Debris Slide

An inventory of 198 landslides and slope failures indicated that most of the landslides are soil/debris slide. Soil covered slopes of the undulating plateau under forest and plantation cover are devoid of contemporaneous landslide, whereas medium to small scale landslides are seen in the cultivated soil covered slopes that are affected by toe erosion. Debris flows and old landslide scars are present mainly on the fringe slopes and at some places on the moderately dissected valley slopes. Debris/soil falls, slips and slides are the cut slope failures seen along the roads in deeply dissected fringe and moderately dissected valley slopes. Shallow sheet failures are noticed at a few places on steep slopes with thin soil cover in the fringe areas.

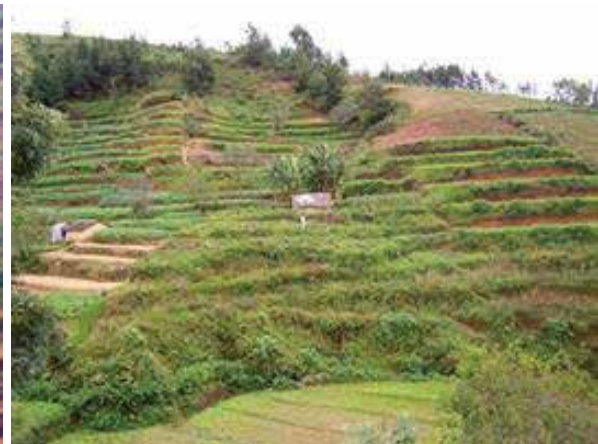
Picture 6 Geranium Farm Debris Slide

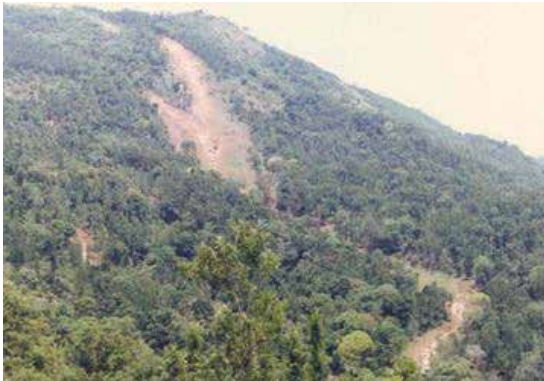
Picture 7 Alagarmadai Debris Flow

Major parts of the newly aligned Addukkam – Periyakulam road and select reaches of Ganguvarpatti – Kodaikanal and Perumalmai – Palani - roads fall under high hazard category, which needs detailed studies for arriving at reach wise suitable preventive/control and corrective measures. Debris flows are present along some of the streamlets in the fringe slopes mainly along Chiterevu – Thandikudi Road, which may be surmounted by increasing the bay width of the culverts to facilitate unhindered flow of debris.

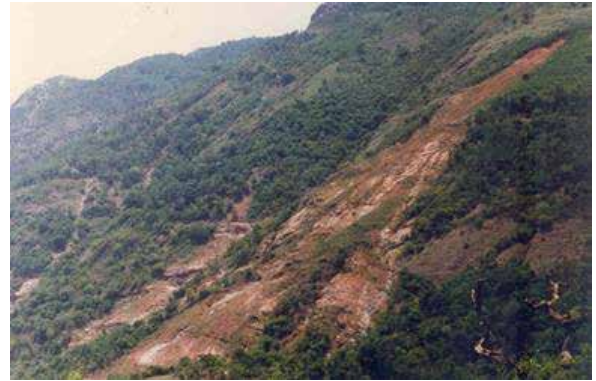
Picture 8 Murukkadi Shallow Sheet Slide

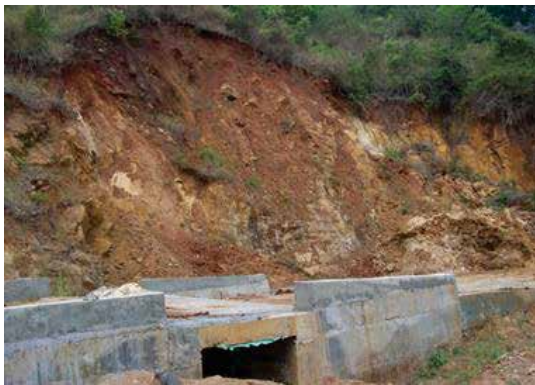
Picture 9 Alagarmadai Cutslope Slide

No conspicuous landslides or scars are observed on the rocky slopes of exfoliation domes in the undulating plateau. Planar and toppling rock failures occurred in the moderately weathered rock mass on the cut walls along roads in the reaches with unfavourably

oriented weak planes. Foliation parallel joint with weathered seam is the causative plane for most of the planar failures. Occasionally, joint planes trending  $N40^{\circ}$  to  $60^{\circ}E - S40^{\circ}$  to  $60^{\circ}W$  are found to be the sliding surface. Only the foliation parallel joint planes are the causative planes for the toppling failures. A common map has been prepared merging slope erosion status map and landslide incidence map.

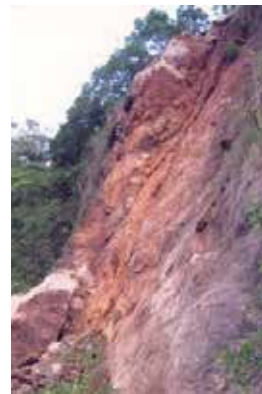
Picture 10 Tomtom parai Rock Slide
