# **Geotechnical studies in short wall mining- A case study of RK New Tech Mine, SCCL.**

## **Abstract**

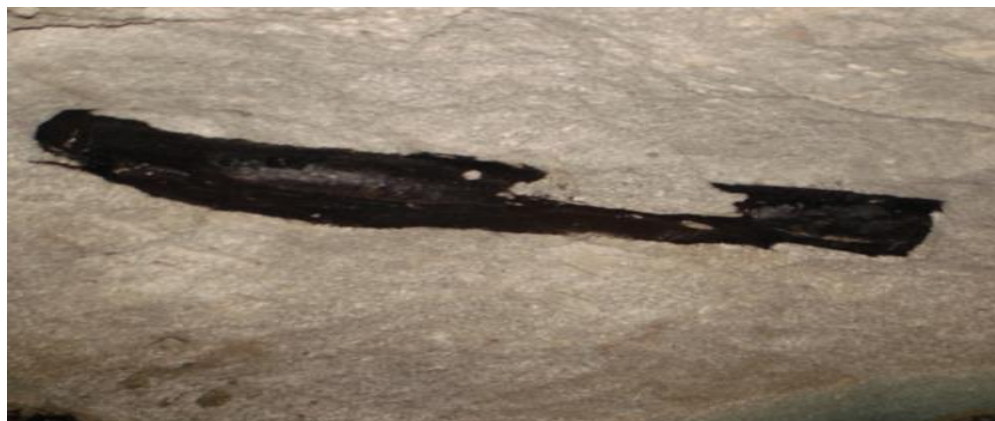
Picture 5 Plant Impression (Trunk Structure) in Roof Sandstone

Leaf impressions are discontinuous planes. Roof strata separate easily along such planes. In the area under reference, roof strata are Medium to coarse grained sandstone consisting of leaf impressions. Along the leaf impressions due to weak bonding between over lying and under lying strata, it leads to separation and failure.
