Geotechnical problems encountered during the excavation of rock ledge for EOT Crane in underground Power house of Shongtong-Karchham Hydro Electric Project-450MW- A case study

The present study deals with a case history of the excavation practice and the stabilisation measures adopted during the excavation of the rock ledge for EoT in Underground Power house of the Shongtong-Karchham Hydro Electric Project in Kinnaur, Himachal Pradesh, India. The area around Shongtong-Karchham HEP falls in the Greater Himalayas. Characteristically the river Satluj in the project and vicinity flows through a moderately deep gorge flanked by steep slopes. These rocks in this part of Himalayas have been categorized in to Vakirata Group (Ravi Shanker. et. al. 1989). Rock mass mostly belongs to good to fair quality, with small poor quality as per estimated Q value. Power house cavern has been aligned along $N43^{\circ}$ - $N223^{\circ}$ after analyzing the discontinuities encountered in the exploratory drift and keeping in view the direction of the principal stress axis determined by Hydro-fracture studies Present alignment makes an angle of 83° with foliation joint (major/principal discontinuity) and

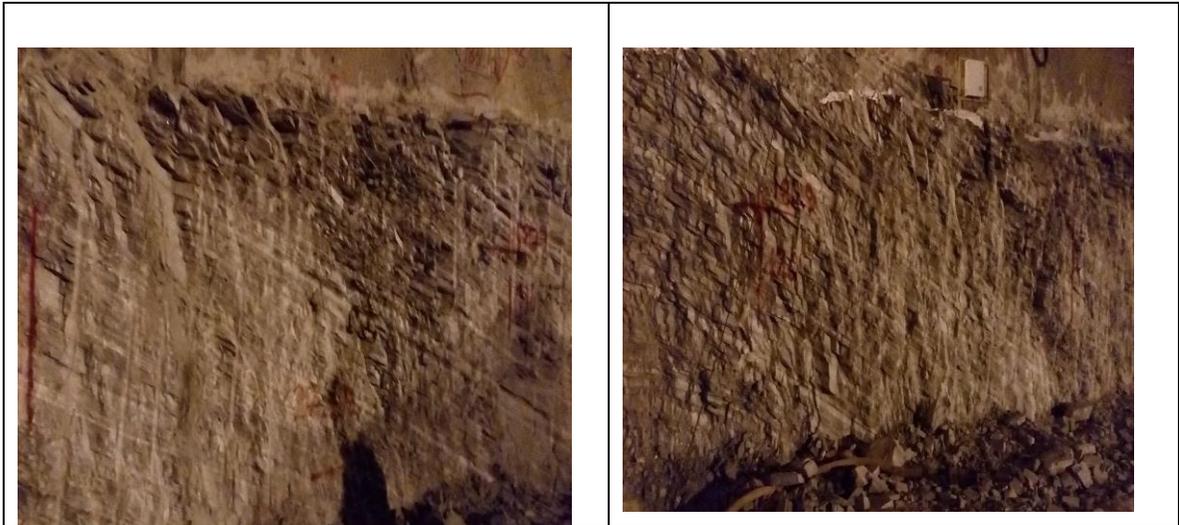
Photograph 1 Photo showing thinly foliated banded gneiss

During excavation of rock ledge, generally Good quality rock mass has been encountered up to RD 50.00m, as ledge has been excavated through massive gneisses in this stretch. However, after RD 50.00m onwards up to end of cavern RD. 131.15m, the rock ledge have been excavated through thinly foliated banded gneiss with av. spacing of 5cm in

general (Photograph 1). As foliation is oriented nearly perpendicular to the longer alignment of the cavern with low dip amount against the direction of the drive, due to blasting, distressing at the top of bench (being unconfined in absence of a remaining bark) offered free escape for blast induced wave propagation resulted in splitting of rock mass along foliation with minor apertures on the vertical face of ledge contrary to the rock section in heading segment above SPL. In view of this closely spaced line drilling (@ 0.5m), split and controlled blasting with use of mechanical breaker has been used to develop the vertical face of ledge so that excavation induced apertures and disturbance to the rock mass of ledge can be contained/minimized.

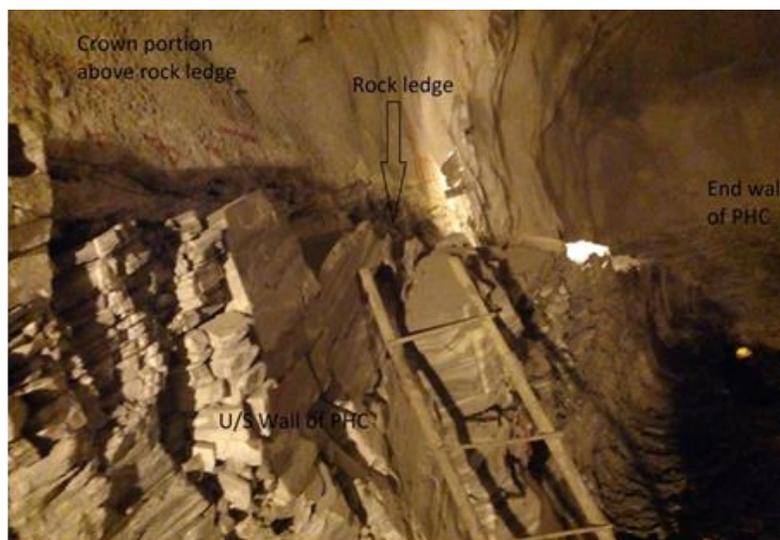
Photograph 3 Photo showing considerable apertures along J2 plane between 104.00-113.00m on the upstream wall.

Considerable apertures (2-7 cm) (Photographs 2 & 3) along J2 plane has been observed between 104.00-113.00m and 116.00-120.00m, and the loose mass is resting in these stretches over the J2 plane (dipping towards the cavern), these have been removed prior to application of shotcrete. The removed/scooped rock mass has been made up with shotcrete and double layer of wire mesh.
