Role of geotechnical instrumentation in construction stage of Hydro project – a case study (Rampur HPS 412 MW)

Rampur Hydro Power Station of 412 MW installed capacity is located on River Satluj, a major tributary of Indus basin, in Shimla and Kullu district of Himachal Pradesh in North India. The plant is designed in tandem with run of the river plant Nathpa Jhakri (1500 MW). Survey and investigation of the project completed in the year of 2004. After the techno economic clearance in Dec 2005, the construction started in Feb 2007. After the seven years of construction period, the project commissioned in May 2014. By December 2014, all the six units were synchronized with the Northern power grid and added 412 MW to the nation. The project comprised of 15.117km head race tunnel, 162.5m deep surge shaft open to sky, a Multifunction , three pressure shafts, Power house, collection Gallery and outfall channel. During construction of tunnel, Power House, collection gallery /TRT many problems were faced which were tackled as these are being assessed with the regular monitoring of geotechnical instrumentation.

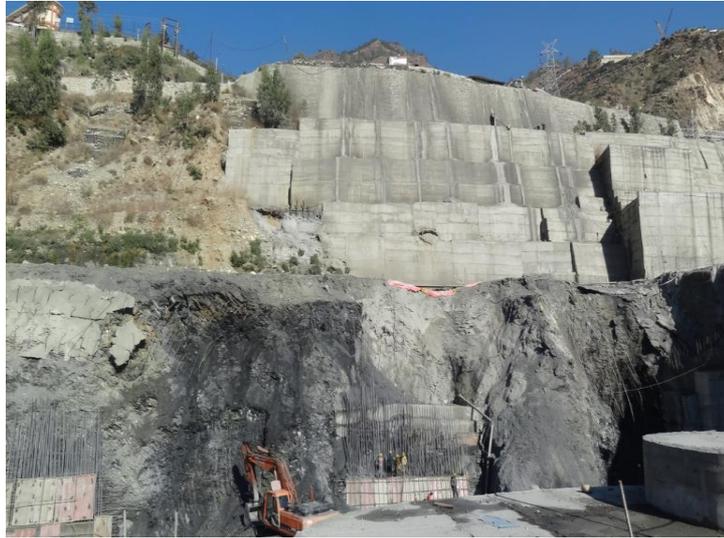
in NNE to NNW direction at an angle of 50° - 60° .The construction of the outfall structure from RD 37 m (TRT gate) to RD 47 m was in progress. The invert of the outfall channel was at El 859m; at right side of it approach road to Power house was at Elevation 880m.Above the road the slope consisting of RBM was protected with RCC cladding wall (Photo 1).

Photograph 1 depicting the Northern slope of outfall channel

Cutting of the northern slope below the road (880m) was done in steps. After the completion of the excavation work reinforced wall casting was in progress. (photo1). The instruments were installed well before the excavation activities .Slope above the road 880 m was being monitored regularly with bi-reflex target, Inclinometer and anchor bolt load cell (photo 2).When excavation started little movement observed in the inclinometer reading and bi-reflex data in southern direction (table 1),but increased with time and as excavation progressed (fig 4)

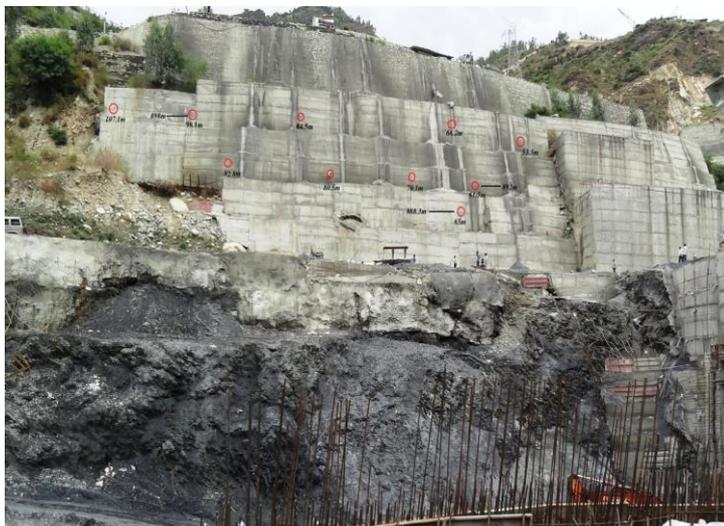
Photograph 2 shows instruments installed at slope.
Above & below the Power house road EL880 m

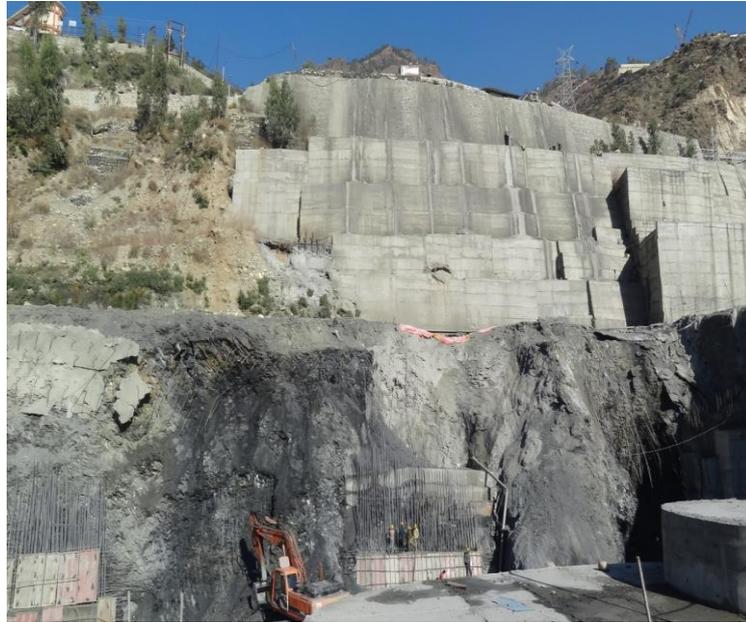
It is important to mention that about 50 workers, two excavators & twin cutter were evacuated before the collapse, keeping in view the safety and collapse took place. The photo 3 & 4 depicting the area before & after slide, as well as extent of slide.

Photograph 3 Before slide

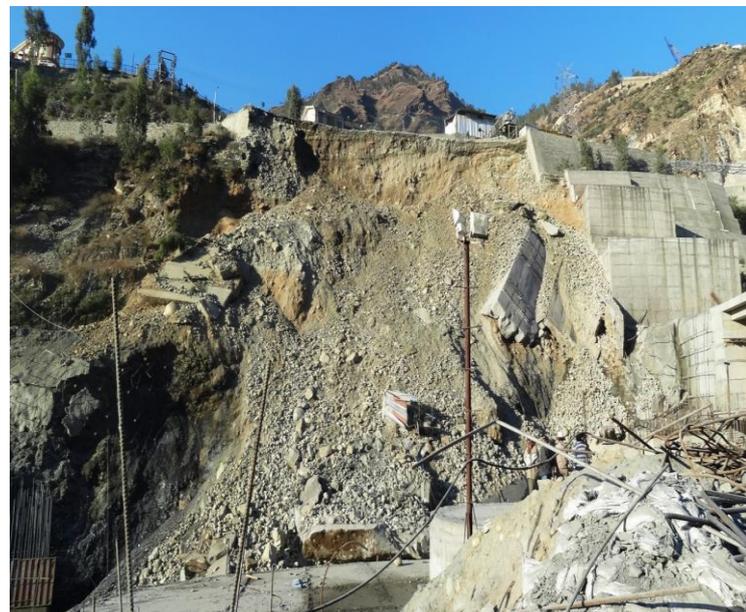
Photograph 4 After slide
