**Different techniques adopted to tackle the geological adversities during the construction of Rampur hydro power station (412 MW) –A case study of head race tunnel**

The Rampur Hydro Electric project (RHEP) with generation potential of 412MW is located on river Satluj, a major tributary of Indus basin, in Shimla and Kullu district of Himachal Pradesh. The project is designed as a cascade tandem operating plant to Nathpa Jhakri project. The design energy approved for Rampur HEP is 1900 million units of electricity per year. The construction of RHEP is completed with generation starting during March 2014. All six unit were commissioned in December 2014. RHEP comprises of 15.117km head race tunnel, 162.5m deep surge shaft open to sky, a multi-junction, three pressure shafts, power house, collection gallery and outfall channel. The RHEP constructed in the lesser Himalayan Zone on Satluj river basin and local geological setup of Project is Rampur- Kullu Group.

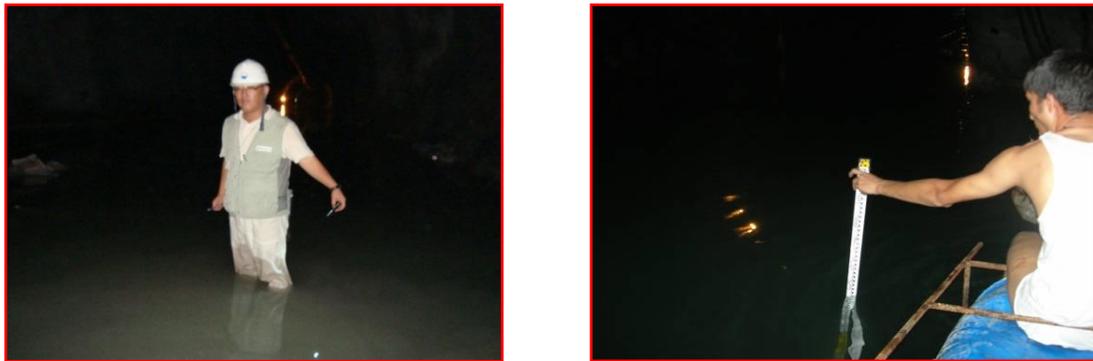
Photo1 &2: Flooding in HRT (boat on RHS for monitoring of seepage water).

The major adversity (unpredicted) during the excavation of this reach of HRT was encountered at RD  $\pm 1349\text{m}$  in the form of heavy ingress of water @180-200 liters/sec from the face & crown. Tunnel was flooded when the discharge suddenly increased to 300-350 liters /sec. The observed physical conditions at face were suggestive of the effect of thrust zone in the close proximity. The rock was highly jointed quartzite with staining along joint surfaces. The seepage water had a temperature of about  $33^\circ$  to  $35^\circ$ . The extent of flooding was so high that it has taken 2 months for restoration of the site.

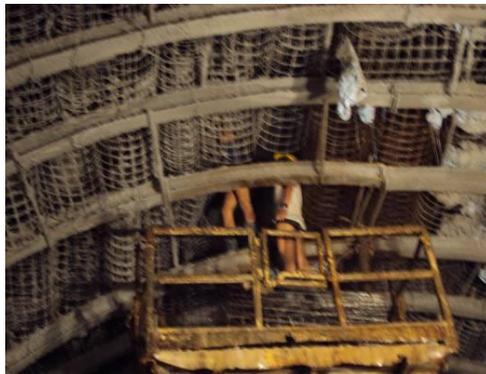
Photo3 Wire mesh rolls filling in cavities

Finally it was decided to dewater the tunnel by installing additional 05 nos. pumps of 60HP each and 8" pipeline in addition to existing dewatering system. In total, the dewatering was done by about 997 HP capacity water pumps. Seepage at face was tackled by making a ramp in the central portion of HRT. Keeping in view the ingress of seepage water, instead of backfill concrete, porous concrete or shotcrete with wire mesh rolls in layers up to the crown was adopted so that seepage water does not block behind the ribs & create pressure.

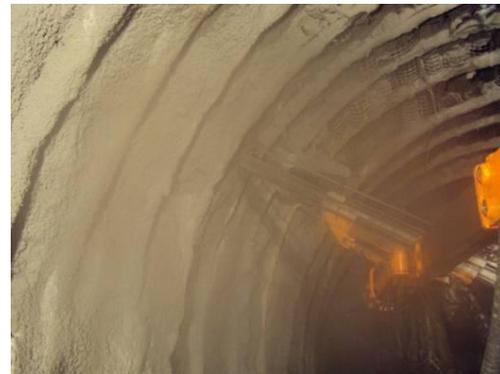
Photo4 Shot creting being done to embed ribs

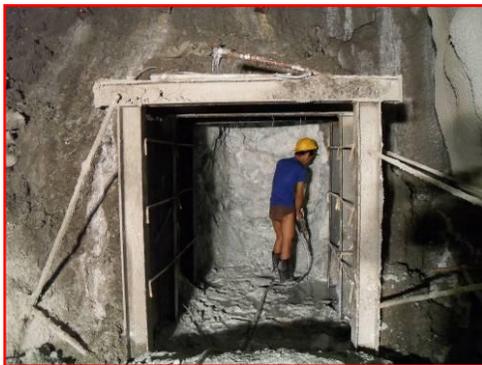
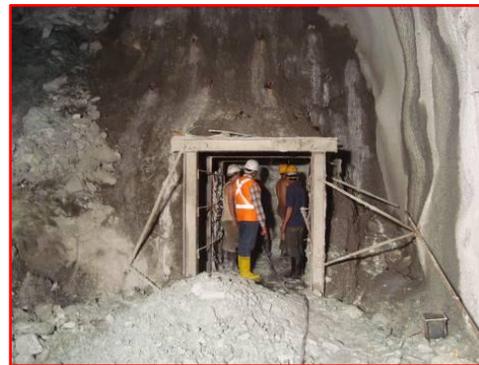
Photographs 5 & 6 Multidrift along thrust zone

- **Multi-drifting:** A drift of size 2mx2m was excavated manually to know the rock conditions ahead in temperature of about 40° C.
- **Injecting PU grout:** The face condition was improved by injecting PU grout by drilling 45mm $\phi$ , 5m long holes all along the periphery and in the face keeping an overlap of 2m.

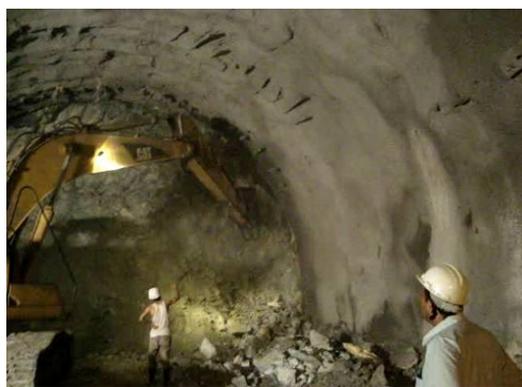
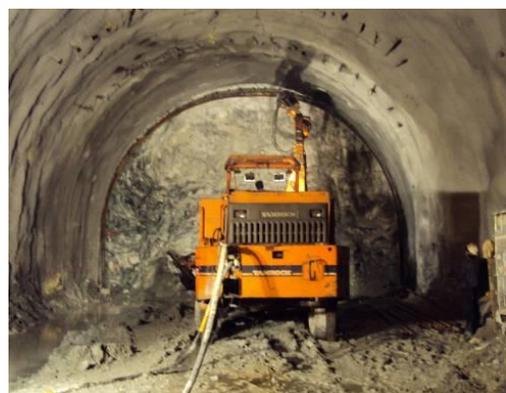
Photographs 7 & 8 Application of hydraulic hammer and impression of fore poling

- Excavation was done with hydraulic hammer only for a step of 1m of each. No drilling & blasting was advisable due to extremely poor rock conditions.
- **Pipe roofing:** 50mm $\phi$ , 5.00m long pipes were inserted along the periphery as pipe roofing after keeping an overlap of 2m.

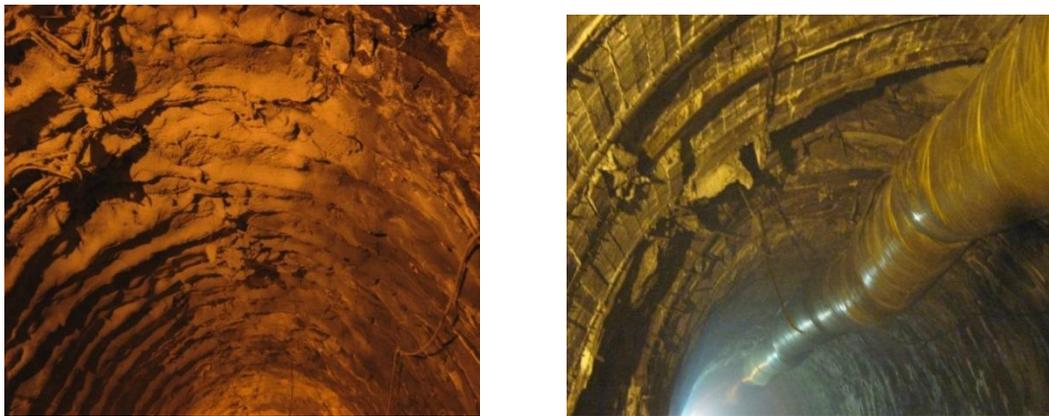
Photographs 9 & 10 Deformation in lattice girders and bending of steel ribs.

The main tunneling hazards during the construction of Kunni HRT were development of instabilities in rear zone of HRT, Squeezing Conditions, Rock Fall, Cavity formation during benching. Failure of lattice girders which were installed in downstream posed a great challenge and squeezing conditions enhanced the quantum of failure. Bending of face plate of the rock bolts, bending and twisting of lattice girders and detachment and development of huge cracks in shotcrete layers was also a common phenomenon observed during execution of downstream reach of HRT.(Photos: 9&10). The modification in design of rock support was adapted later to counter this problem.

Apart from this, large cracks were also observed in shotcrete and the installed support system was encroached into the final section of concrete lining from crown, left wall and right wall portion.

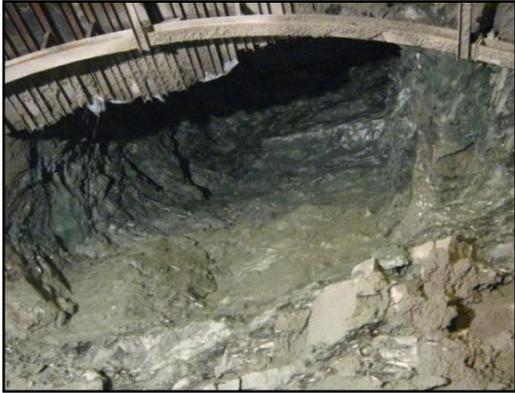
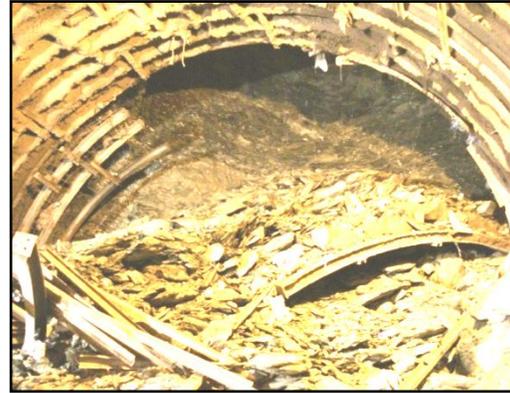
Photograph 11 & 12 Extent of cavities formed at RD's 52 and 63m respectively

S.No.	Date	RD(m)	Extent of Cavity
1	06-11-2009	52	cavity of around 6.0-7.0m height formed in the crown.
2	10-11-2009	54	Loose fall of around height 7-8m damaged 2no. Ribs and forepole umbrella.
3	01-12-2009	63	Damaged 3 sets of steel ribs and channel fore poles.
4	01-01- 2010	55-79	Whole reach got collapsed.

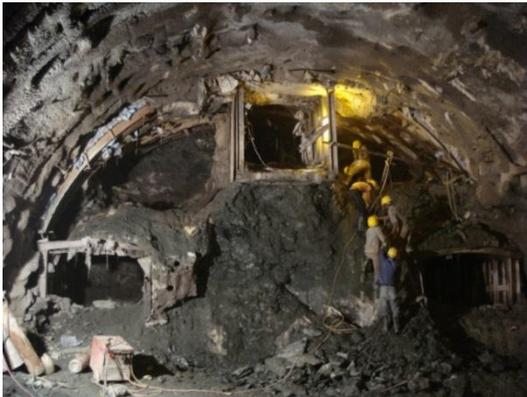
Photo 13 Multi drifting in progress

- **Pre-grouting and Pipe fore poling:** These methods were followed to tackle this cavity reach. For the pre-grouting 50mm diameter & 5m long holes were drilled at a spacing of 0.5m in 2-3m behind the face. PVC pipes were inserted in those holes & grouted. Then Pipe fore poling was performed at the face & grouting was done in those pipes.
- **Multi-drifting:** After the pre-grouting and pipe-fore poling, multi drift excavation was started at RD 55m by excavating two drifts at bottom (LHS & RHS). These drifts were of size around 2m X 2m. Another drift of similar dimension was excavated at the crown of length about 15m. After this the space between two drifts was manually excavated and supported by steel ribs one by one. This method was followed up to the RD 68m.

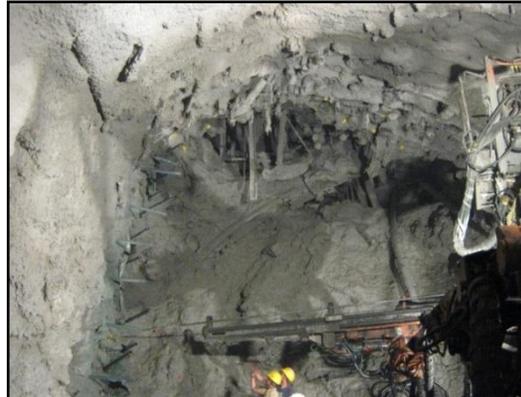
Photo 14 Pre-grouting at face

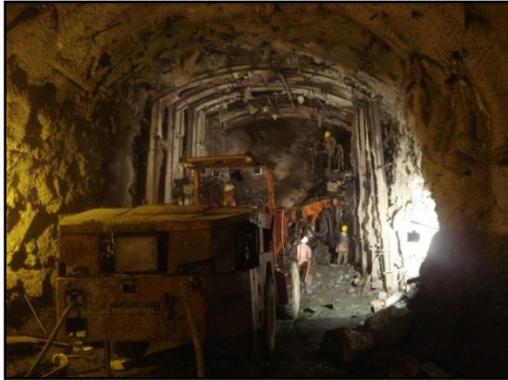
Photo 15 Excavation of HRT  
through D- Shaped Adit

From RD 68m onwards excavation was followed in Adit shape (D-shape) as it was difficult to excavate the full section in loose muck. In parallel grouting was continued to consolidate the loose muck in crown and sides. In this method crown segments of steel rib of size ISHB 150 X150mm @ 34.60 kg/m were used and verticals of about 6m were used having section ISHB 200 X 200 mm @ 40 kg/m. This method remained very much successful for us. Both sides and crown was well consolidated by intensive grouting and smaller section of excavation helps a lot. This method followed till the end of cavity i.e. up to RD 80 m.

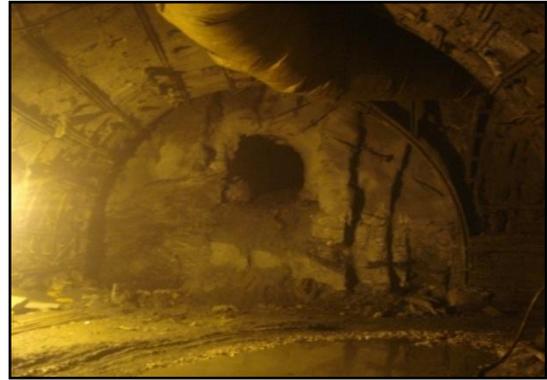
Photo 16 Drift from Bye pass junction  
(U/S Side)

After that excavation as drift shape from bye pass junction (U/S side) commenced of having dimensions 2m X 2m.
