Incidences of Slope Failures along NH-1A, Jammu & Kashmir

Abstract

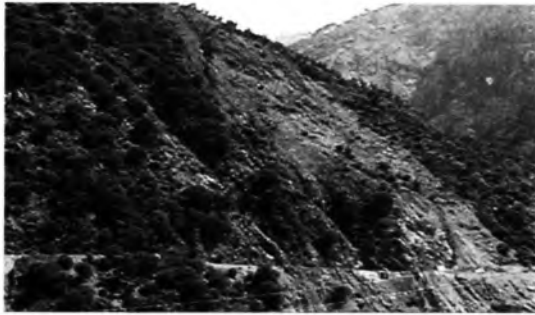
In this section, the road is cut through the interbedded sequence of rocks of Autochthonous folded belt. Along the total length and in close vicinity of this section, twenty major slides have been recoded. The section contains the major Kehia maur slide, Seri slide zone and Ramban slide zone. The Ramban slide zone (Photo-1) is debris slide on which regular recurrences of slide are reported. It forms the earlier left bank alignment of the NH-1A, which is now closed for regular traffic. Another alignment of NH-1A was made and opened for regular traffic on the right bank of the Chenab river, which is also affected by the debris slide. The widely dispersed manifestation of the fragility of highly folded and sheared metamorphic rocks is the major contributing factor. These rocks are susceptible to nala erosion by the surface water. Freezing and thawing action of snow and melt water resulted in gully erosion of the debris mass, rendering the slope unstable. Furthermore, process of road building/ widening results into the recession of the slides vertically as well as laterally. The Seri slide is a debris cum rock slide in which, the fragile rock mass of mudstone is converting into the debris, which is susceptible to failure. Another slide along

Photo-1. Ramban slide

Mitra *nala* is also one of the major landslides affecting the national highway. It is also a debris slide induced by toe undercutting of the *nala*. For containing these slides, back dressing/easing of overburden slope profile near the head, benching, and boulder pitched wall with wire crate at critical spots besides providing geojute cover all along the slide surfaces could be suitable for their mitigation.

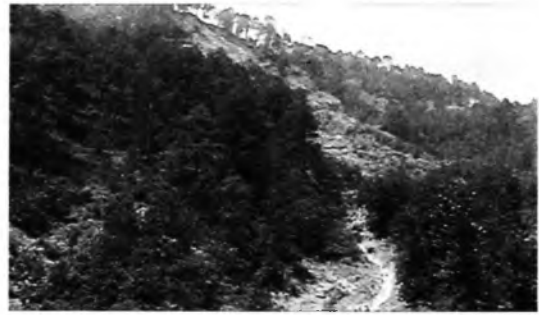
Here also the road is passing through the interbedded sequence of Autochthonous folded belt. In the close vicinity and along the total length of this section, nine major slides have been recorded. This section contains the major Nashiri slide zone (Photo-2), which has affected more than one km of the road section as well as nearby villages of Khandel and Nal, which are affected by its southern extension. It is a massive debris slide caused by *nala* erosion. Steep gradient of *nala* with huge discharge during monsoon accelerates toe erosion, resulting in to retrogressive slide of debris material resting on the steep slopes of about 50°. The fresh and barren nature of the detached slide mass and scarp with freshly fallen trees indicate active nature of slide and exposed rocks of fragile nature at crown with steep slopes provide enough space for slide to grow. For containing the slide, back dressing/easing of overburden slope profile near the head, benching, and boulder pitched wall with wire crate at critical spots besides providing geojute cover all along the slide surface may be of use. Diversion of Nashiri *nala* along the road can prevent the road by further recurrences of landslide, as toe cutting in the lower reach could be avoided.

Photo-2. Nashri slide

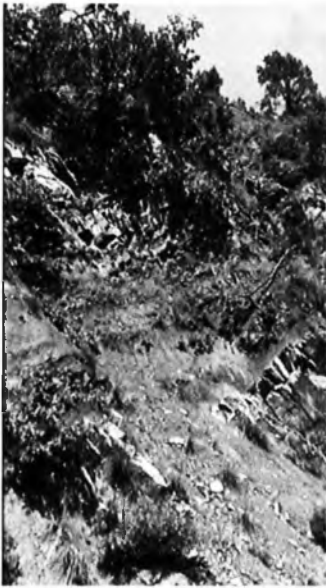
Along this section eleven major slides have been recorded in which the major slide is at sharp hairpin bend near the Patnitop pass. This is a massive rock cum debris slide (Photo-3) caused by competency contrast between the interbedded sequence of sandstone mudstone and siltstone of Murree Formation. During rain/snow fall, surface runoff and seepage of water through the mud/siltstone make the rock mass more fragile and susceptible to erosion, which ultimately leads to failure of slopes involving bigger sandstone boulders. Another major debris slide affecting the road is at 92 km stone in which younger riverbed deposits are failing due to gully erosion during monsoon. Slope flattening and benching, boulder pitched wall with wire crate at the road level can contain these slides and prevent the road by further recurrences.

Photo-3. Rock cum debris slide near Patnitop.

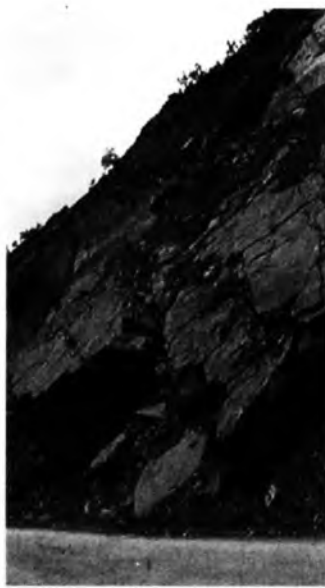
Along this section seven major slides have been recorded. The Dharamthal slide and slide between Nagnoo and Maund bridges are the major zones of debris failure while the one which is at 77 km stone along the road is a typical example of planar failure (Photo-4). Retaining structure at road level and back dressing/ easing of overburden is the suitable measure to contain this type of slide. The Main Boundary Fault also passes through this section separating Murree Group of rocks from Siwaliks. Here another debris slide is active along the left bank of Tawi river in which the river borne terrace material has been dislodged, affecting the field and village population on the lower terrace (T-1).

Photo- 4. A planar failure at 77 km stone along the road

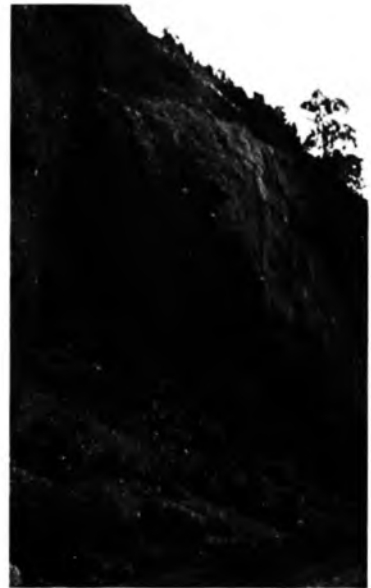
Along the Tikri-Katra road section, Sirban dolomites and Quaternary sediments (overburden mass) are exposed. There are only two problematic landslides (Photo-5) recorded along the road. They are debris slide in an assorted assemblage of angular to sub angular fragments of gravel to cobble size with occasional boulders of limestone/dolomite of sub-recent Quaternary sediments of Vaishno Devi Formation. These slides are initiated due to toe erosion by the river and further aggravated by surface runoff and water seepage into the fragile deposits. Here provisions of toe support by providing retaining structure and scaling to remove rock overhangs are the suitable measures to contain these slides.

Photo-5. Debris slide near Painthal.
