## **Encountered geological & geotechnical challenges and their remedial measures during construction of large chambers in weak rocks - A case study from Lesser Himalayas, Uttarakhand, India**

As an integral part of Tehri Hydro Power Complex (HPC) located in the state of Uttarakhand in Northern India; an underground 4 x250 MW Tehri Pump Storage Plant (PSP) parallel and close to the existing 1000 MW Tehri Hydro Power Plant (HPP). Tehri PSP is located on the left bank of Bhagirathi River in the district of Tehri about 1.5 km downstream of its confluence with River Bhilangana. The major project components are Machine Hall, Upstream Surge Shafts, Butterfly valve chamber (BVC), Penstock assembly chambers (PAC), Downstream Surge Shafts, a pair of TRTs and Outlet structures are in construction stage. During underground excavation one of the important aspects for a speedy and safe excavation is to characterize rock mass for its stand up time. The encountered litho-assemblages are Massive Phyllitic Quartzite (PQM), thinly foliated Phyllitic Quartzite (PQT), Sheared Phyllite (SP) (is observed only in the close vicinity of the shears). Several challenges are facing during construction of the

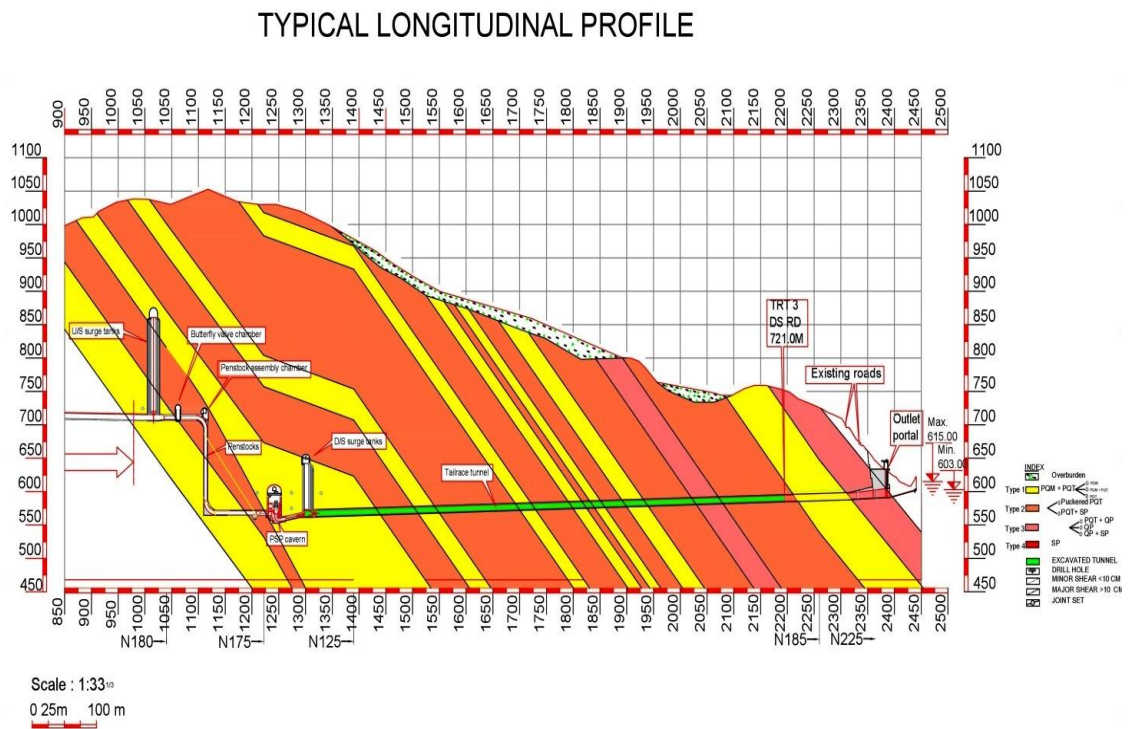
Figure 2 L-section of encountered geology during excavation of various components.

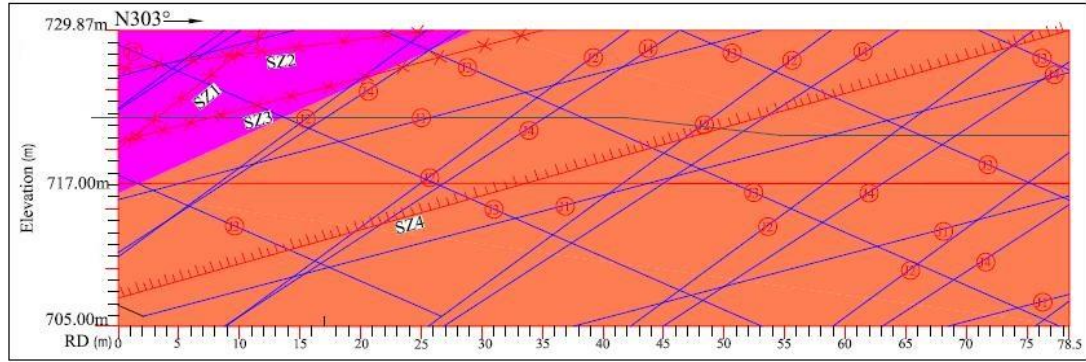
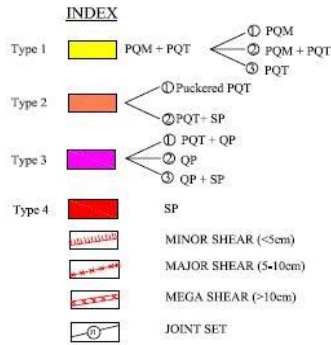
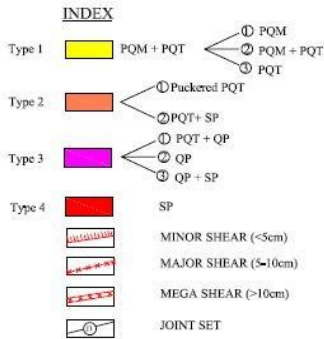
Figure 3 L section of encountered geology during tunneling of BVC & PAC

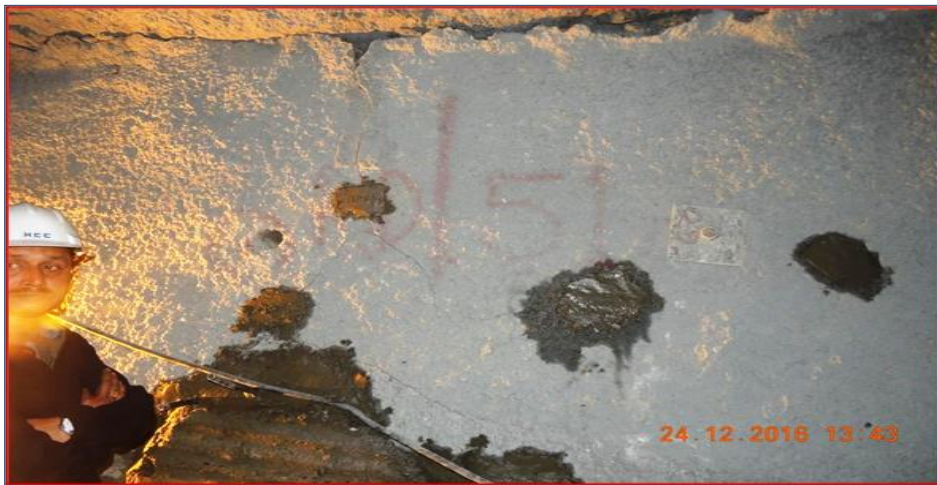
Figure 6 Rock bolt failures at RD 51.0 m

Distressing problem in D/s wall between El. 725.37m to El. 723.87m (December 2016): At RD 51.0m, two numbers of rock bolts were failed. The bearing plates of these rock bolts were detached from the bars (Figure 6). Apart from that, the bearing plates of the rock bolts between RD 45.0m to RD 56.0m and RD 66.0m to RD 70.0m were showing bending along with few cracks (Figure 7). The rock type in this stretch mainly consists of phyllitic quartzite thinly bedded with sheared phyllite (PQT+SP) and rockmass class belongs to Class IV (mostly) and V. Instrumentation monitoring through BRTs and MPBX is continuously being done and no major fluctuations have been noticed during this period.

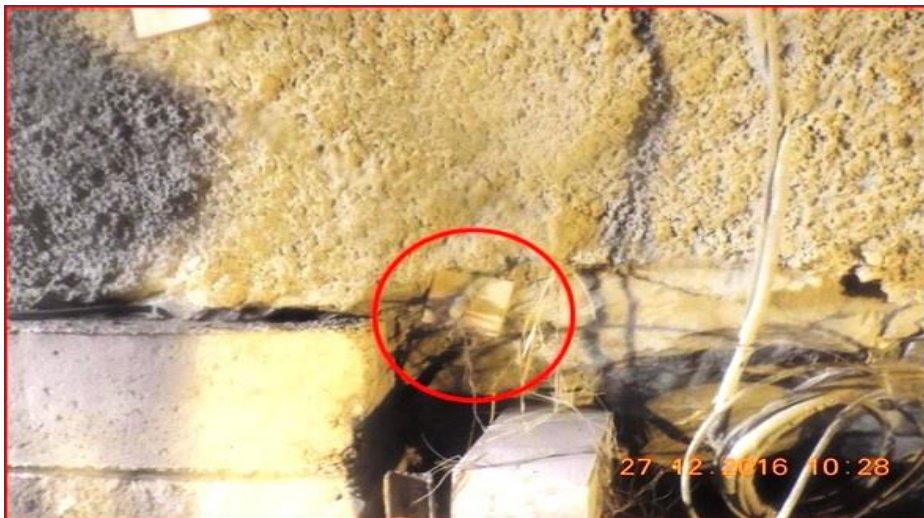
Figure 7 Bending in bearing plates of rock bolts (encircled in red)

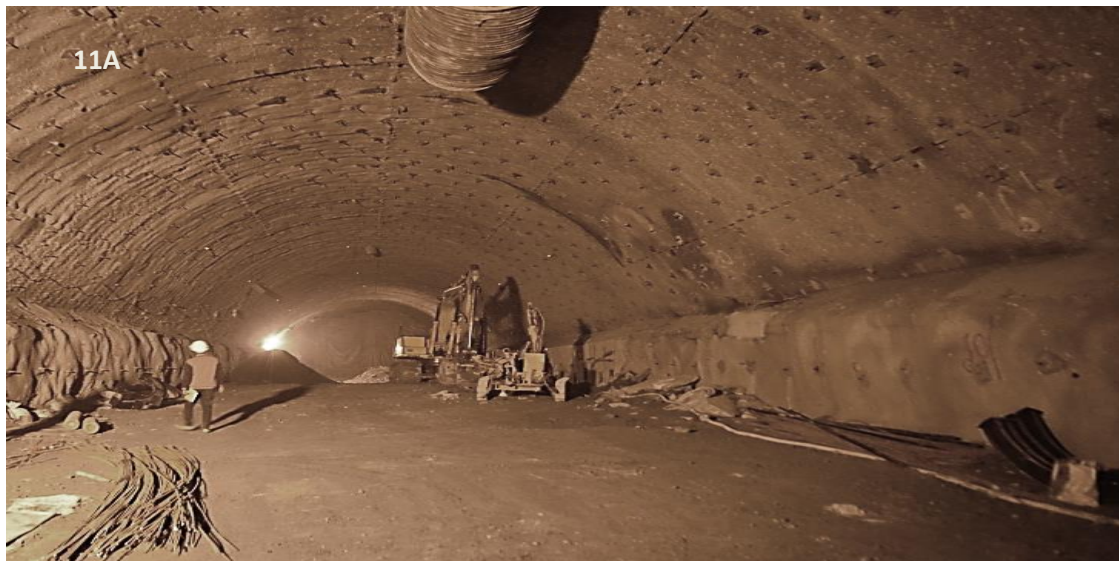
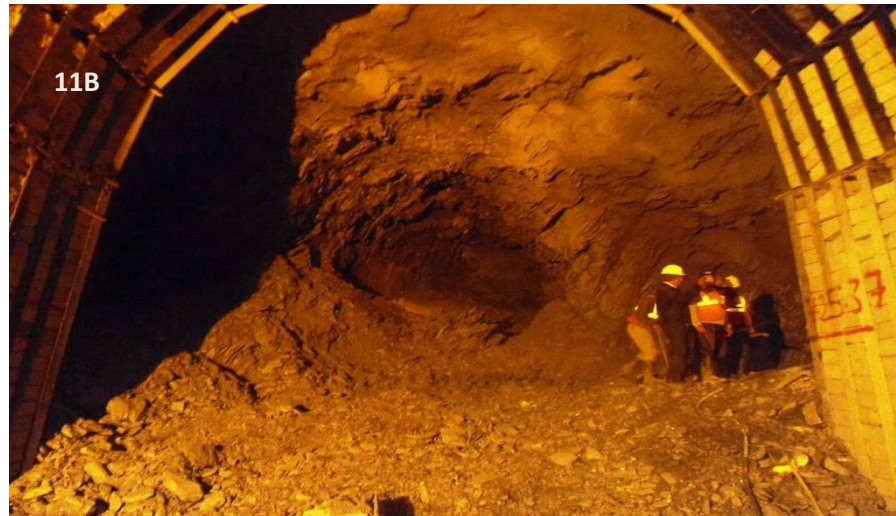
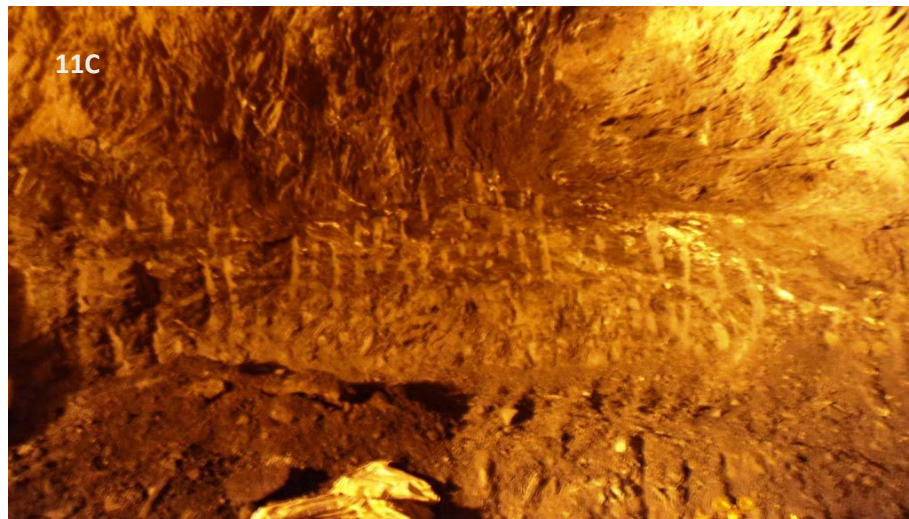
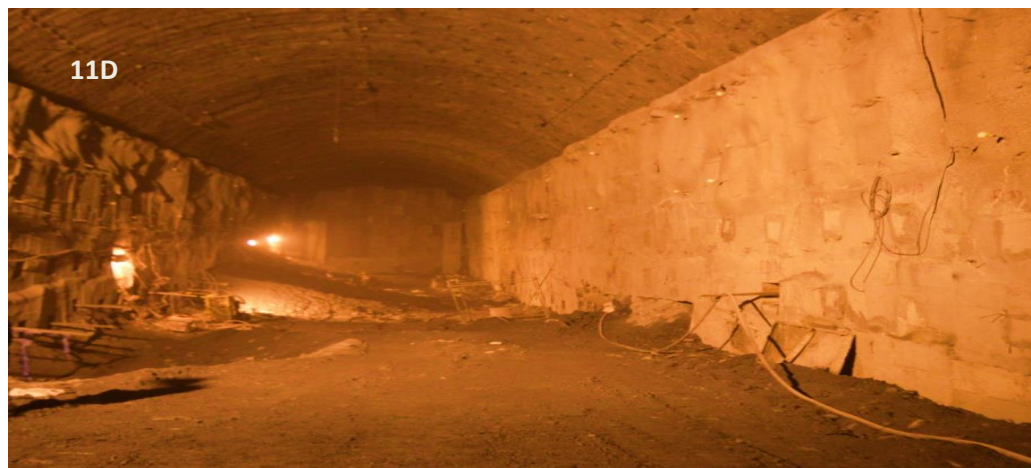
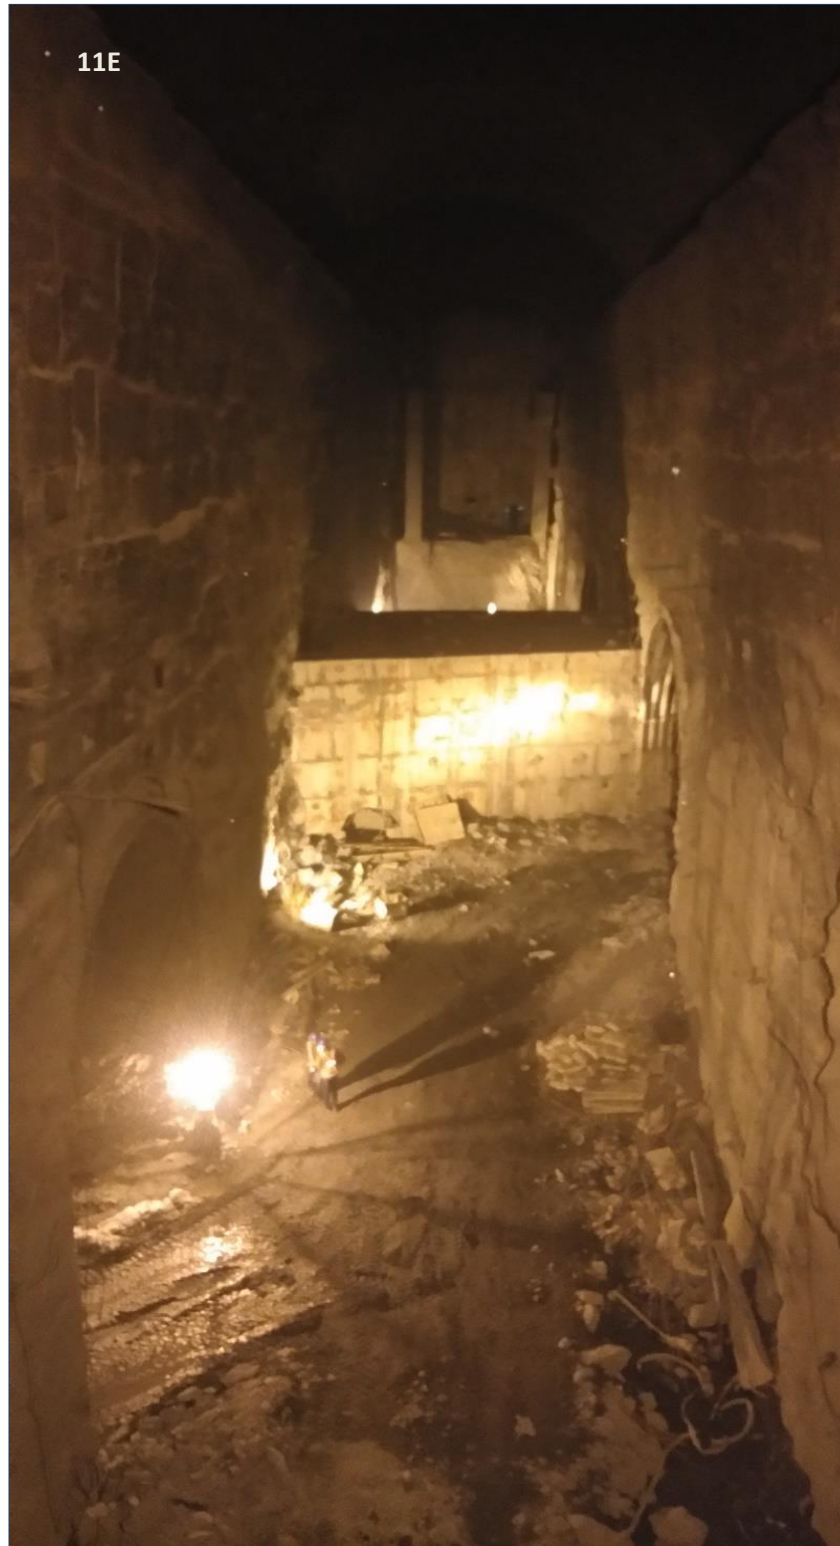
Photo 11(A) Heading Excavation after full rock support, 11(B) Pilot tunnel excavation in BVC along with side slashing, 11(C) Weak rock condition in BVC, 11(D) showing the installation of cable anchors in the walls. 11 (E&F) Complete excavation of BVC&PAC
