# Geotechnical Assessment of Diversion Tunnels, Lower Subansiri Hydro- Electric Project Assam & Arunachal Pradesh

A.K.Choudhury\* and Biswajit Das\*\*

Five tunnels each of 9.5m diameter and 600m average length have been constructed through the left abutment of proposed 132m high concrete dam across Subansiri river for the purpose of diverting water during construction.

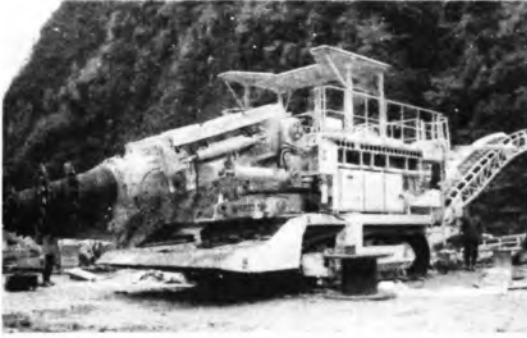
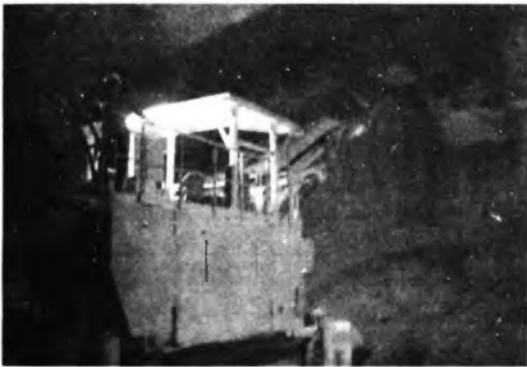
Fig. 2: Road Header PAURAT-242 after commissioning

could not achieve the rated output of 120 to 140 cum/hr. (Picture of PRAT 242 after commissioning and operation inside the tunnel, Fig. 2 & 3) The support system in the tunnels consisted of 5 cm thick initial shotcreting followed by rock bolting (2 to 3 m length) and final shotcreting (10 cm thick) with wire mesh.
