# Effect of Joint Orientations on Blast Induced Damage in Gneiss Rock Mass Subjected to Repeated Blast Vibrations

M. Ramulu<sup>1</sup> and T.G. Sitharam<sup>2</sup>

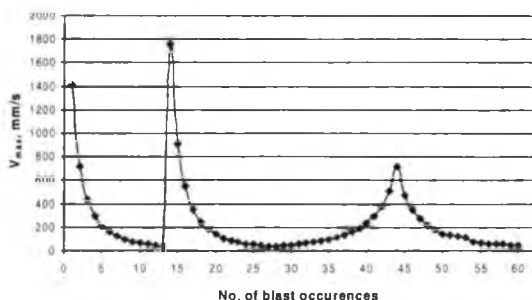
Peak particle velocities versus no. of occurrences of dynamic loading at gneiss rock mass with acute angle joint orientation is shown in Fig. 8. The vibration intensity range from 40 to 1753 mm/s at the monitoring location. The displacements of extensometer rods of 3 and 4m depth at the left-side tunnel wall were proportional to the  $V_{\max}$  for few near-field blast rounds of MAT face blasts, where the  $V_{\max}$  is above  $V_{cr}$  (Fig. 9). There was no considerable change in the extensometer readings of both 3 and 4m rods for all the  $V_{\max}$  levels below  $V_{cr}$  (353mm/s) for the MAT and CVT face blasts. After 40 blast rounds, the displacements were again observed for TRT face blasts, even at the vibration levels 233.6 mm/s, which is below the  $V_{cr}$ . There were no displacements observed below the  $V_{\max}$  level of 116mm/s. This effect gives an inference that the damage zone was below 3m from the tunnel perimeter. The exact depth of damage zone inside the tunnel walls could not be found with extensometers. Therefore, borehole camera observations were used for

Fig. 8. Peak particle velocities versus no. of dynamic loading cycles for gneiss rock mass with acute joint orientation

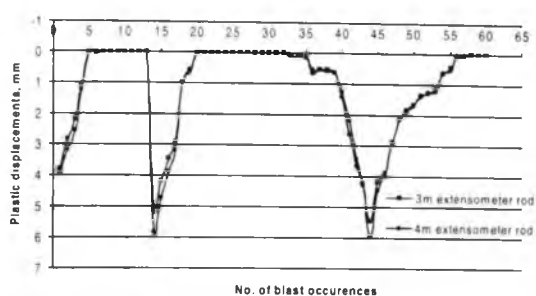
Fig. 9: Plastic deformations of extensometer rods in gneiss rock mass with acute joint orientation

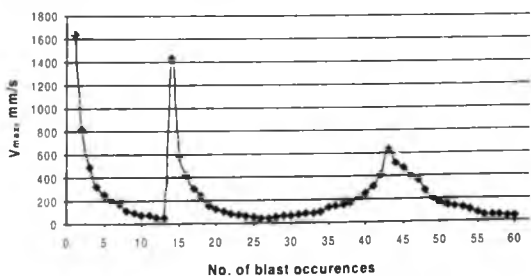
Peak particle velocities versus no. of occurrences of dynamic loading at right-side of the tunnel are shown in Fig. 11. The vibration intensity recorded at the monitoring location ranged from 42 to 1644 mm/s. The displacements indicated by the extensometer rod of 3m depth at the right-side wall were proportional to the  $V_{\max}$  for few blast rounds at the MAT whose  $V_{\max}$  were above  $V_{cr}$  (427mm/s), as shown in Fig. 12. After 16 blast rounds, it was observed that the displacements suddenly dropped to negligible levels even though the  $V_{\max}$  recorded was above  $V_{cr}$ . This effect gives an inference that the damage zone reached the anchor point of the 3.0m extensometer rod after few close

Fig. 11: Peak particle velocities versus no. of occurrences of dynamic loading in gneiss rock mass with obtuse joint orientation

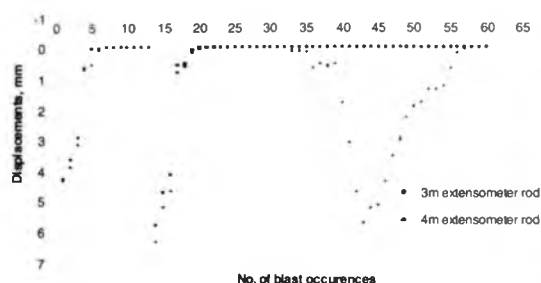
Fig. 12: Plastic deformations of extensometer rods in Gneiss rock mass with obtuse joint orientation

field blast loadings. This might be the reason why the 3.0m extensometer rod did not respond to even the vibrations levels which were greater than the critical vibration levels. There were substantial displacements observed to the 4.0m extensometer rod (Fig. 12) for the  $V_{max}$  levels above  $V_{cr}$  for the MAT and CVT blast rounds and no displacements ( $>1\text{mm}$ ) were observed for the  $V_{max}$  levels
