# **Geotechnical Problem Encountered in HRT of Pallivasal Extension Scheme, Idukki District, Kerala**

*K. Aravind,*

## **Abstract**

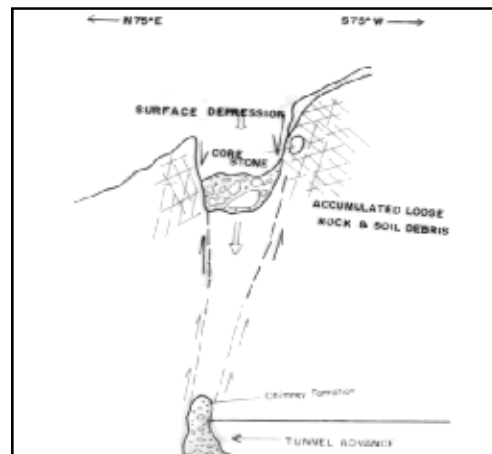
Figure 2 Wedge failure from the crown of HRT Face-2, at ch. 1170 m

The section close to the formed cavity is marked by blocky jointed rocks. The instability has arisen due to gravity falls of the jointed rock blocks from the crown. The falling blocks are separated from the surrounding rock mass by at least 3 intersecting joints to form a free falling wedge (figure 2). The vertical line drawn through the apex of the wedge falls within the base of the wedge, thus satisfying the condition of wedge failure. The 3 great circles plotted in a stereo net (figure 3) representing 3 joint planes, form a closed figure surrounding the centre of the net (representing apex of the wedge).

Therefore, the loose dead rock mass above the crown in the cavity zone were recommended for cement-sand grout (1:1) to consolidate the water saturated mass by pushing 6 – 9 m length G.I. pipes. In addition to the steel rib support, to further strength the crown and facilitate a safe advance, pipe roofing or pipe umbrella system was recommended. To impart homogeneity to the weathered rock mass in the subsided land on Tata Tea estate (picture - 2), it was recommended to grout from surface, with slurry of silica flour, cement and bentonite. Accordingly, the KSEB has incorporated the suggested recommendations and advancing driving the HRT without any hindrance.
