Geotechnical assessment regarding feasibility of proposed additional spillway site, Hirakud dam project, Sambalpur district, Odisha

Geological Survey of India, Eastern Region, State Unit: Odisha, Bhubaneswar

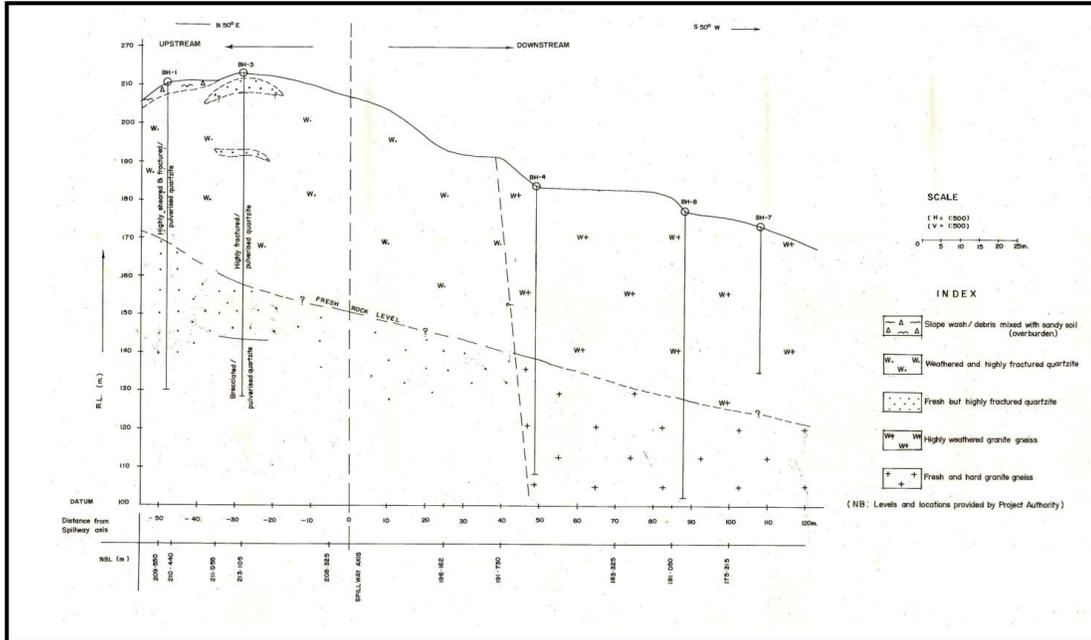
Core logging of bore holes no. 1 & 3 drilled at the u/s part of the proposed additional spillway site indicates presence of intensively fractured, brecciated & sheared quartzite with low core recovery & very poor to poor RQD. Based on drill core log data geological cross section and longitudinal sections were prepared and geotechnical parameter values are plotted on the map to understand the subsurface condition of the site. (Figures 11, 12, 13 & 14). Brecciated quartzite (angular to sub angular rock fragments of quartzite set in siliceous & /or pulverized rock mass, fault gouge), highly porous and friable rock mass extends up to drilled depth. Occurrence of highly fractured (brecciated) & sheared core pieces from surface level up to drilled depth with intermittent interception of sludge of gougy/ pulverized rock mass etc. conforms likely presence of a structurally weak zone. Three drill holes (drill hole no. 2, 11 & 9) drilled on the proposed spillway alignment intersected fresh but intensively fractured quartzite rock at depth 7.47 m at the left side & 0.52 m at the right side and at depth rock becomes highly pulverized and forms powdery mass. Study of geotechnical parameters also indicate a very poor quality of rock mass in terms of competency as reflected from low uniaxial compressive strength (17.77-78.15 N/mm²).

Figure 11 Geological sections from upstream to downstream of proposed additional spillway site.

Based on the above facts, the site does not appear to be suitable for a spillway site from geological point of view and search for alternative site has been recommended.

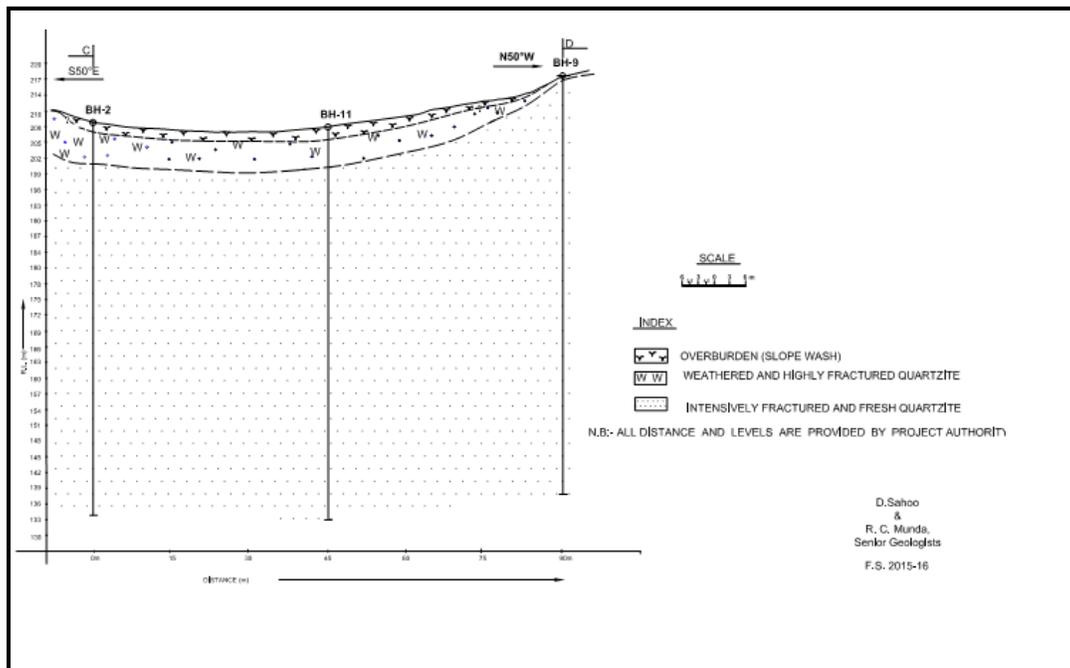
Figure 12 Longitudinal Section
